Richmond Road Turbine Spatters

Ken Bell
Rondeau Watershed, March 11th 2008

FINAL REPORT

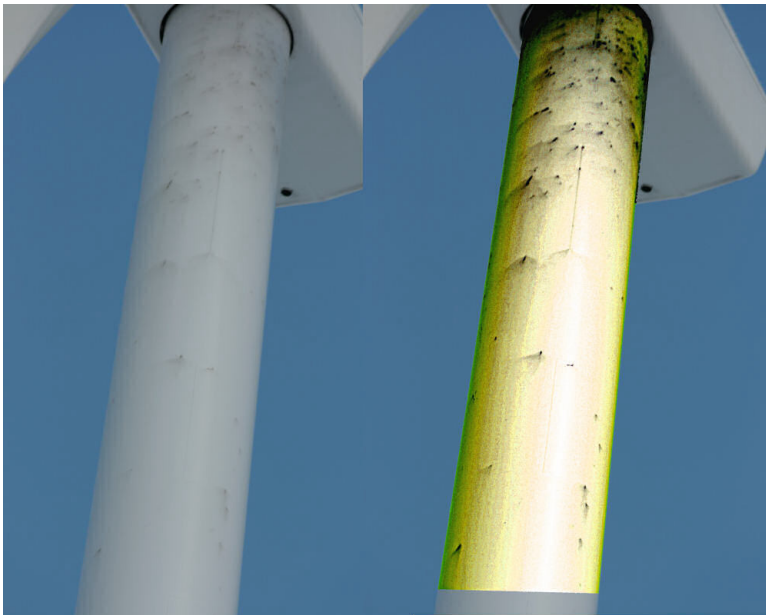
I noticed, on the top 3rd of the north turbine column, a number of spatters that appeared to radiate from the southwest.

*Richmond Road turbine, March 1st 2008
Image enhancement used to clarify the spatters*

From the direction and distribution of the spatters it appears that individual tracks were moving a high velocity, from the South-southwest. Parabolic spatter patterns indicate a direction of impact. Notice on the lower spatter vectors, the angle of impact is quite high indicating something falling. The lower density of spatters further down the column is probably correlated and would indicate bodies either losing forward momentum or being thrown at a descending angle.

Unless a realistic alternative explanation that takes into account the available data is forwarded, I would recommend, further observations of all turbine surfaces. If the spatters represent a mechanical failure then the possibility of environmental pollution exists. With more data such as the physical properties of the lubricant, this method will be refined. If on the other hand, spatters result from an avian collision then questions surrounding the subject of flight avoidance must be asked.

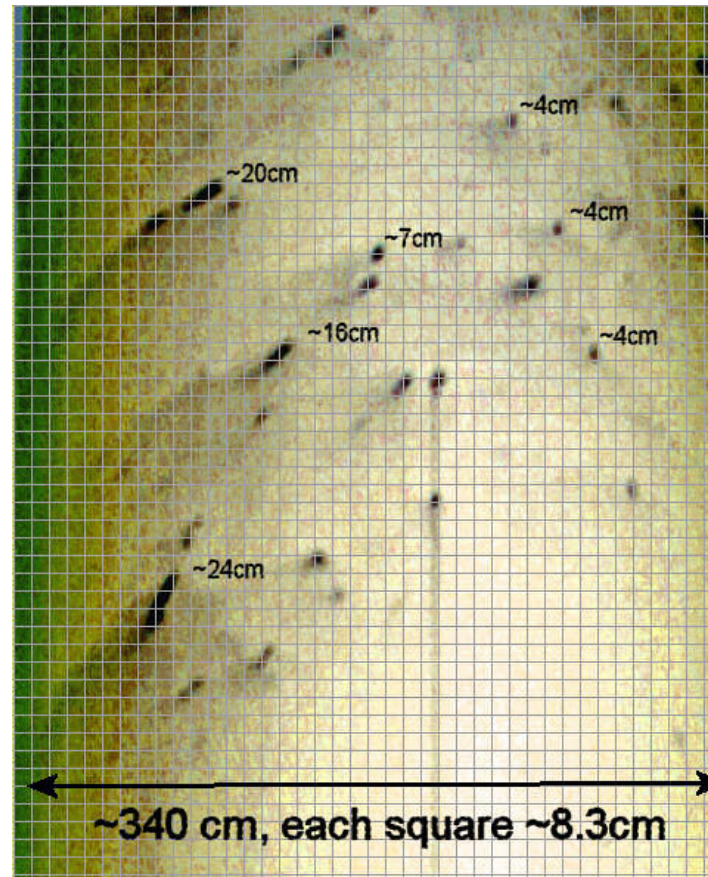
Below, in this photo smaller spatters are 16% the size of larger ones.

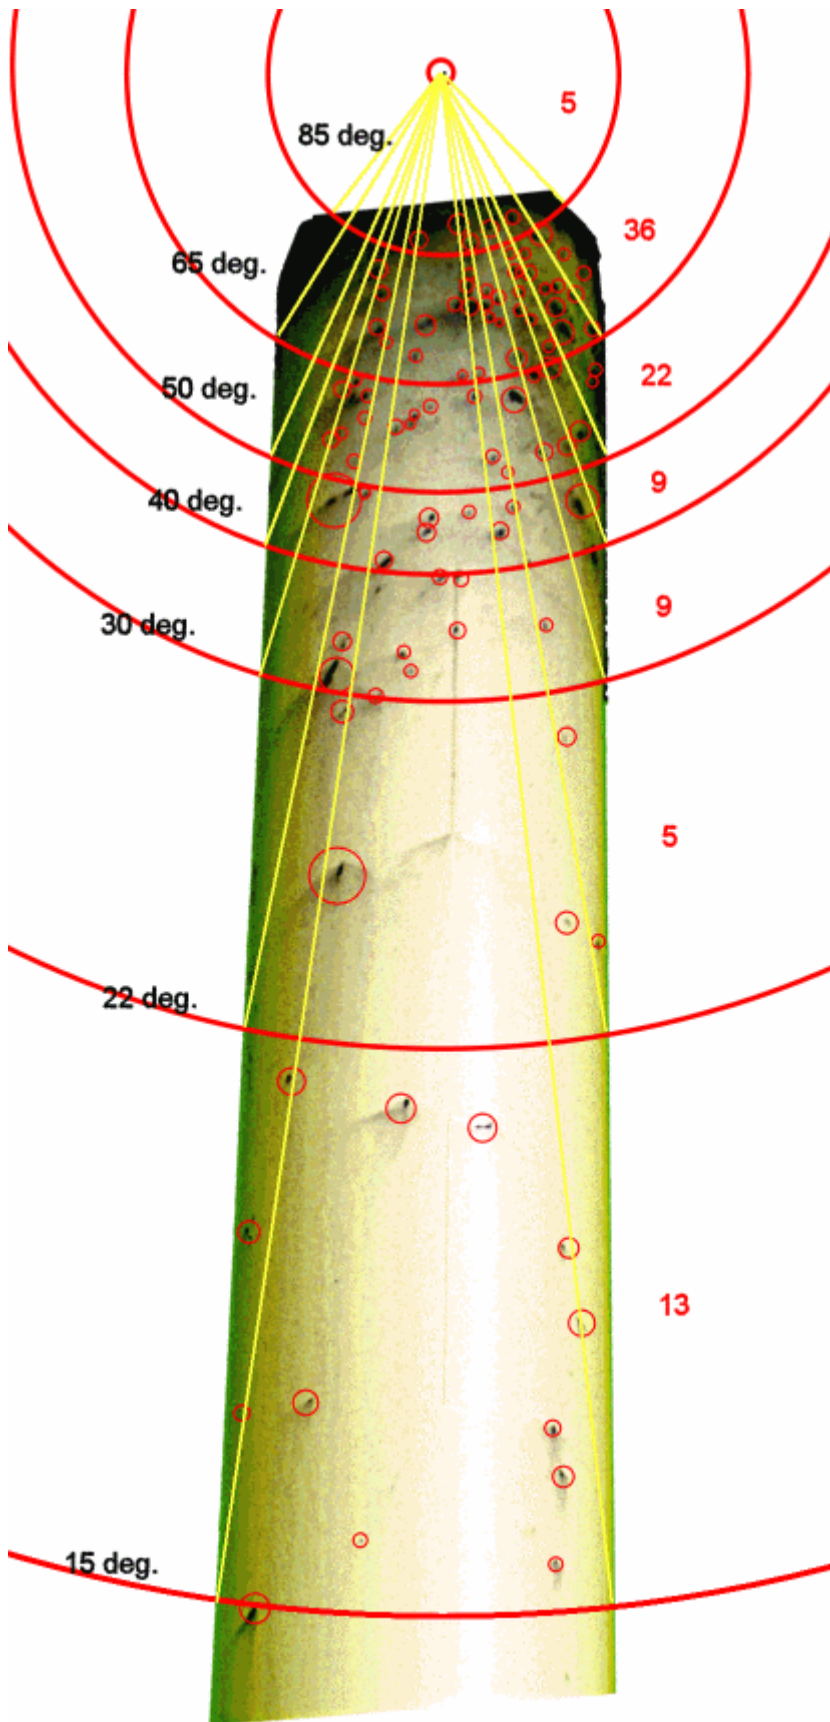
Below is an image enhanced cutout of the column of the North Richmond Road turbine. The red arcs define an area within which a transect count is made. Counts are numbered along the right of the column. The yellow radiating lines from the top center define the transect angles that are used to determine the proportion of the swept ring that each transect occupies. Counts are projected throughout the transect ring in proportion to the sector area.

Transect 1	360	/85	x5	=	21
Transect 2	360	/((85+65)/2)	x36	=	173
Transect 3	360	/((65+50)/2)	x22	=	138
Transect 4	360	/((50+40)/2)	x9	=	72
Transect 5	360	/((40+30)/2)	x9	=	93
Transect 6	360	/((30+22)/2)	x5	=	69
Transect 7	360	/((22+15)/2)	x13	=	253

TOTAL calculated over swept area 819
