WINDFARM DEVELOPMENTS ON BLANKET BOG

***A cautionary tale from Derrybrien, Co Galway,
and
pointers for safeguards needed when similar developments
are proposed for the United Kingdom***

John Phillips, MA, CBiol, MIBiol

September 2005

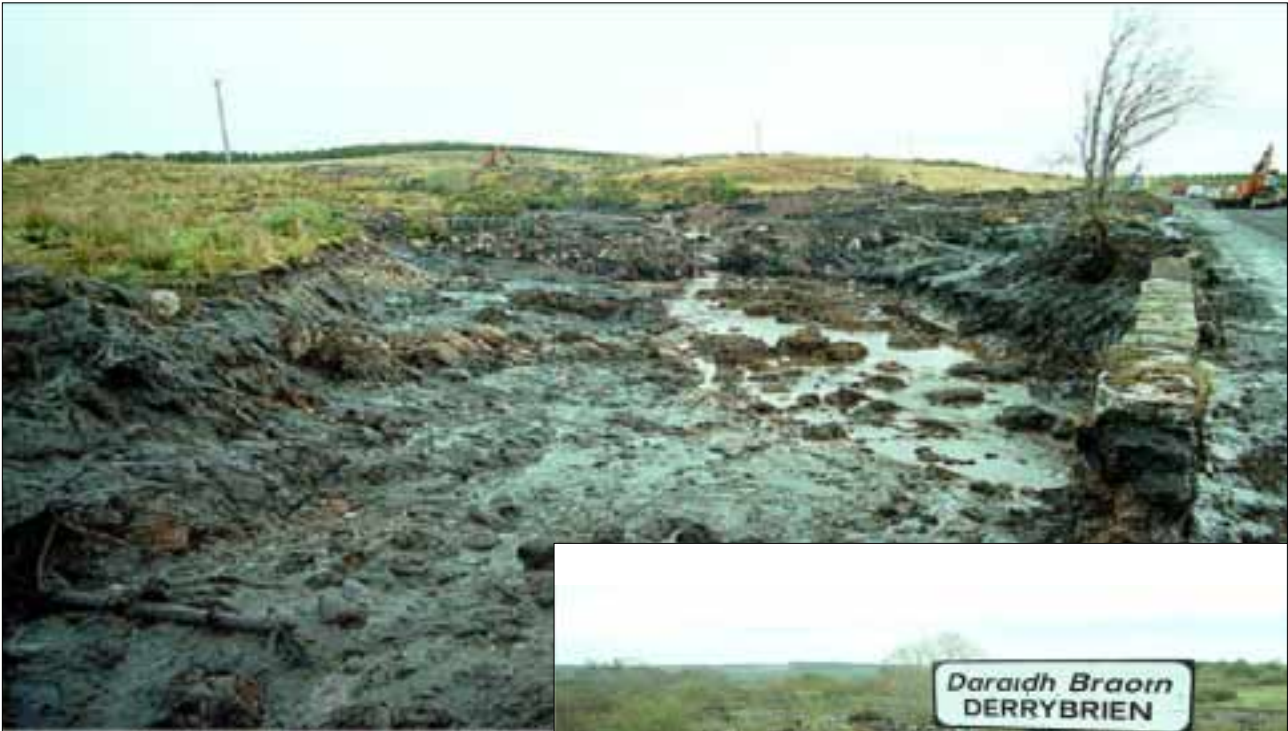
Plate 1, above: Peat from the bogslide, by now a thixotropic slurry, pressing on the Flaggy Bridge just east of Derrybrien. The bridge was closed for several days amid fears that it would collapse. The watercourse is normally three to four metres below the road level.

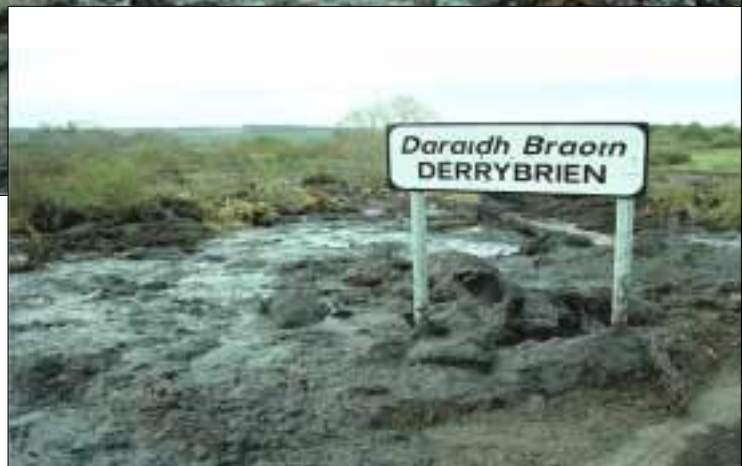
Plate 2, right: a road sign just by the bridge.

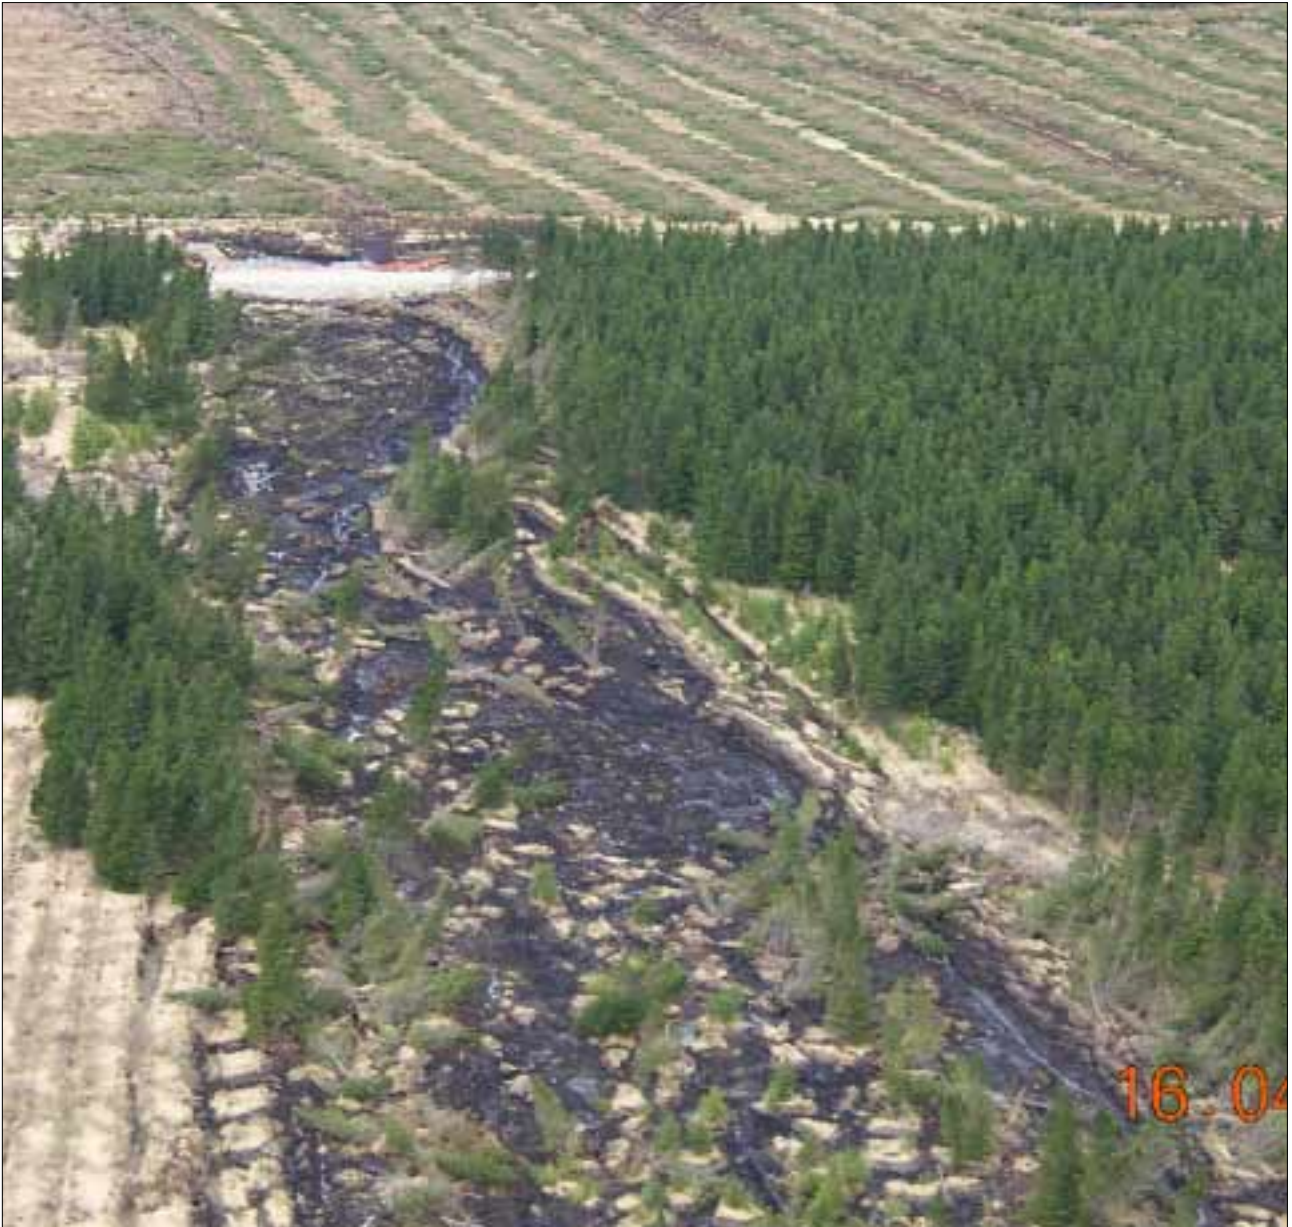
Plate 3: An aerial view of the source of the slide of 16 October 2003, taken in April 2005. The base of T68 is clearly visible.

It came to rest about a kilometre down the slope but, following torrential rain, slid further into a local watercourse on October 29 and, from there, down the Owendalulleagh River into Lough Cutra.

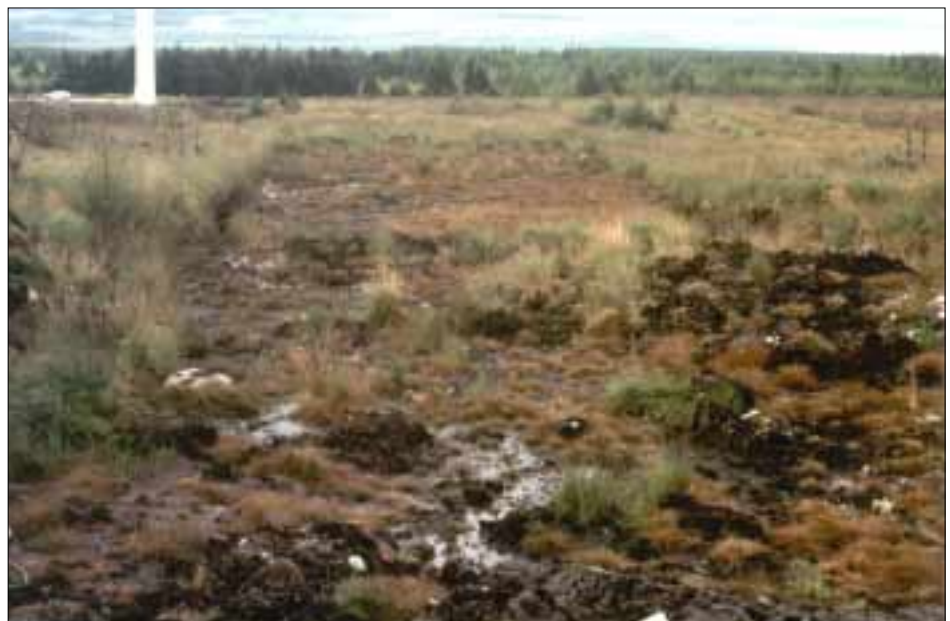
Plate 4, right: The source of a much smaller slide that occurred on 2 October 2003 (see text). It originated by a floating road near T17, some 250 metres west of T68.

There had already been a small slump measuring some 40m x 20m on October 2. This occurred on a ca 40° slope by the edge of a newly-constructed floating road built for servicing the site (plate 4).

The first (and warning) landslide on October 2, 2003 occurred alongside a floating road where the acrotelm had failed. The mechanics of this are straightforward. Loading the acrotelm results initially in compression and sinking and thus the deformation of the acrotelm underneath. After a while, the acrotelm is stretched beyond its tensile strength and elastic limit to the point where it tears. If the road is running along a contour, this weakness will predispose the peat to slip because the cohesion of the cover over the acrotelm provided by the overlying acrotelm against gravitational forces has been compromised.

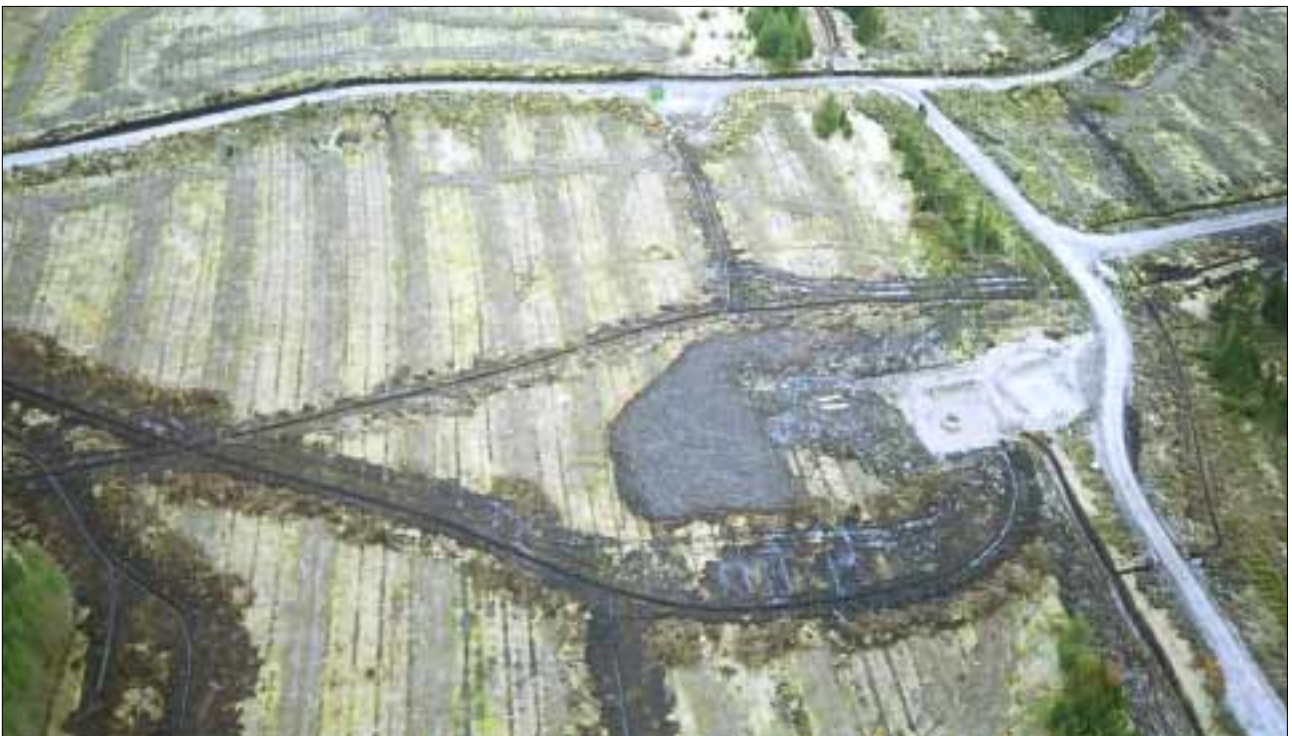
Plate 6: An aerial view of the site showing floating roads used for access tracks and a near-complete turbine base awaiting final mineral back-fill. Note the excavated peat side-cast and left exposed. The light green/grey areas are trees cut by a 20-tonne tree harvesting machine and laid in rows to support the weight of the machine as it progresses on the blanket bog. The trees have been left to decay.

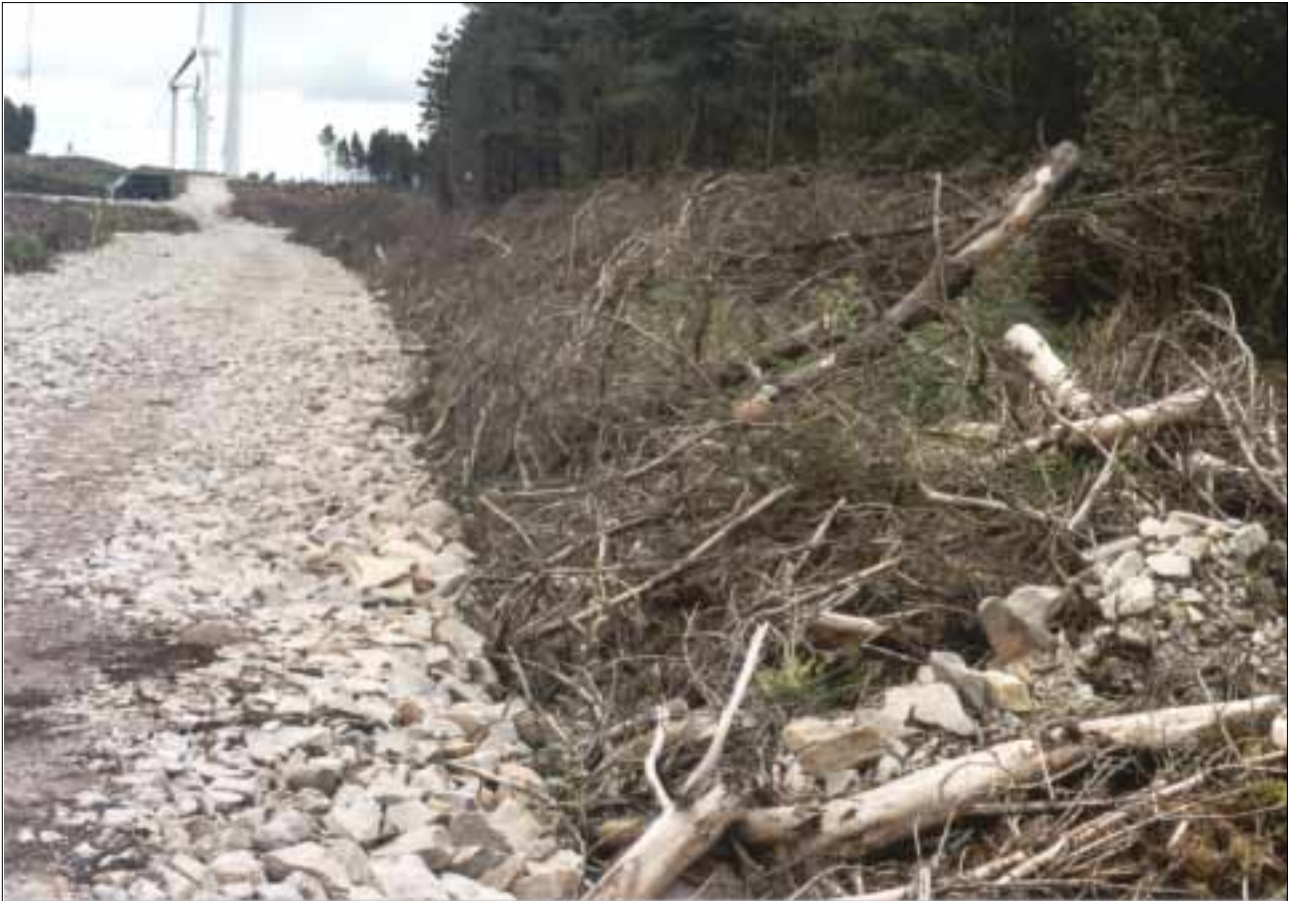
Plate 7: A supposedly 'floating' road actually sinking rapidly and likely to flood when heavy rain falls.

Lengths of road constructed in this way in the early days of the project now lie a full metre below the level of the surrounding bog (plate 7) and are waterlogged in places. The contractor’s solution was to pile on more mineral material to raise the road surface above the water-table. This further increased the loading. Elsewhere, where the pressure of the road on the acrotelm had caused it to sink, sticks which protruded from beneath the road were by now pointing priapically skywards.

As the roads are about four metres wide, the surface loading on the acrotelm is in excess of three tonnes per running metre, equivalent to a ground pressure of over 0.8kg/cm². The regular passage of vehicles with a loading as low as 0.3kg/cm² can cause acrotelm to fail as will repeated foot traffic (*viz* the Pennine Way – an average human being walking on blanket bog exerts around 1.5 to 1.8 kg/cm²). In contrast, the high-capacity cranes required for turbine construction weigh around 80 tonnes unladen and load the roads by anything up to 4kg/cm² over a wide area.

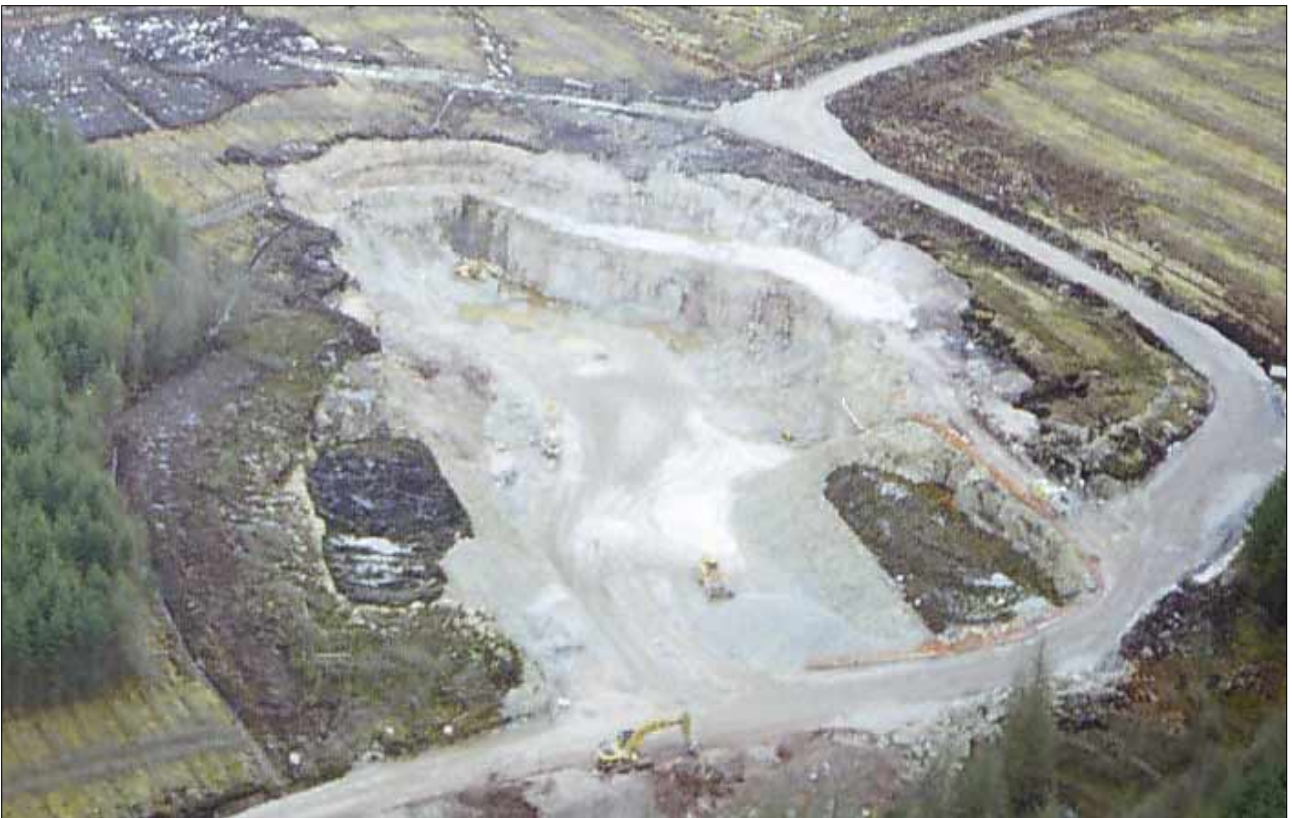
Plate 8: An aerial view taken in April 2005 of the largest 'borrow' pit on the site, excavated from stratified limestone and originally over-burdened with two metres of peat and three of boulder clay, seen here cast to the side. The excavators suggest the scale. Its volume is estimated at 150,000 m³.

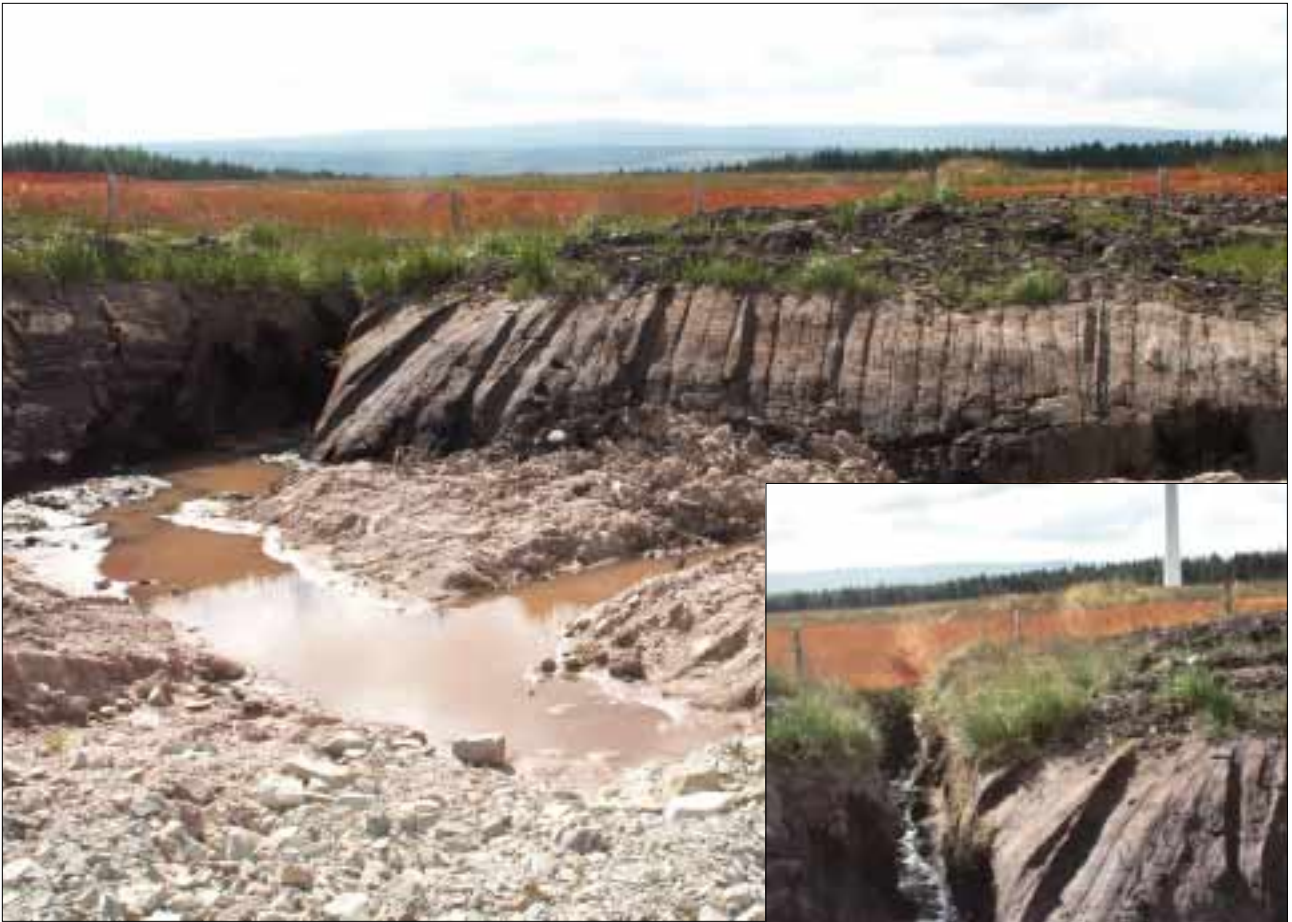
Plate 10, above left: The surround for a turbine base showing boulder clay under the peat.

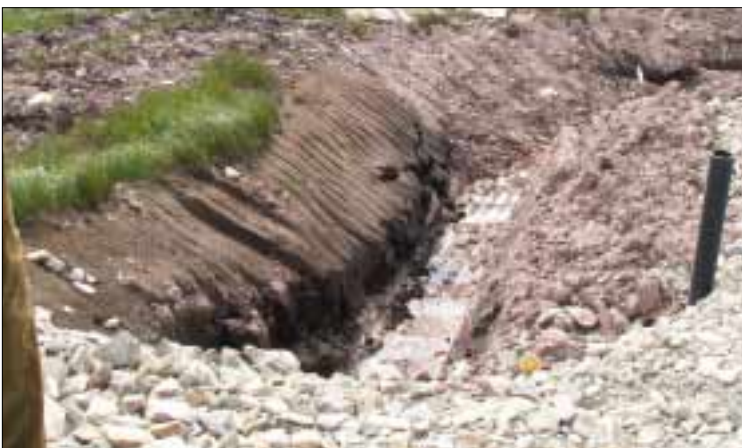
Plate 11, left: In several places on the site, the boulder clay exposed in this manner is already eroding, leaving the peat high and dry.

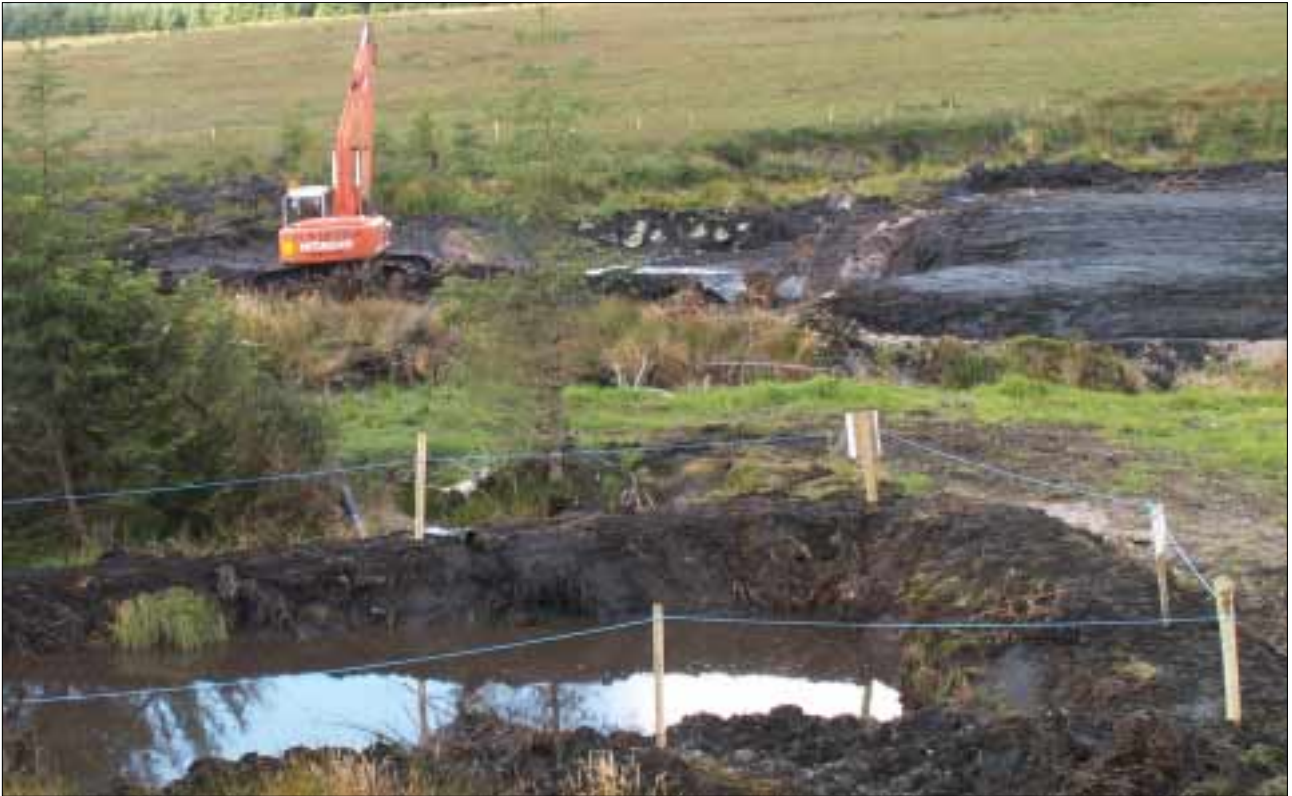
Plate 13: Spooning displaced peat with a digger into specially-constructed lagoons where, it is planned, the scattering of hayseeds will stabilise the slurry and prevent further pollution of the watercourses and the Lough Cutra SAC/SPA. See page 11.

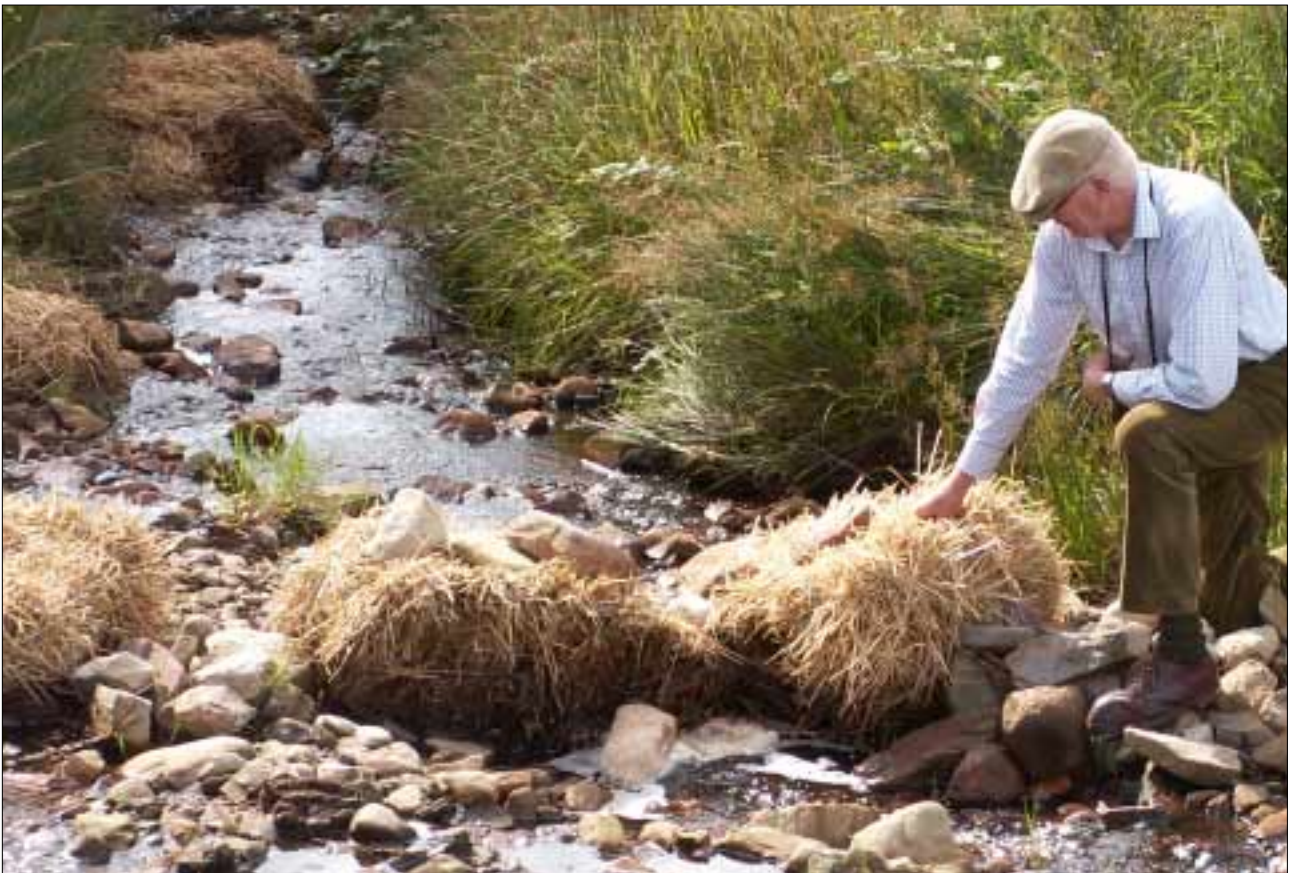
Plate 14: A ‘silt trap’, sited adjacent to the above lagoon, made from barley-straw bales. At low flow levels, the water runs through the stones in the stream bed and little, if any, of the suspended matter is trapped. When the flow is high, it pushes the bales aside and the increased load of suspended matter again goes straight down the watercourse. Two displaced bales can be seen on the top left of the picture. Unless these bales are replaced on an eight-week cycle, their decomposition is itself pollutant.

Two important points about using straw in these circumstances are a) that regard must be paid to eutrophication caused by decomposition of the straw used in the filter beds and b) for the beds to maintain effectiveness they need to be renewed at least every eight weeks even under normal rainfall patterns, a regime that would have to be maintained more or less indefinitely and certainly long after the site was decommissioned.

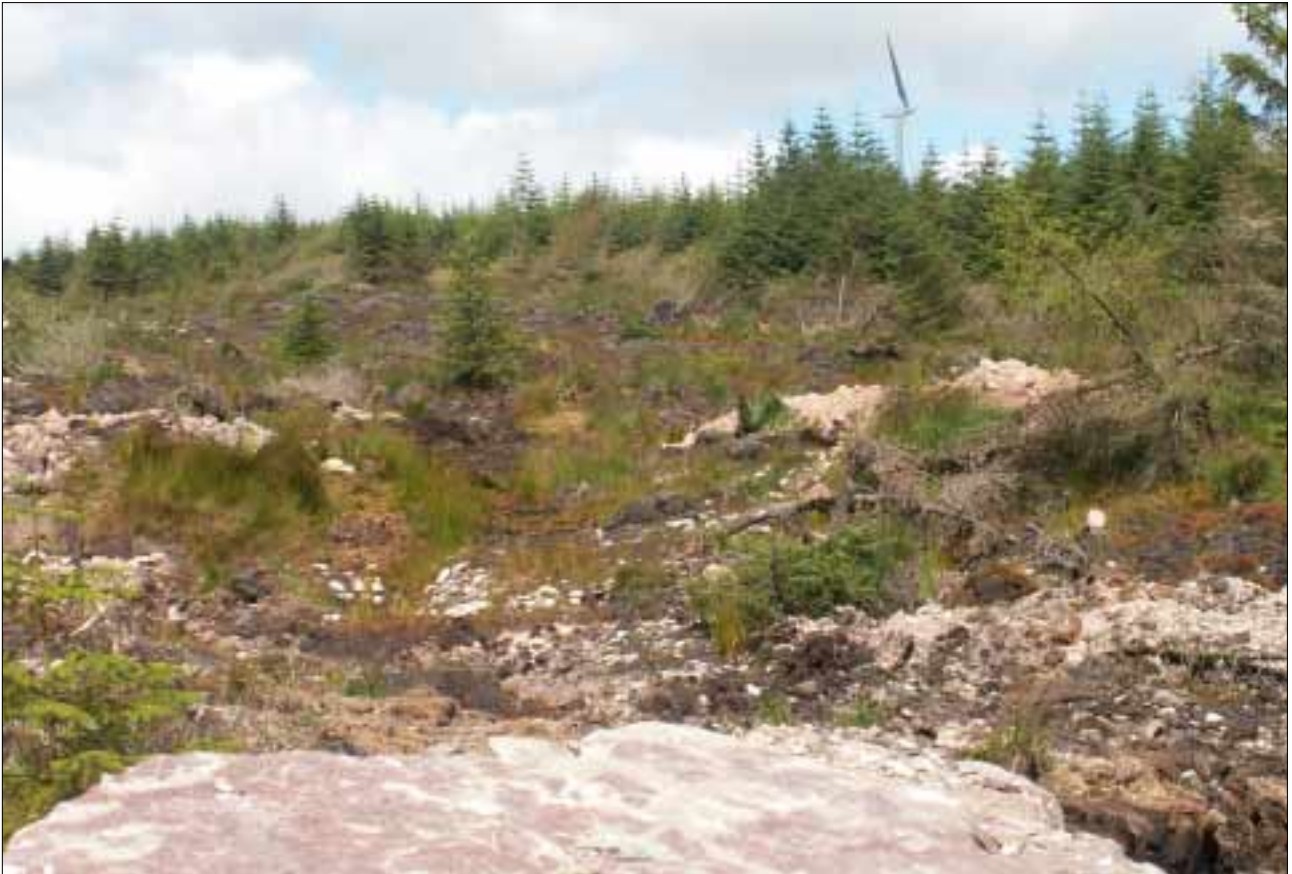
A causeway forming a dam designed to hold back some of the collapsing bog was inspected. When asked how much rock had been used (out of a 'borrow' pit opened specially for the purpose), the host said '20,000 tonnes' (plates 16-18). The author forebore to point out that, although 450,000 tonnes of material had passed the spot two years previously, the causeway with its through-pipes was holding up probably no more than 100 tonnes of peat slurry on its up-side.

Plate 16, above: Looking up from a causeway built across the path of the slide to stop peat that is no longer there from sliding again. Note the drop in ground level compared to the surrounding afforestation.

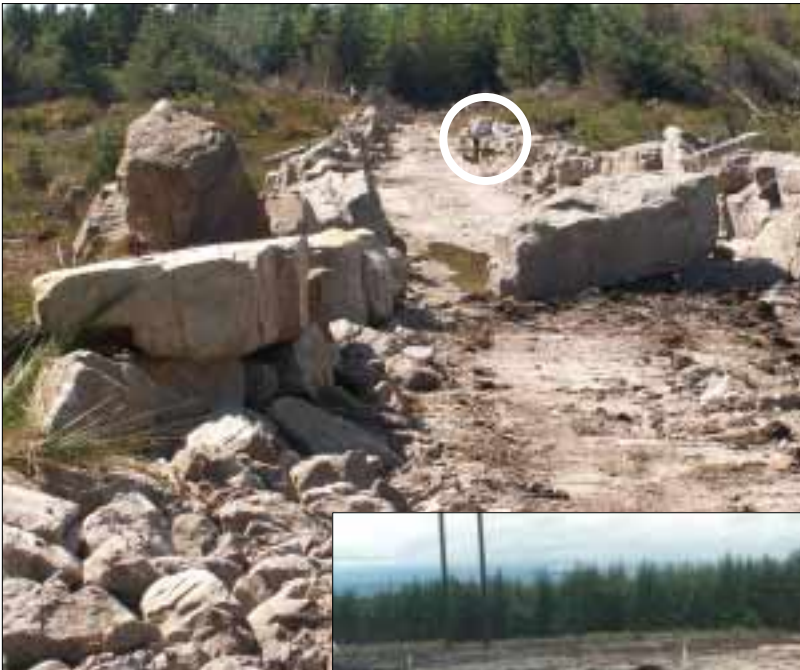
Plate 17, left: Looking across the causeway which took 20,000 tonnes of rock to build. For scale, note the person (circled) standing half-way across. The reasoning behind its construction is hard to fathom if it is anything other than a political palliative.

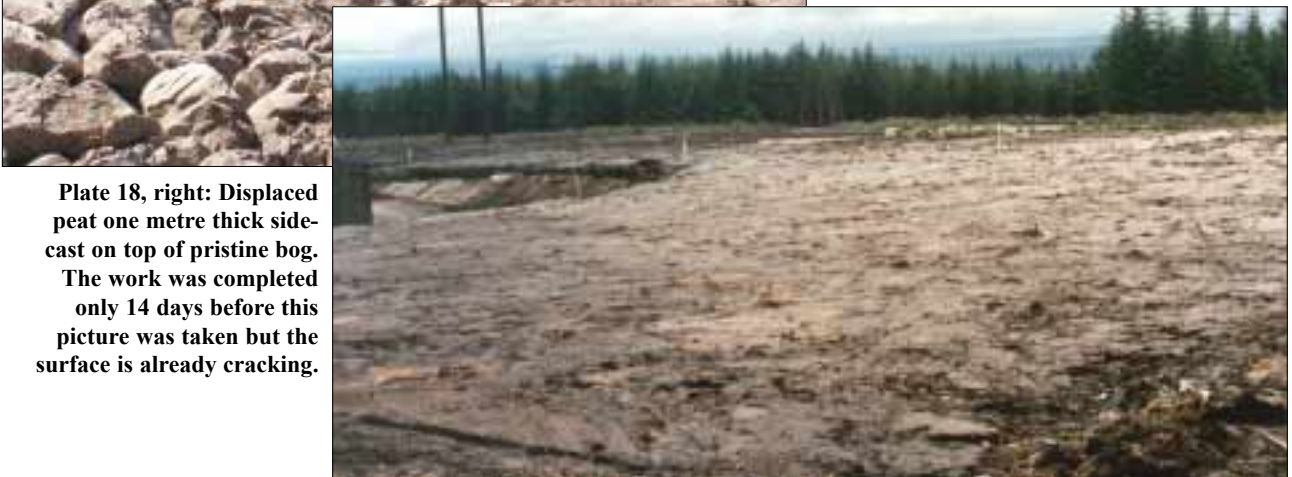
Plate 18, right: Displaced peat one metre thick side-cast on top of pristine bog. The work was completed only 14 days before this picture was taken but the surface is already cracking.

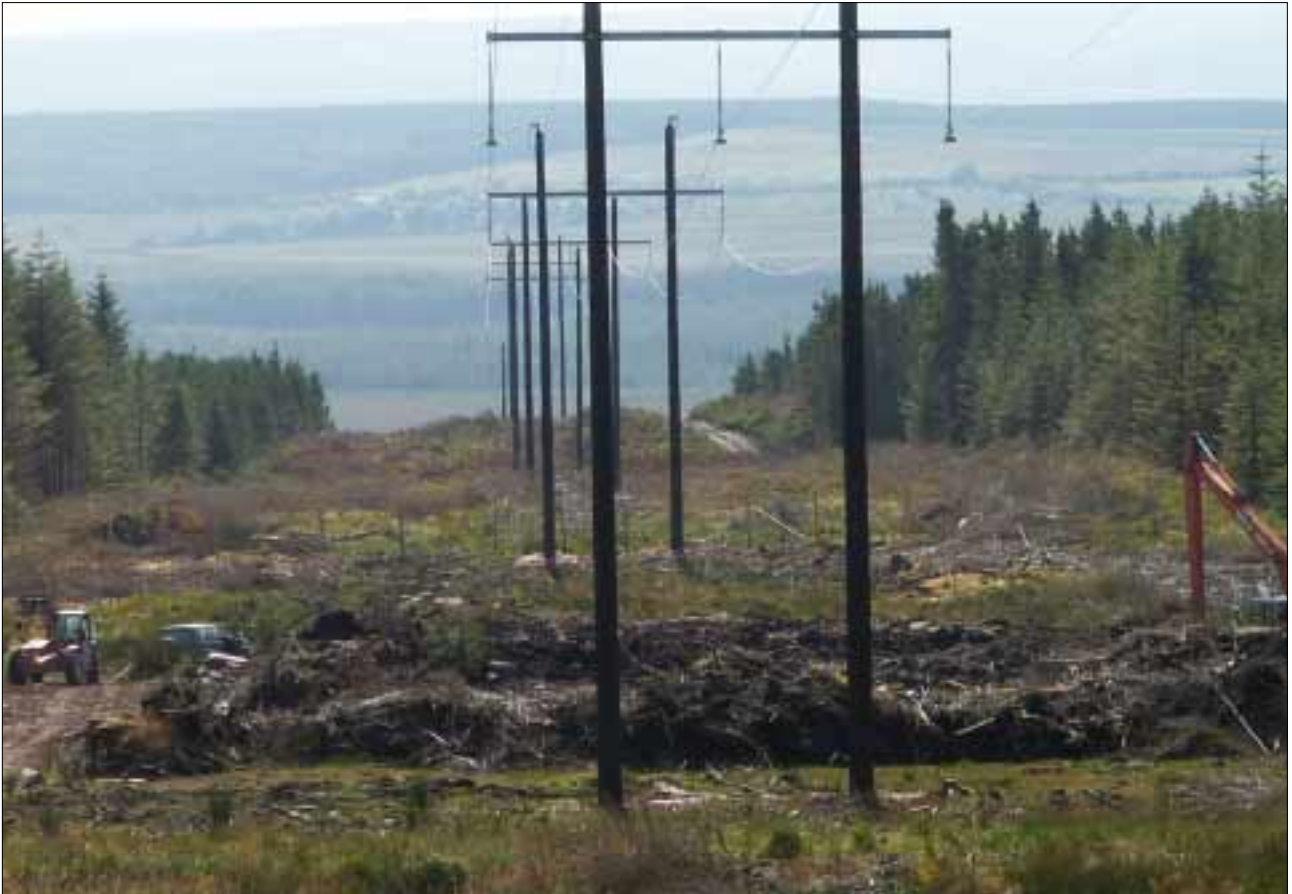
Plate 19: One of the peat lagoons discussed on page 13. The watercourse polluted by the bogslide runs right to left behind the mechanical digger in the left foreground. Peat still in the watercourse, now restrained by a bund, was being lifted into the peat-walled lagoon visible in the foreground. (The power line is the site's 110kV link to the grid.)

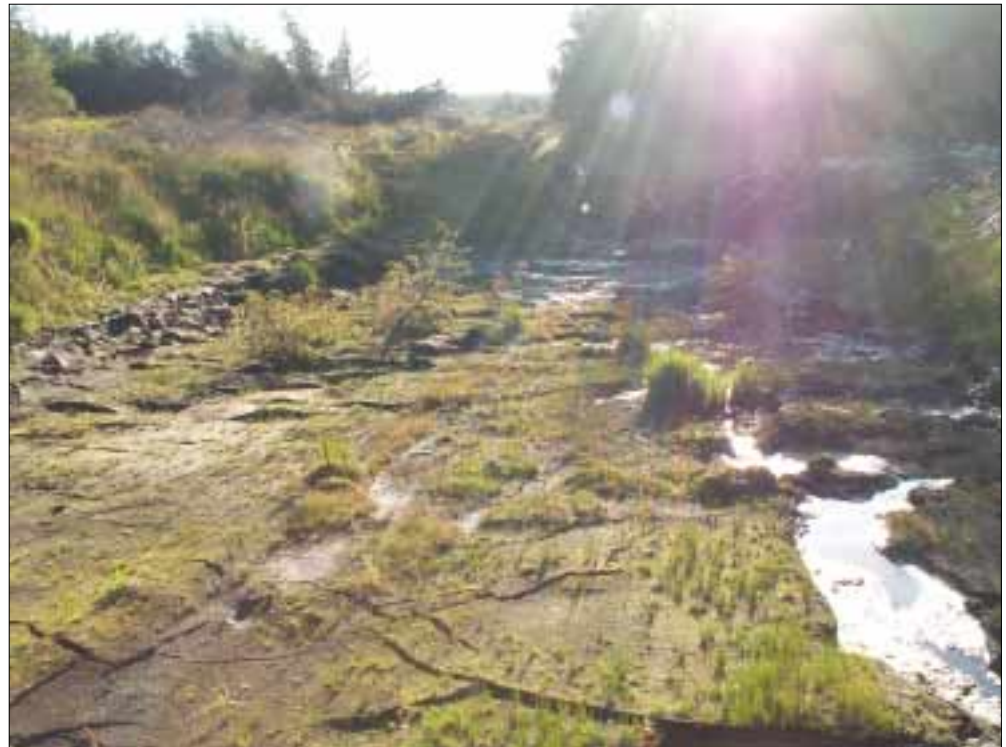
Plate 20: The view upstream from the bund, a few hundred metres downstream from the causeway shown on page 14. Twenty-two months after the slide, residual peat was being spooned out with an excavator and dumped into a prepared lagoon, see above. Here, it will dry out and decay, releasing CO₂ to atmosphere.

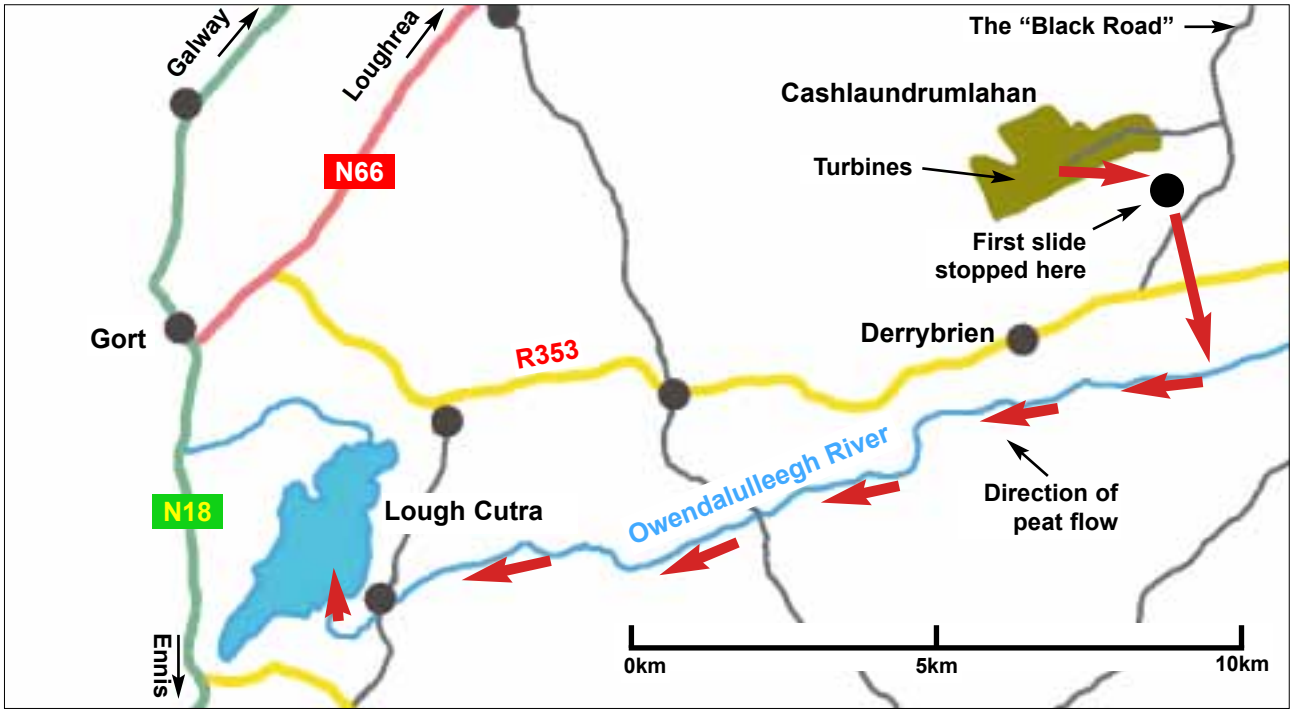
Plate 21: The approximate path taken by the bogslide from the base of Turbine 68 on top of Cashlaundrumlahan into a local watercourse, over the Derrybrien-Loughrea ‘Black Road’, across the R353 Portumna road and into the Owendalulleagh river. It then flowed downriver into Lough Cutra.

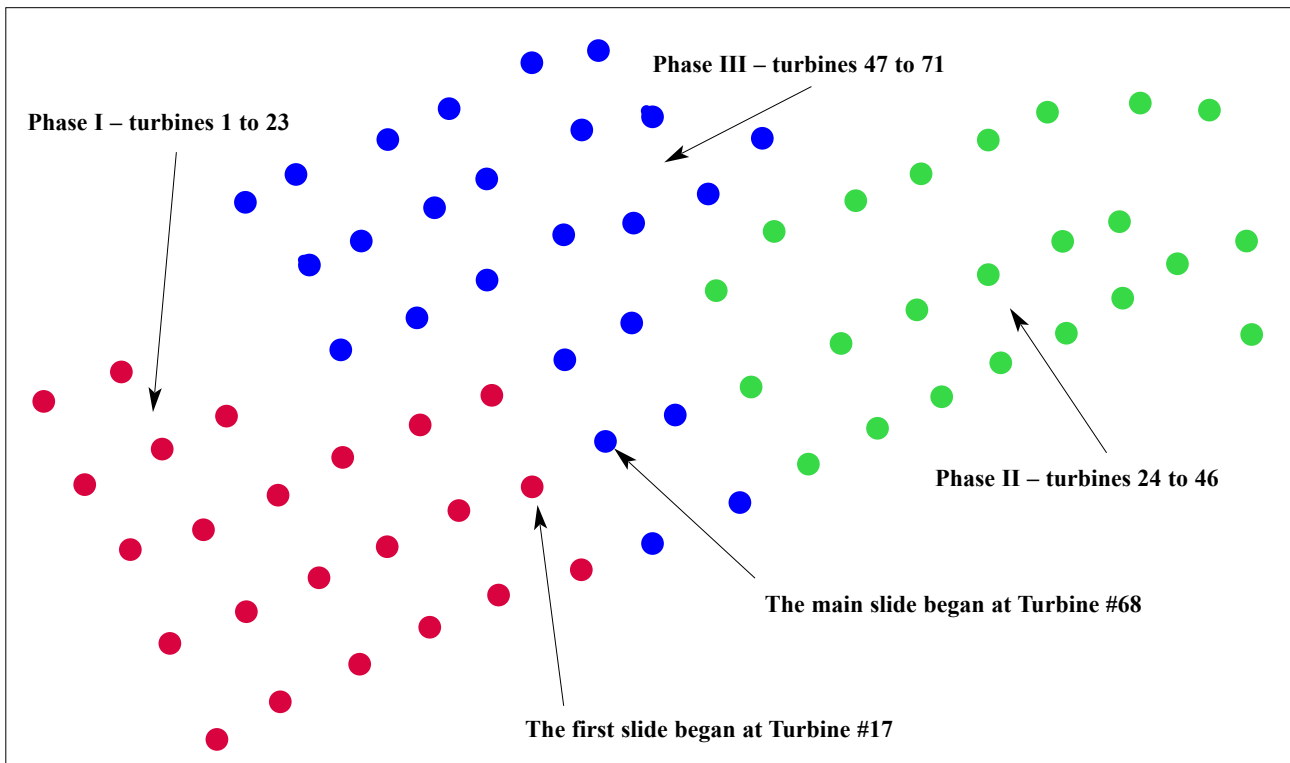
Plate 22: The layout of the turbines on the Derrybrien site. The small slide of October 2 occurred at T17, approx 230 metres west of the point of origin of the main slide of October 16, which was at the base of T68. It is apparent that the EU Environment Commissioner’s concerns over ‘salami slicing’ and other assessment issues have some substance.

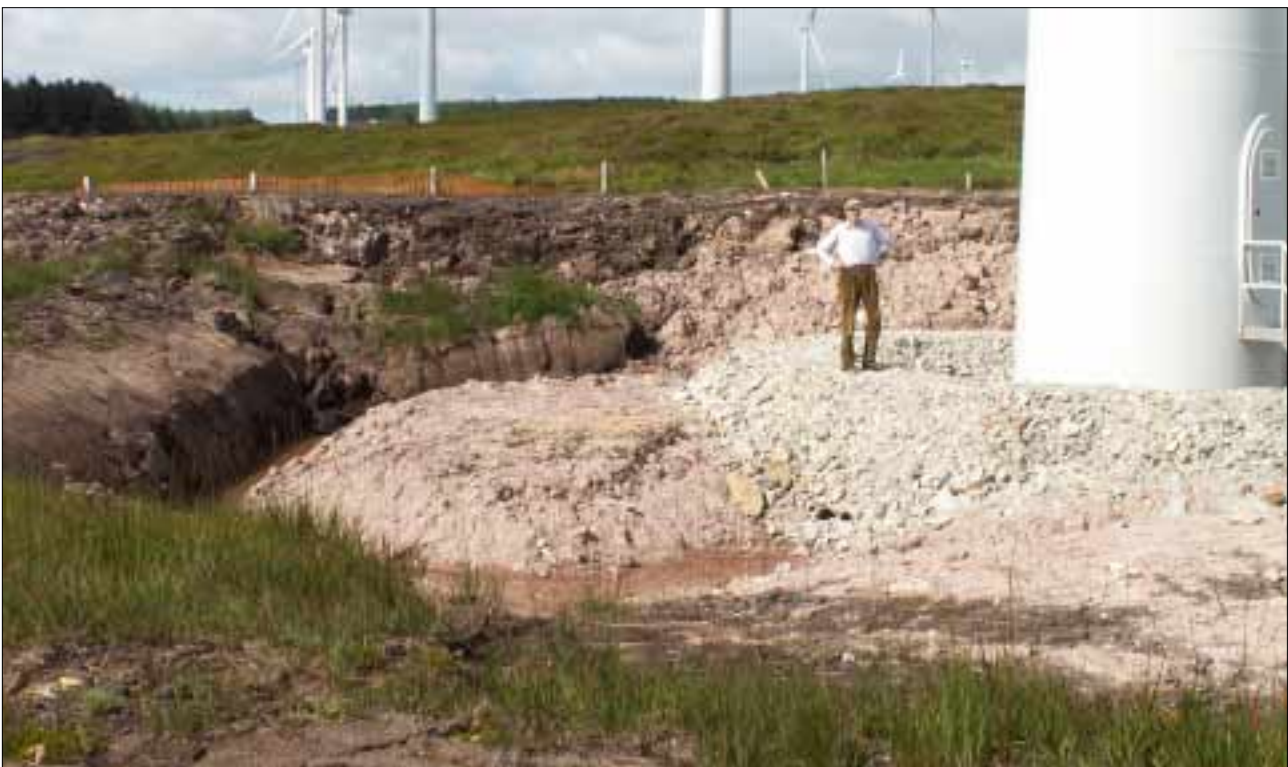
Plate 23: A completed turbine base on Derrybrien showing exposed peat which will oxidise and erode over time. While other peatland projects propose different construction techniques, the risk of pollution and landslip remains whenever such terrain is industrialised, whatever the perceived political acceptability of its purpose.
