WINDFARM DEVELOPMENTS ON BLANKET BOG

***A cautionary tale from Derrybrien, Co Galway,
and
pointers for safeguards needed when similar developments
are proposed for the United Kingdom***

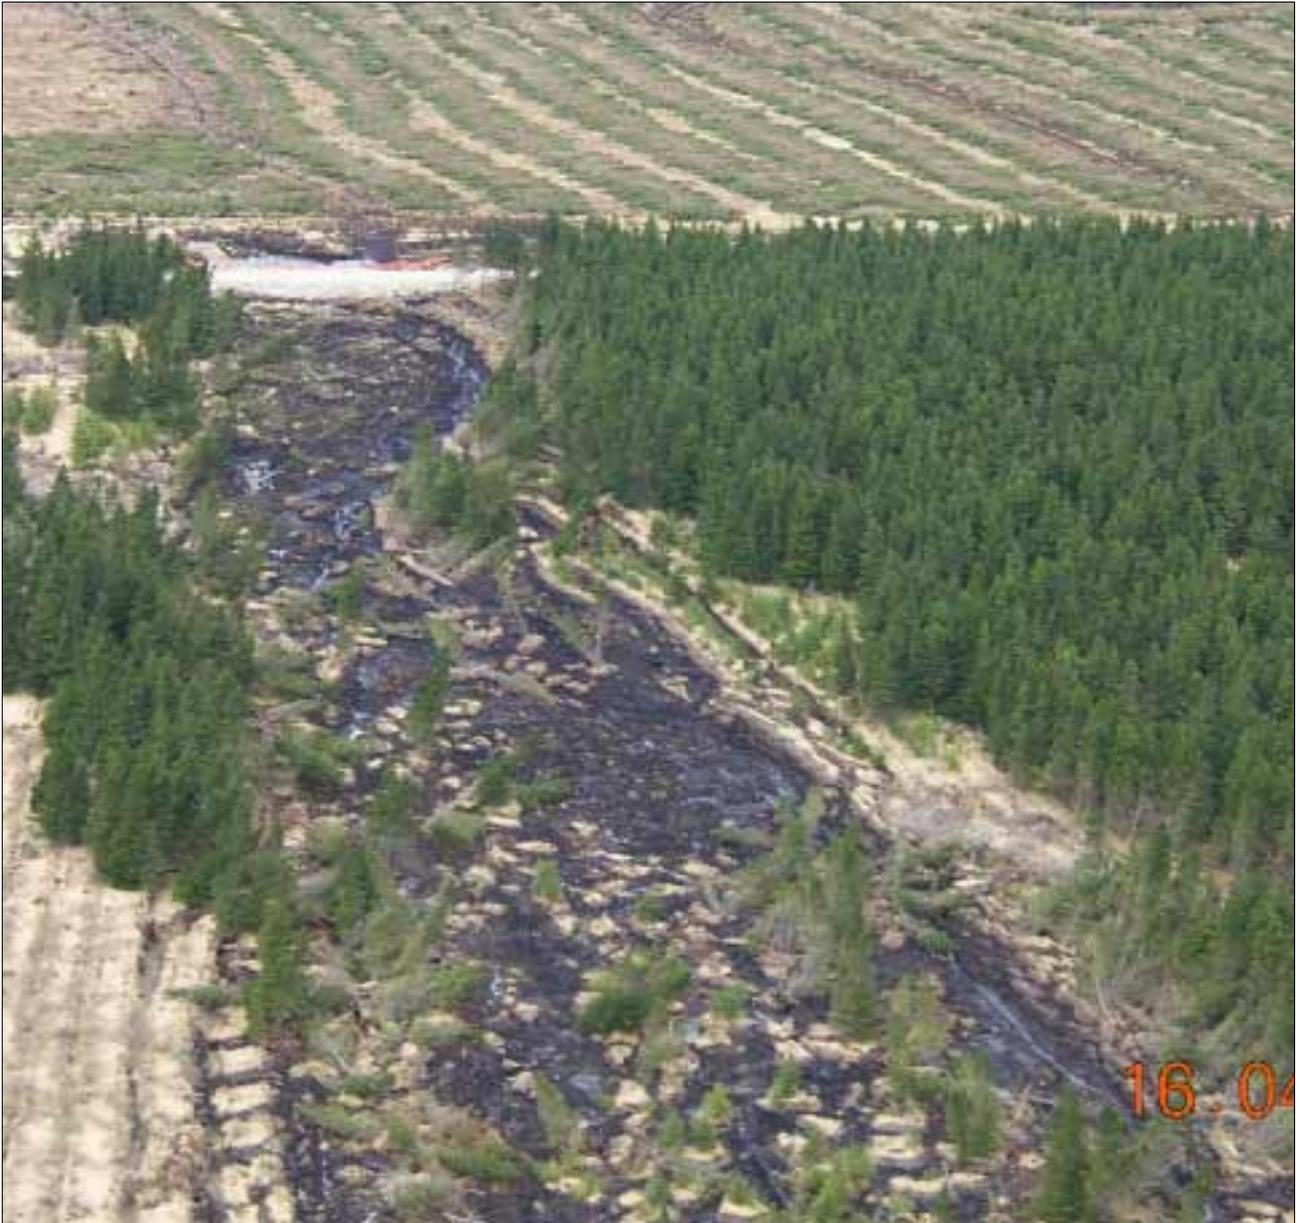
Plate 3: An aerial view of the source of the slide of 16 October 2003, taken in April 2005. The base of T68 is clearly visible.

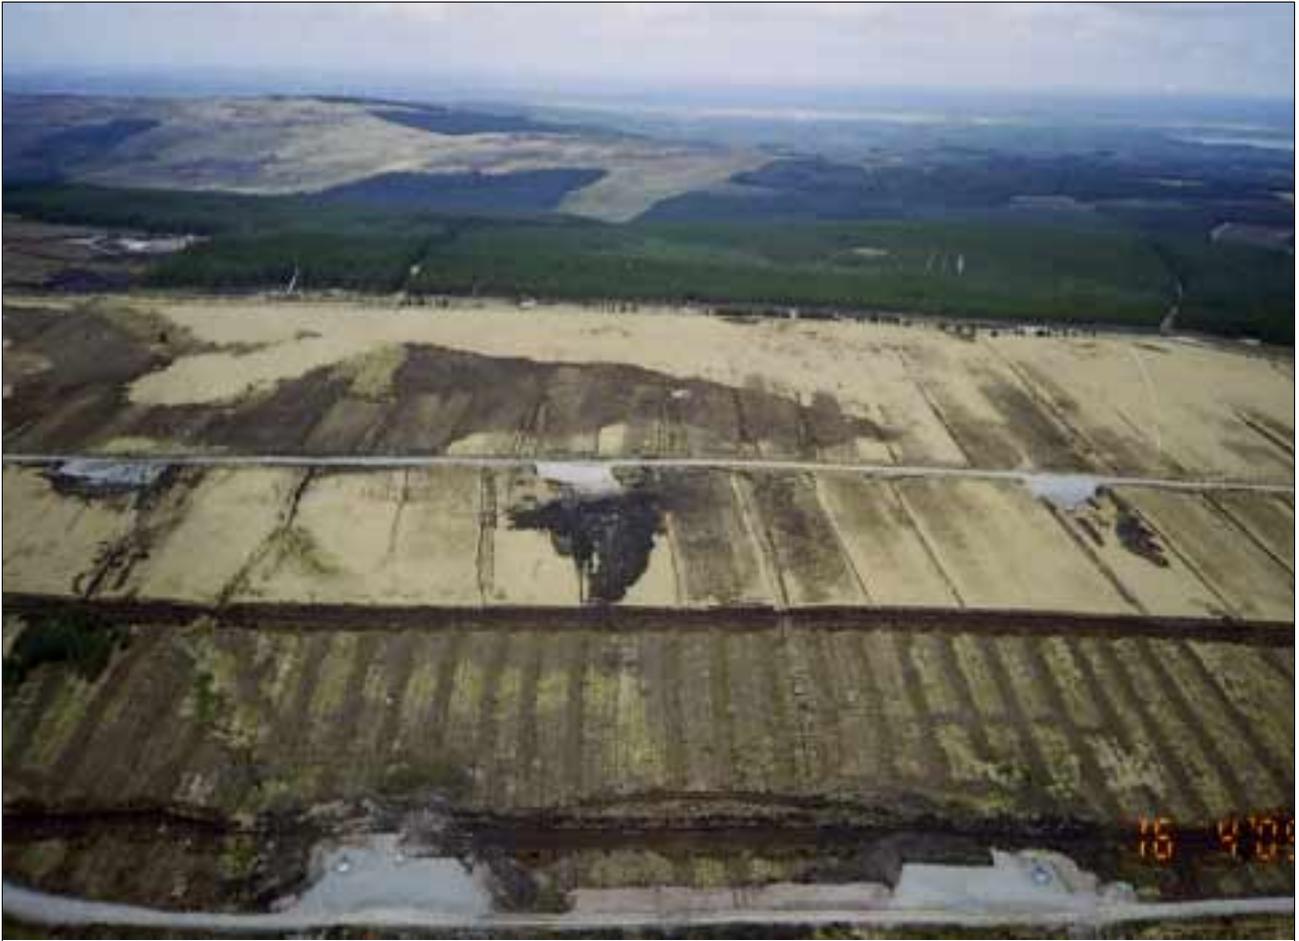
Plate 5: An aerial view of the site looking north towards Loughrea. A nine-turbine wind power site at Sonnagh Old is just visible on the skyline on the top left of the picture.

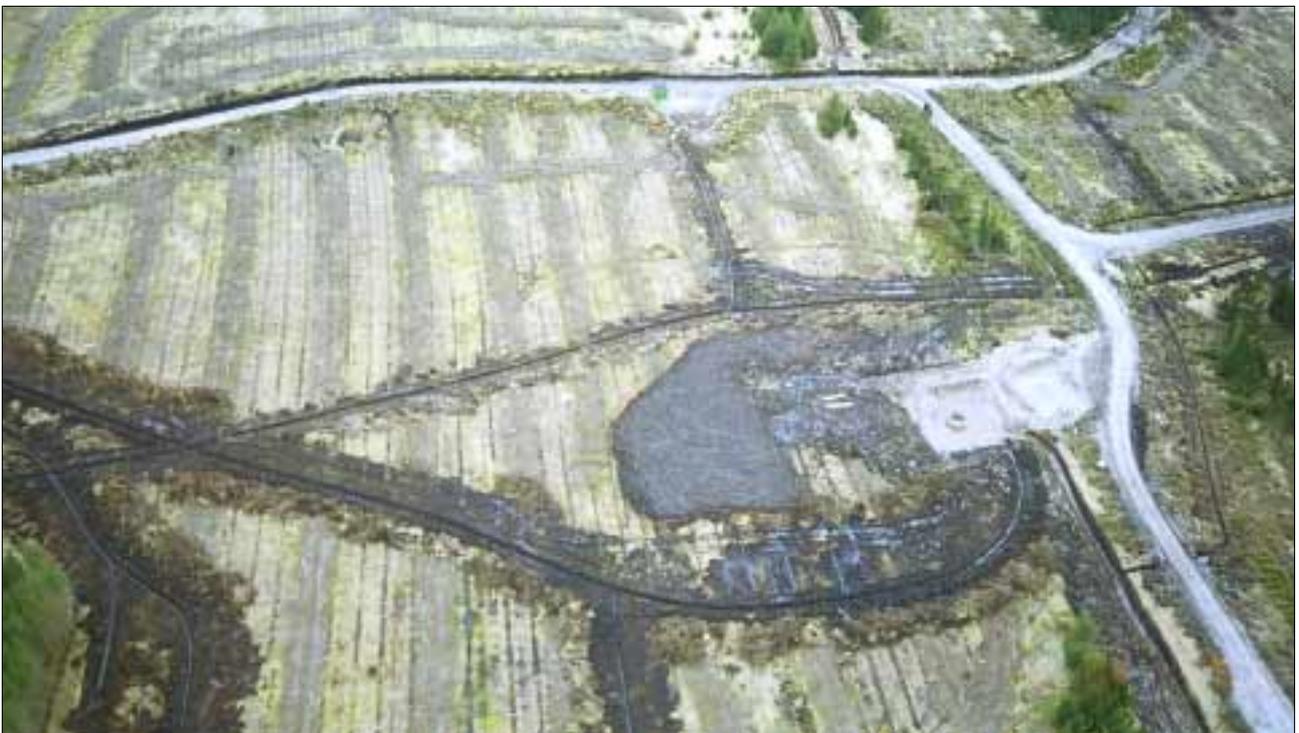
Plate 6: An aerial view of the site showing floating roads used for access tracks and a near-complete turbine base awaiting final mineral back-fill. Note the excavated peat side-cast and left exposed. The light green/grey areas are trees cut by a 20-tonne tree harvesting machine and laid in rows to support the weight of the machine as it progresses on the blanket bog. The trees have been left to decay.

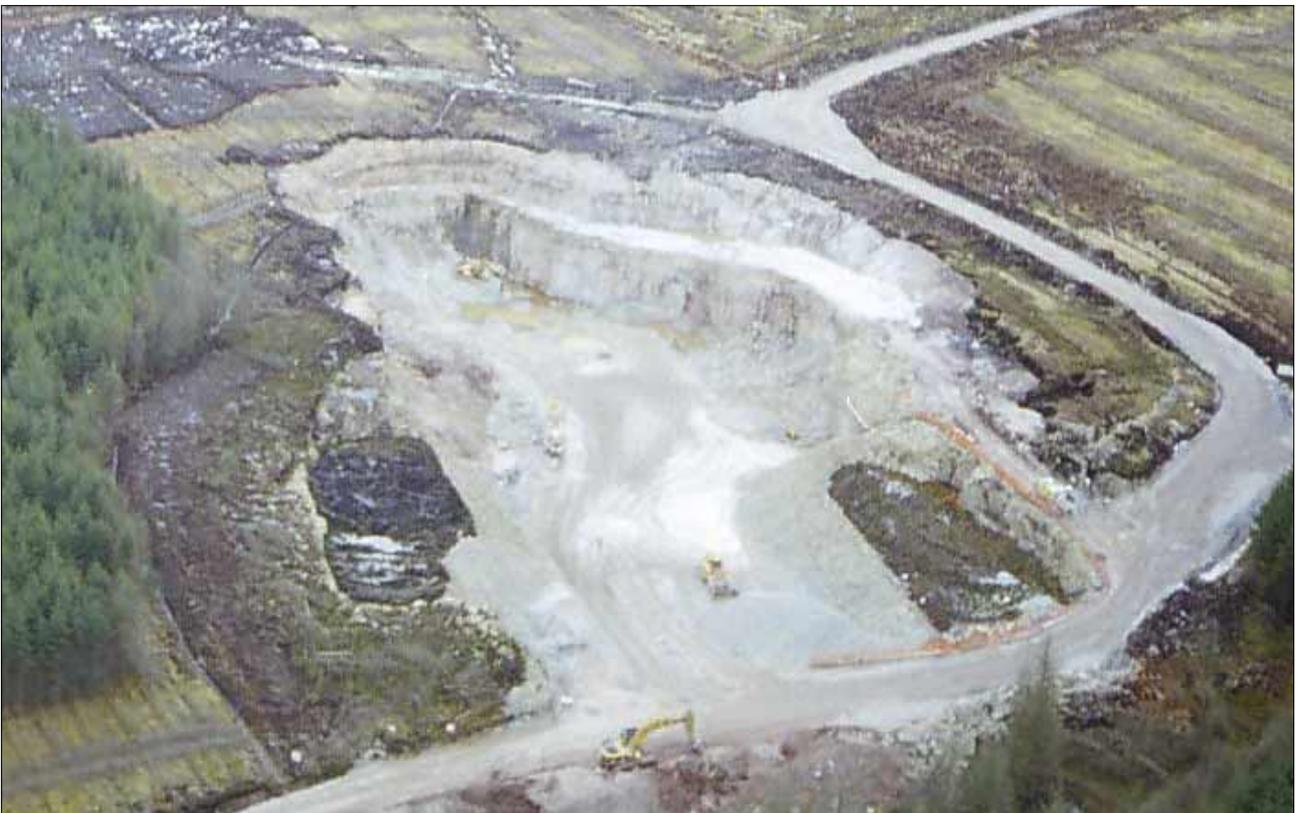
Plate 8: An aerial view taken in April 2005 of the largest 'borrow' pit on the site, excavated from stratified limestone and originally over-burdened with two metres of peat and three of boulder clay, seen here cast to the side. The excavators suggest the scale. Its volume is estimated at 150,000 m³.

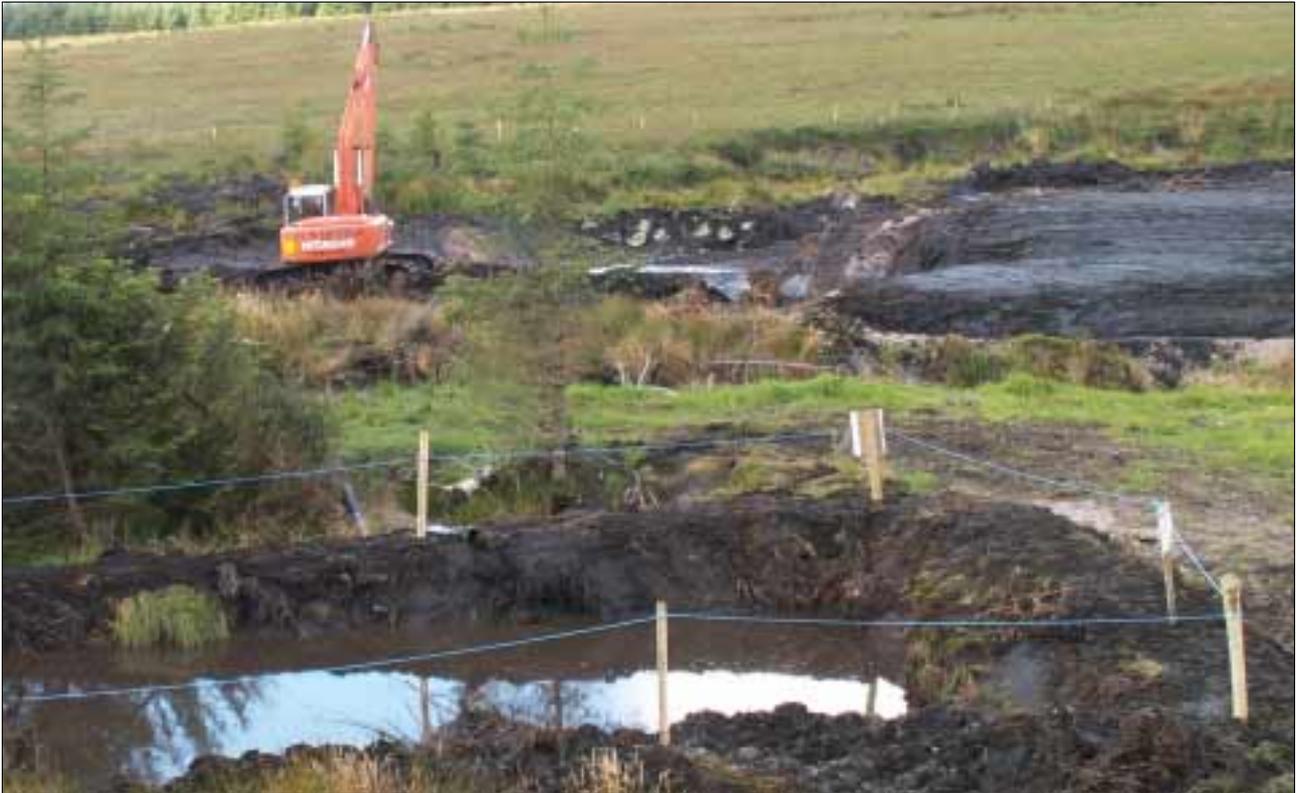
Plate 13: Spooning displaced peat with a digger into specially-constructed lagoons where, it is planned, the scattering of hayseeds will stabilise the slurry and prevent further pollution of the watercourses and the Lough Cutra SAC/SPA. See page 11.

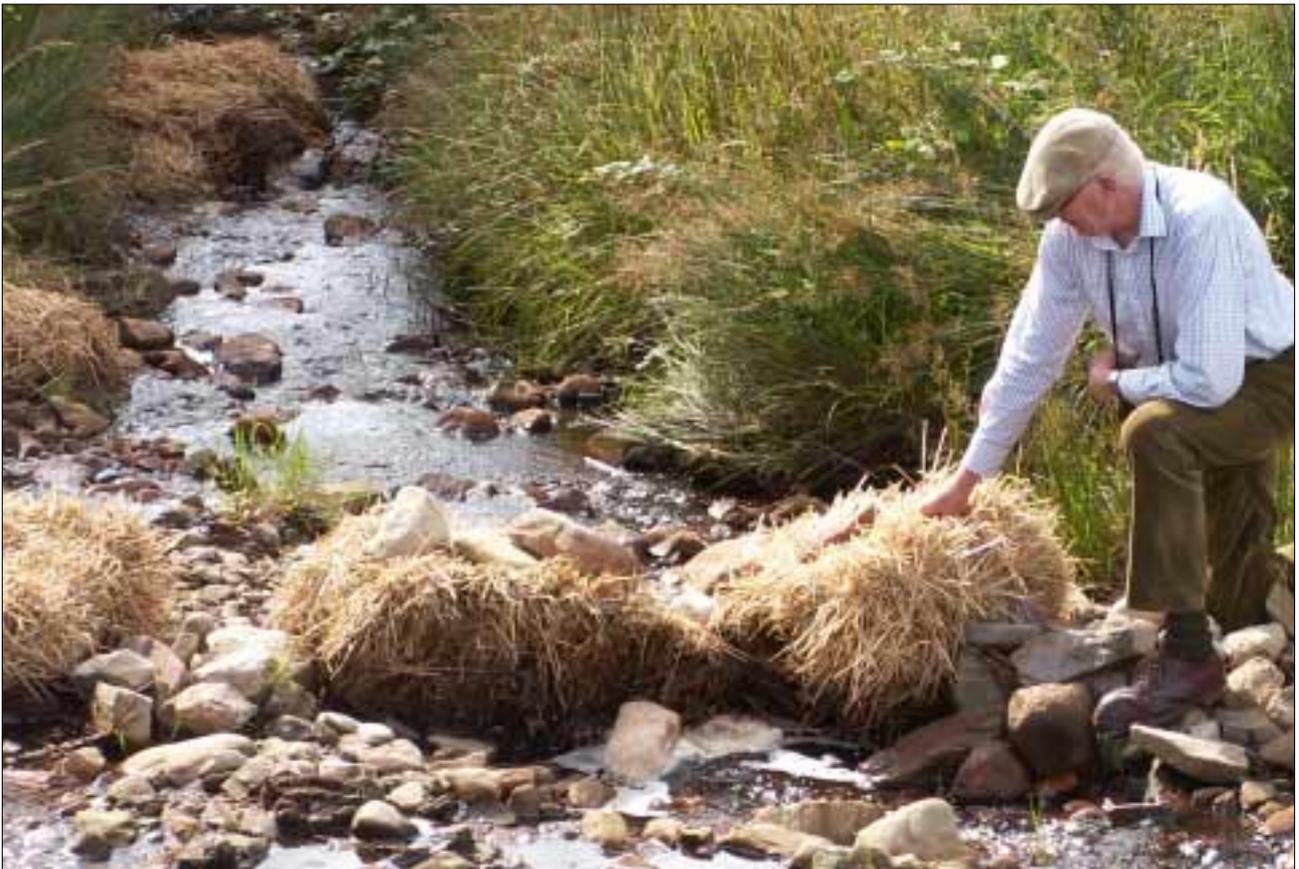
Plate 14: A 'silt trap', sited adjacent to the above lagoon, made from barley-straw bales. At low flow levels, the water runs through the stones in the stream bed and little, if any, of the suspended matter is trapped. When the flow is high, it pushes the bales aside and the increased load of suspended matter again goes straight down the watercourse. Two displaced bales can be seen on the top left of the picture. Unless these bales are replaced on an eight-week cycle, their decomposition is itself pollutant.

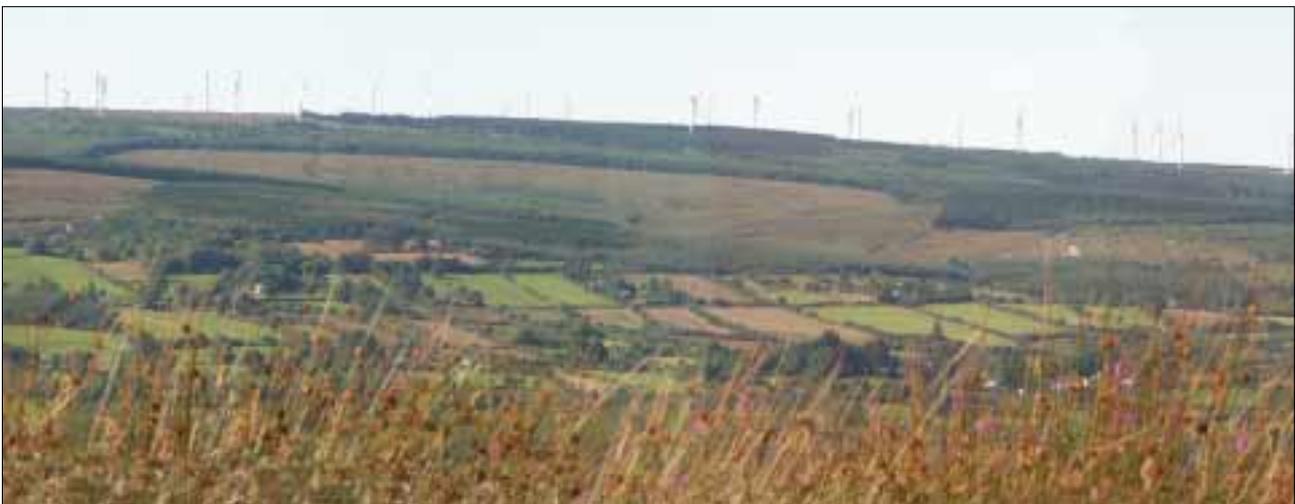
Plate 15: Cashlaundrumlahan, highest of the Slieve Aughty mountains, viewed here from the south. Derrybrien is a scattered community whose dwellings straddle the Gort-Potrumna road. This runs through the middle of the cultivation at the foot of the mountain (left to right in this picture). The slide occurred to the east of the village.

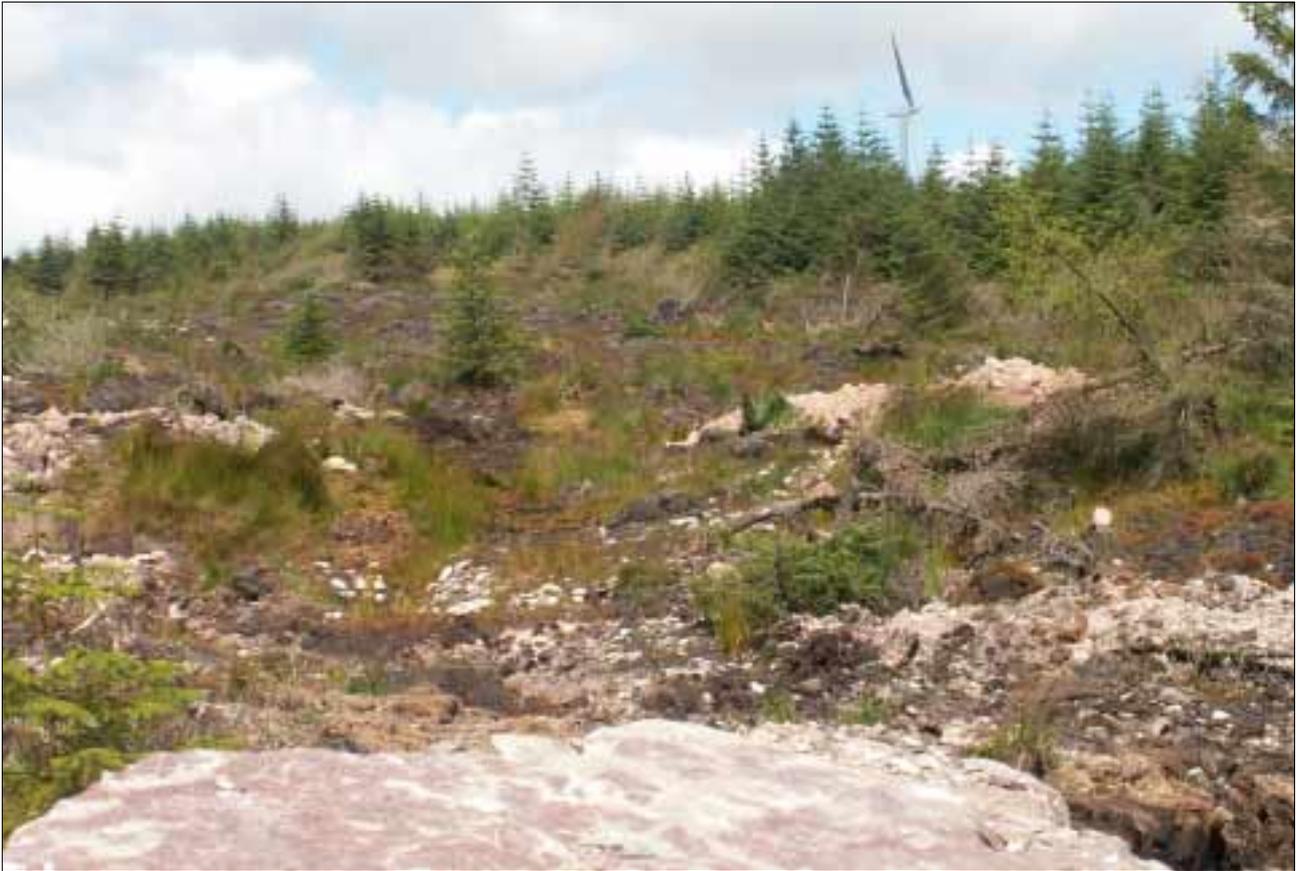
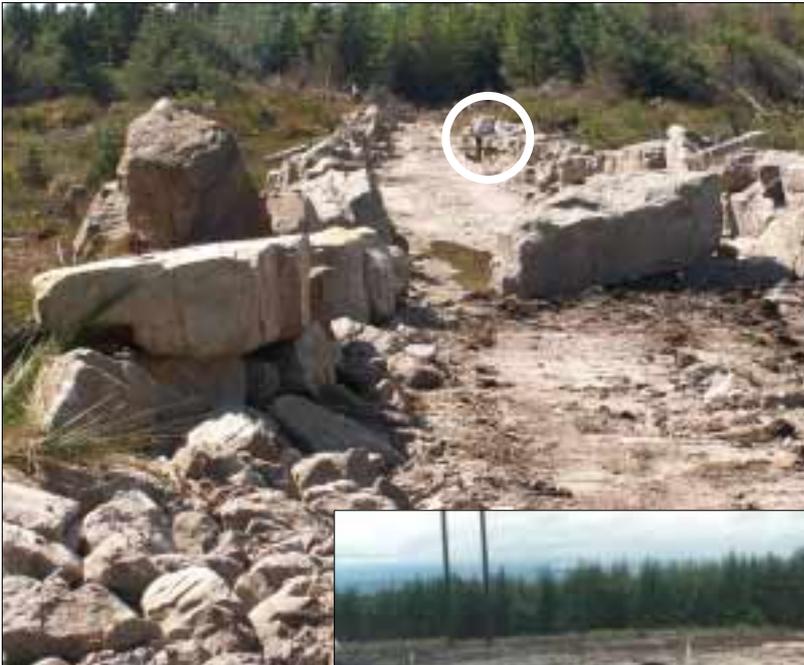
Plate 16, above: Looking up from a causeway built across the path of the slide to stop peat that is no longer there from sliding again. Note the drop in ground level compared to the surrounding afforestation.
Plate 17, left: Looking across the causeway which took 20,000 tonnes of rock to build. For scale, note the person (circled) standing half-way across. The reasoning behind its construction is hard to fathom if it is anything other than a political palliative.

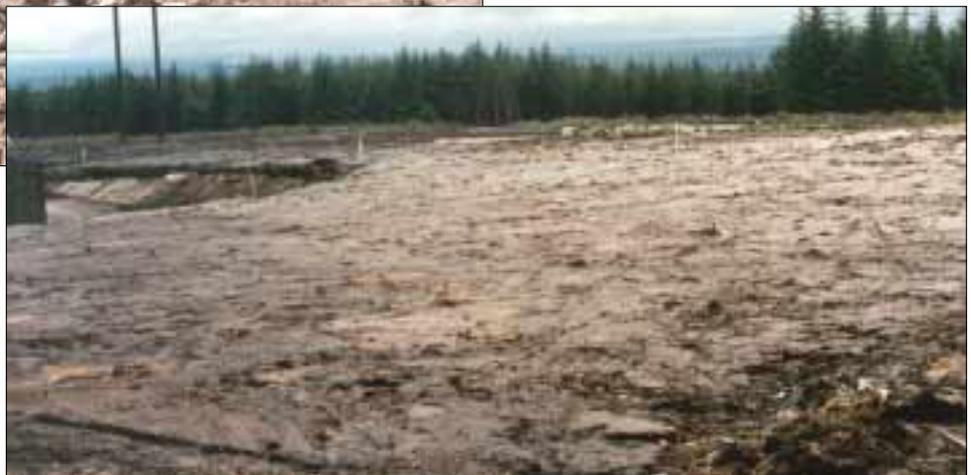
Plate 18, right: Displaced peat one metre thick side-cast on top of pristine bog. The work was completed only 14 days before this picture was taken but the surface is already cracking.

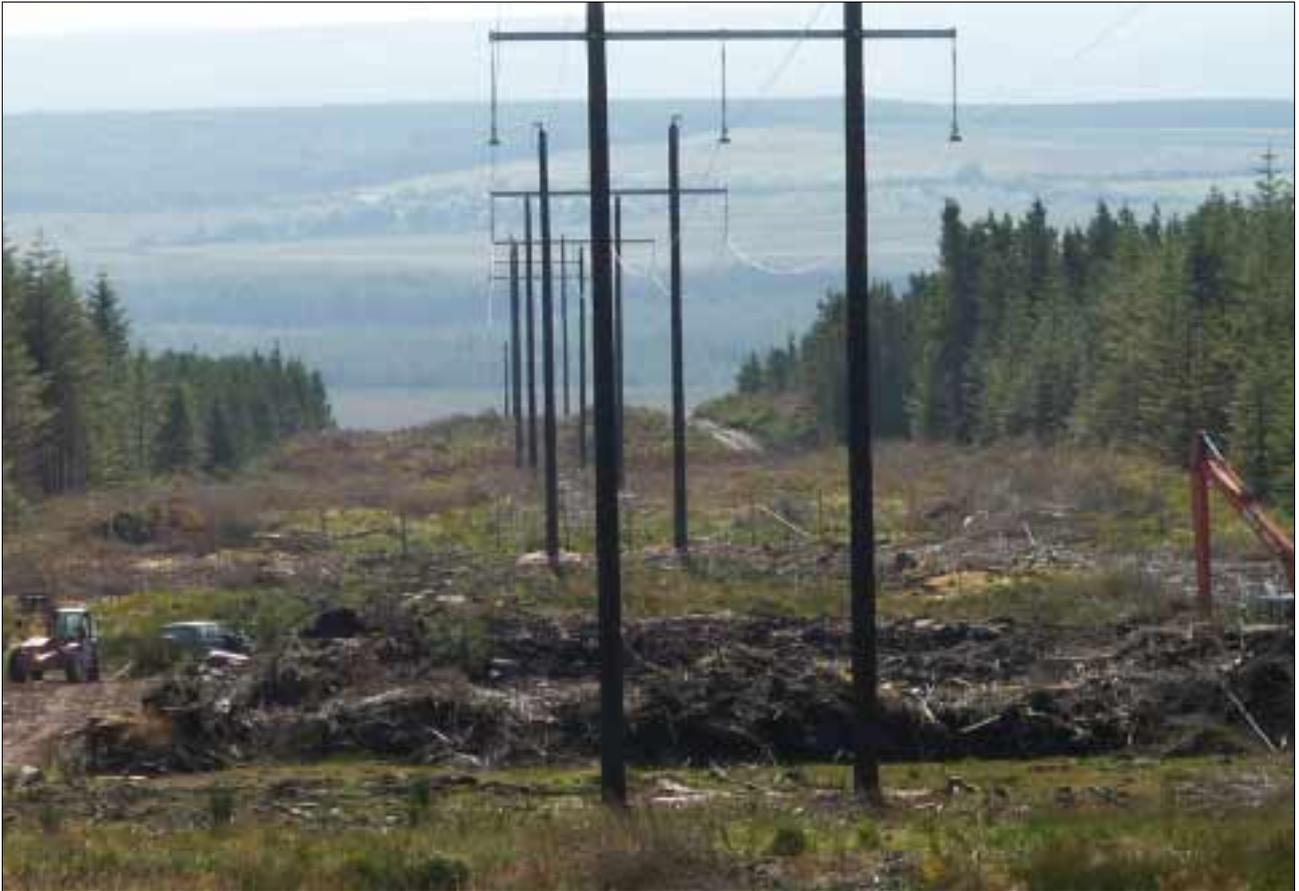
Plate 19: One of the peat lagoons discussed on page 13. The watercourse polluted by the bogslide runs right to left behind the mechanical digger in the left foreground. Peat still in the watercourse, now restrained by a bund, was being lifted into the peat-walled lagoon visible in the foreground. (The power line is the site's 110kV link to the grid.)

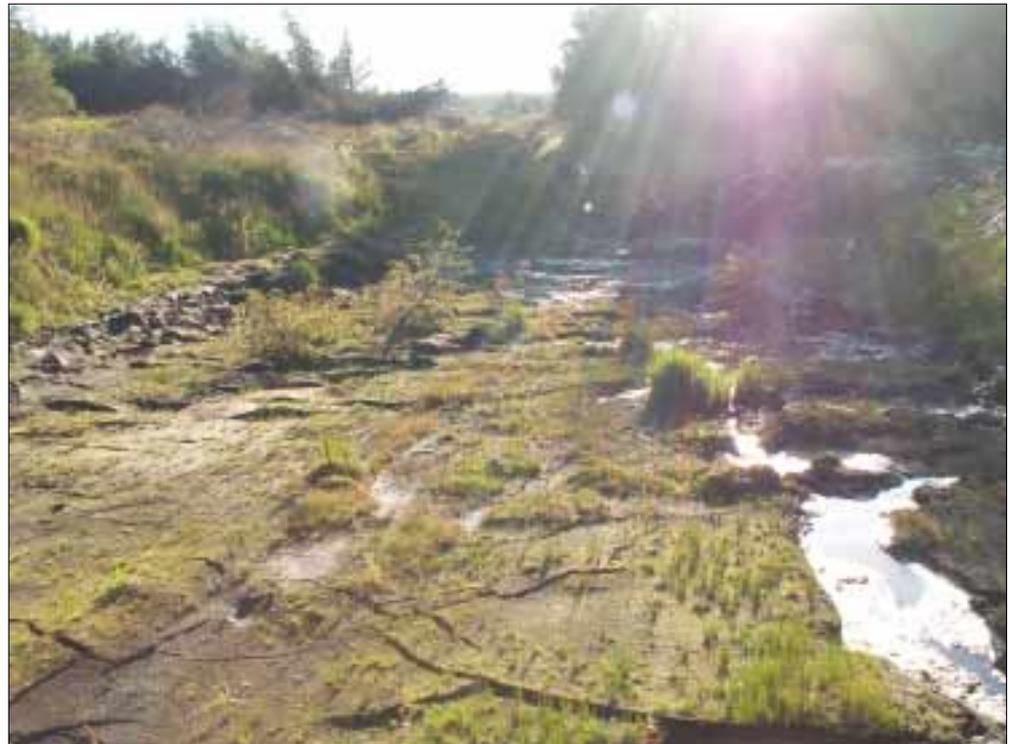
Deposition of peat slurry on the mudflats of the Firth of Forth SPA Ramsar site could upset the ecology of these sensitive areas and affect the birds living there.

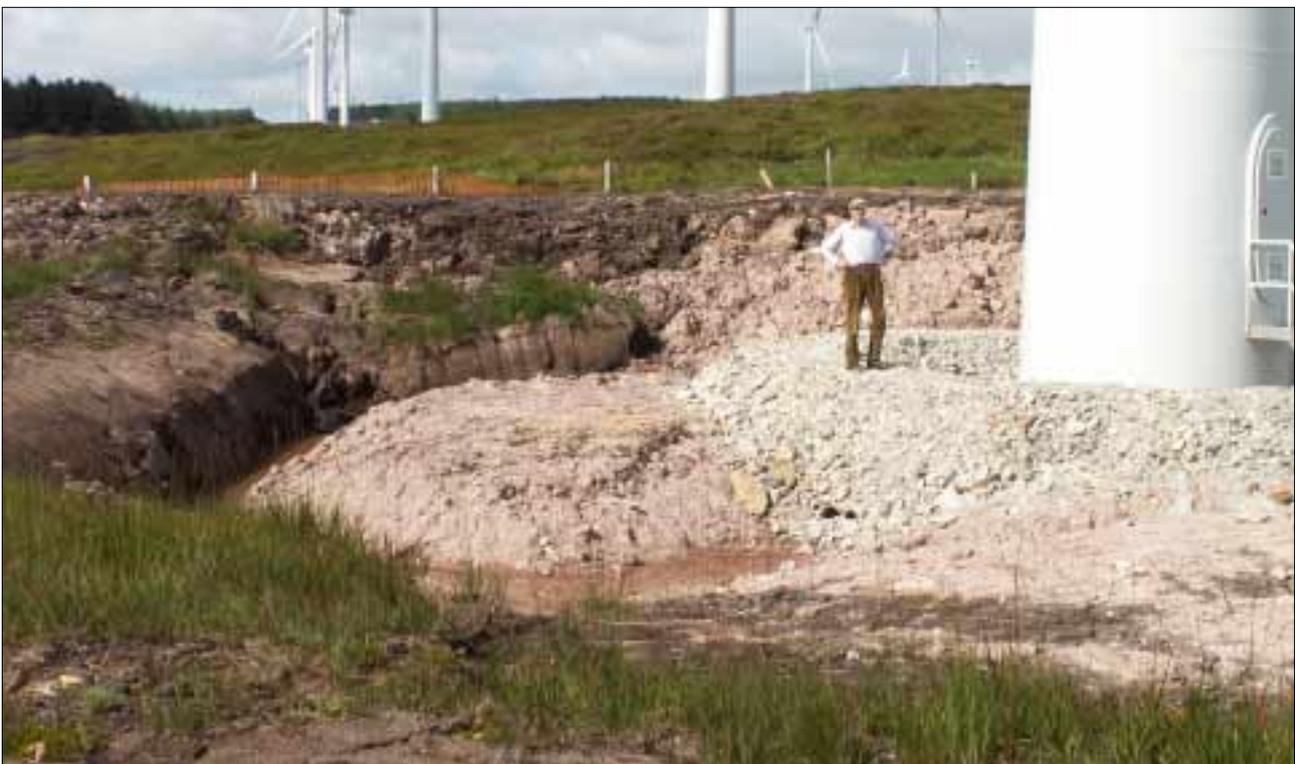
Plate 23: A completed turbine base on Derrybrien showing exposed peat which will oxidise and erode over time. While other peatland projects propose different construction techniques, the risk of pollution and landslip remains whenever such terrain is industrialised, whatever the perceived political acceptability of its purpose.
