Environmental issues at the Braes of Doune wind farm

A report prepared by

John Phillips, MA, CBiol, MBiol

August 2006

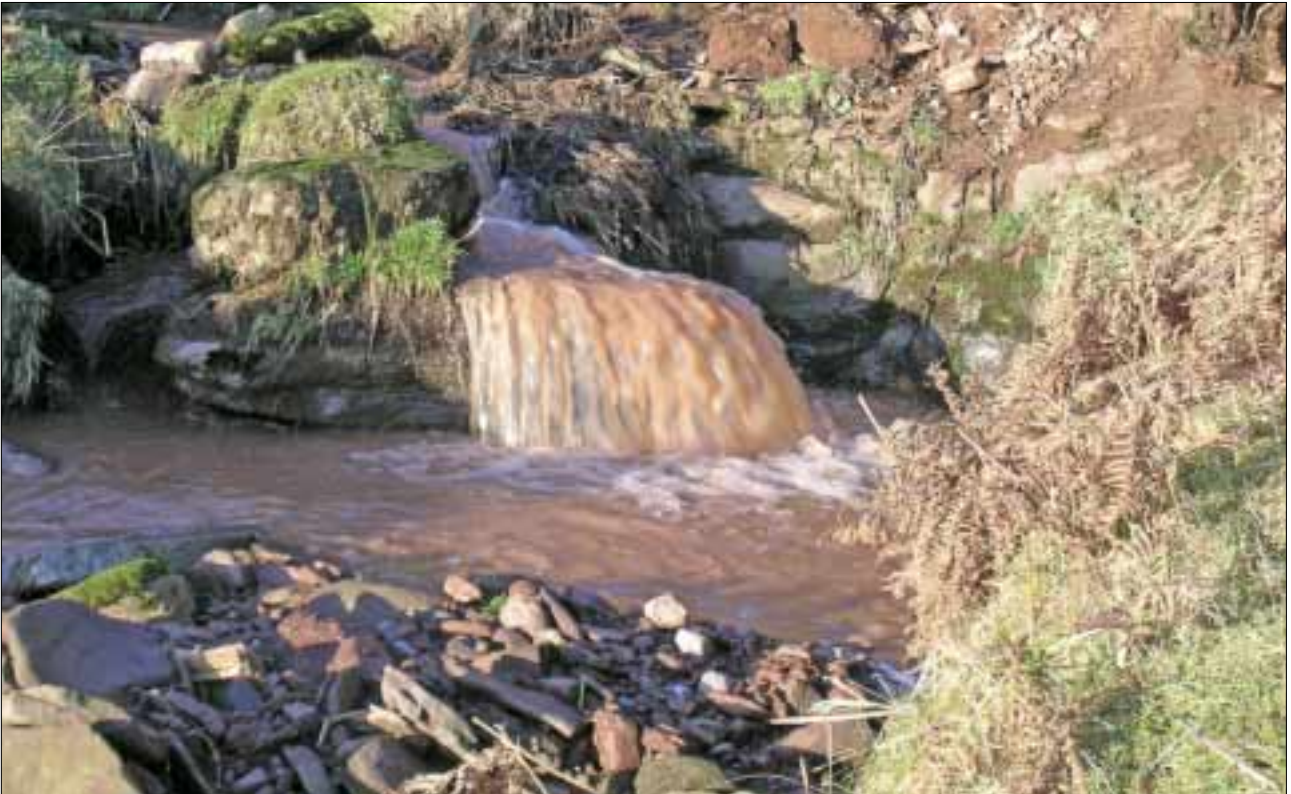
Water draining from a newly-constructed track road driven seven kilometres east of the Braes of Doune site to allow access to its grid connection. When this picture was taken, polluted run-off from the tracks was flowing unimpeded into local waterways before entering the Bullie Burn (above) and on into the River Teith Special Area of Conservation. (12 December 2005, NN 813 104.)

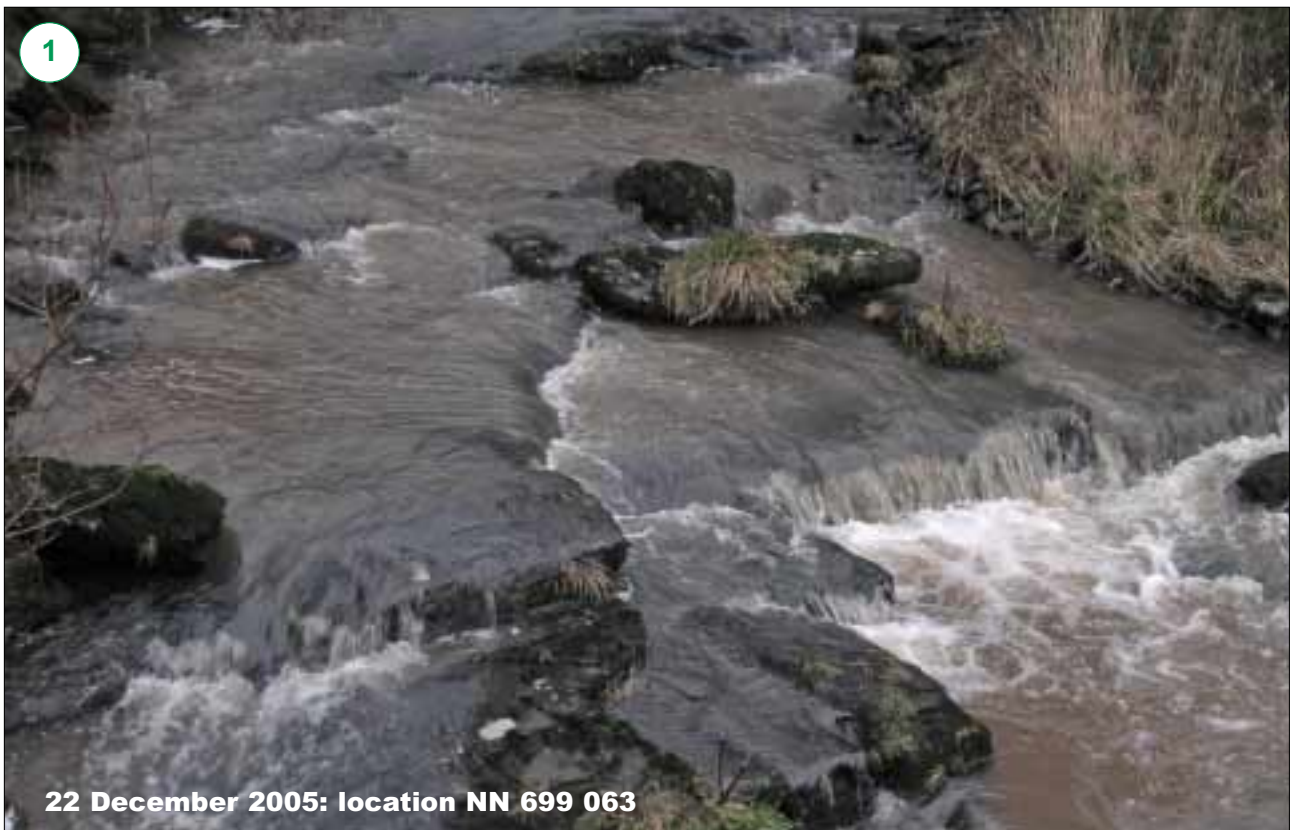
22 December 2005: location NN 699 063

A series of photographs taken from a bridge over the Annet Burn immediately south of a site depot and close to the site's main access road suggest significant silt loading at least from December 2005 to March 2006.

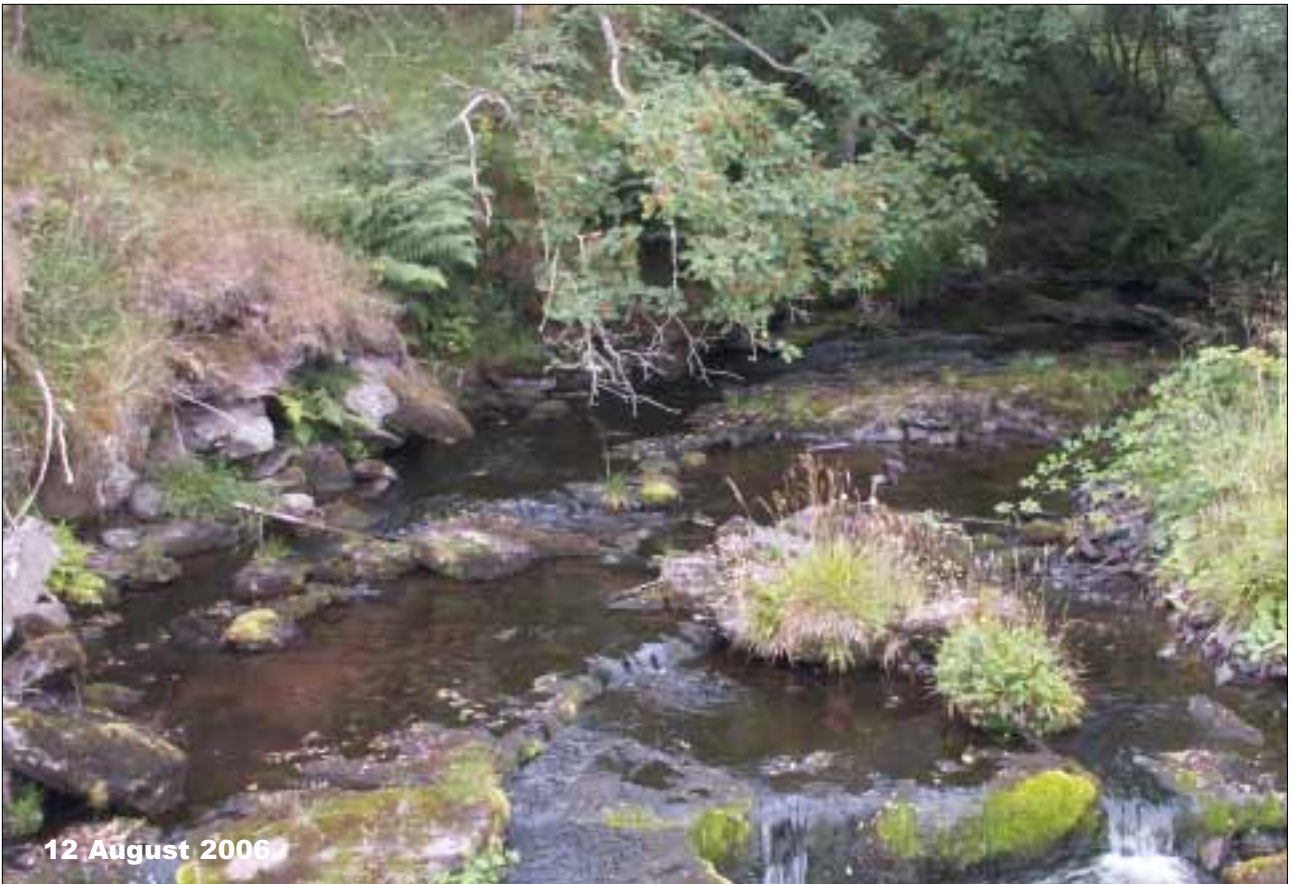
The Annet Burn after a lengthy dry spell. There is no apparent turbidity though there seems to be residual sedimentation on the river bed.

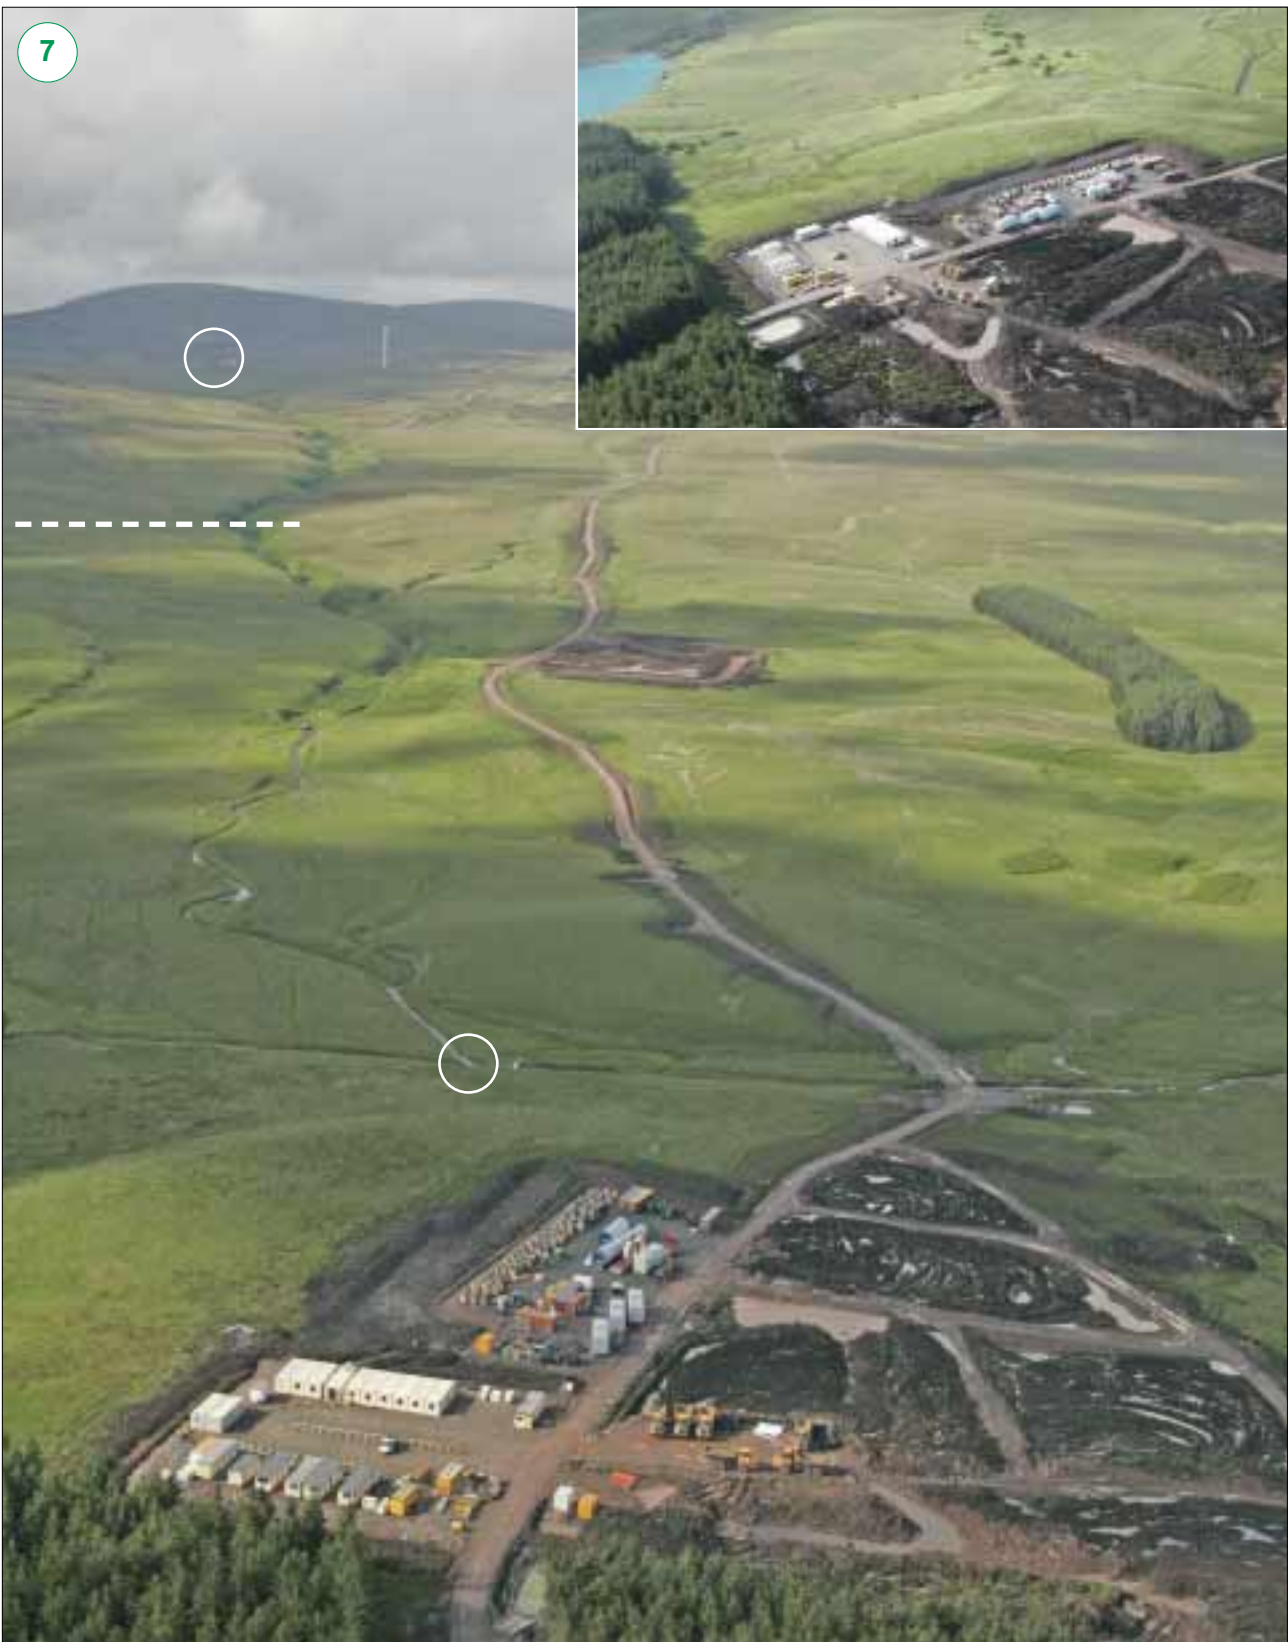
The view looking north up the Garvald (right) and Ardoch Burns. The depot in the foreground (pt 7) lies at the southwest of the site just east of Loch Mahaick – much of the land between is an SSSI (inset). The southerly quarry (pt 4, p 19) is in the middle of the picture. The northerly quarry (pt 2, opposite) and the confluence of the Garvald and Ardoch Burns (pt 6, p 24) are circled. A map sent by SNH to riparian owners shows the southernmost stretch of the Garvald (not the Ardoch) as part of the SAC though this may just be a trivial clerical error. Whatever, it places the SAC's local northern limit at about the level of the dotted line. Note the excavated peat deposited by the side of track.

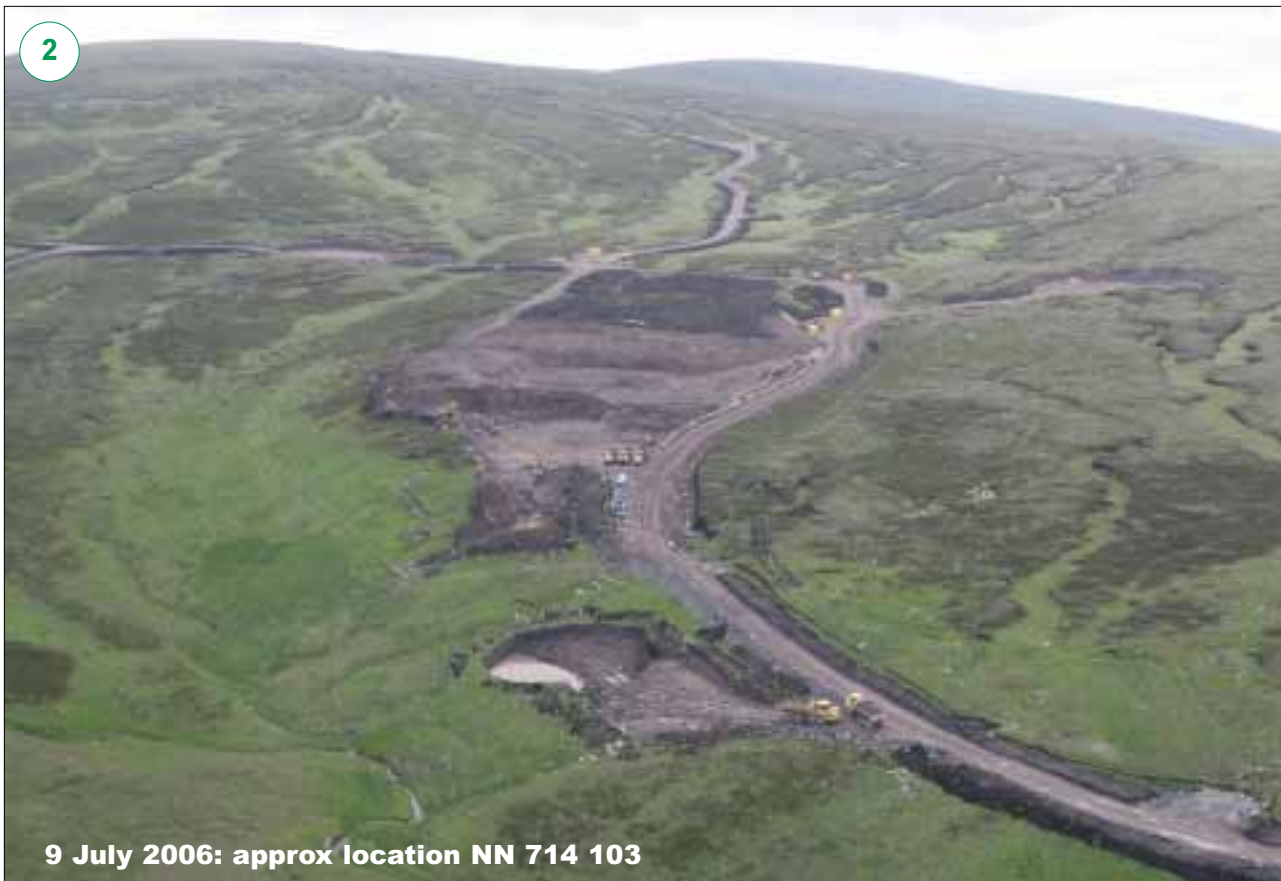
9 July 2006: approx location NN 714 103

The northerly of two quarries ('borrow pits') and peat dumps. It lies proximate to the Garvald Burn, probably about two kilometres upstream of the SAC boundary (the location of the boundary is unclear – see opposite).

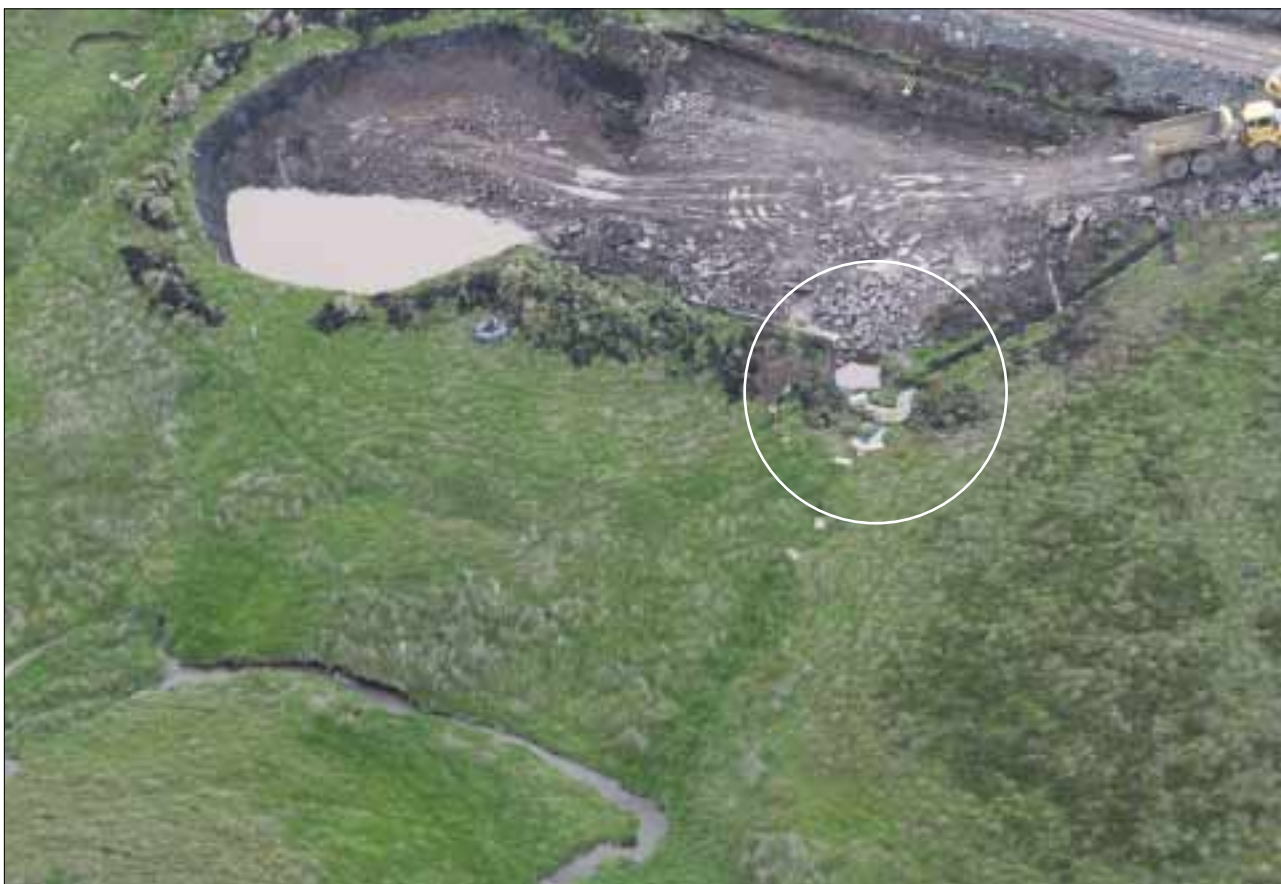
A close-up of the turbine excavation in the above picture. Note the depth of excavated peat, the turbidity of the undrained water and the proximity of the site to the Garvald Burn, into which the excavation drains by design.

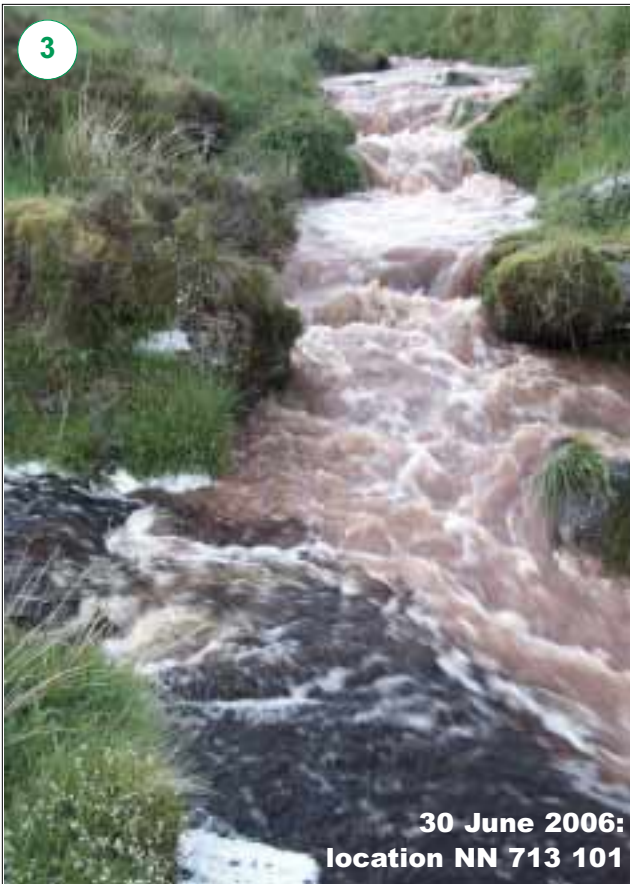
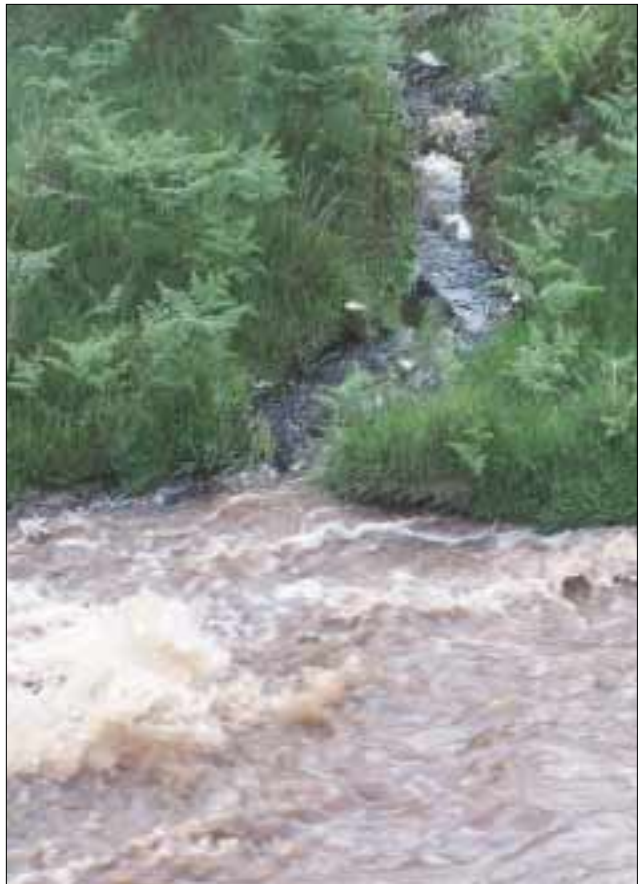
A tributary joins the Garvald Burn just downstream of the northerly quarry. The clear stream drains an area to the west, remote from construction activity.

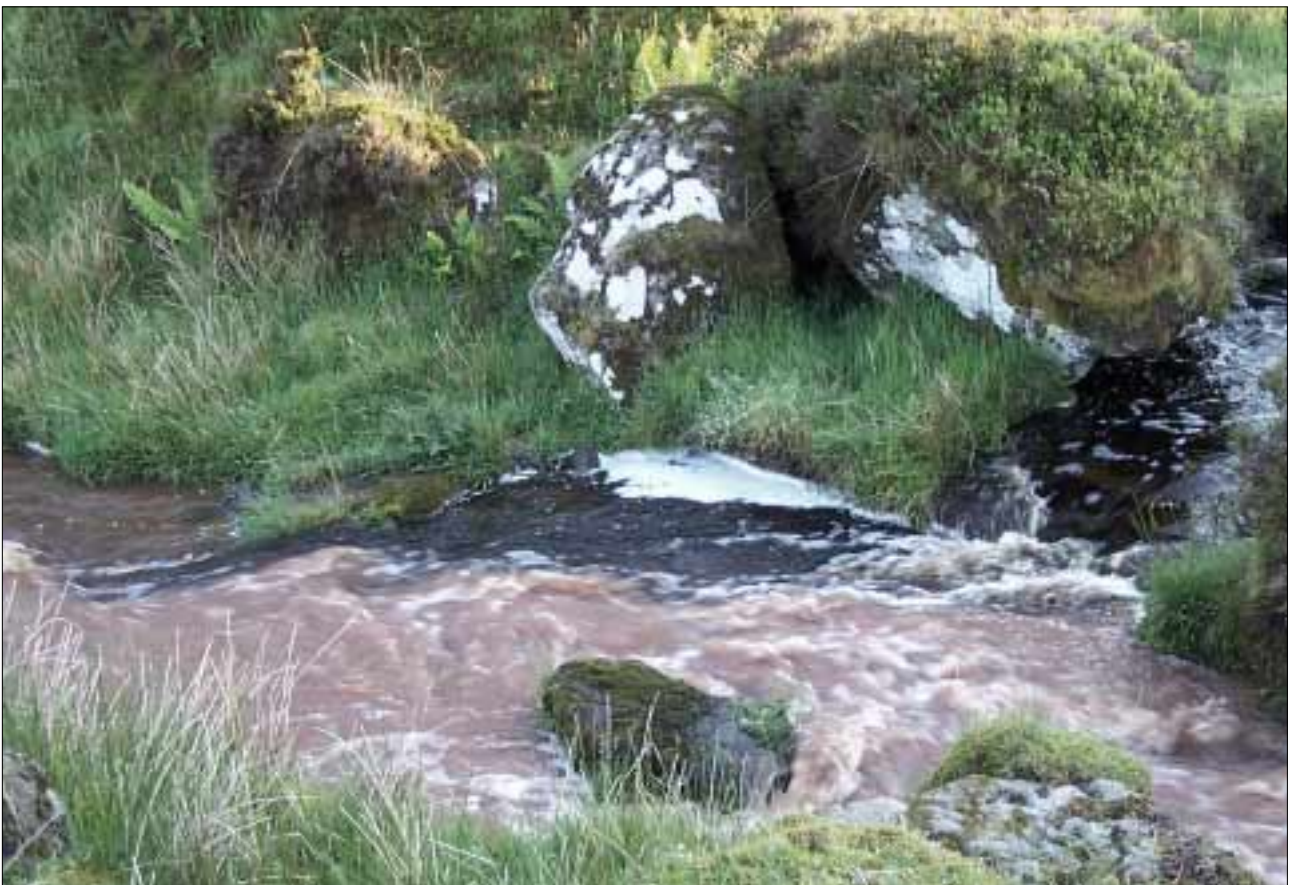
The top left picture is viewed from the west bank of the burn and the other two from the east bank.

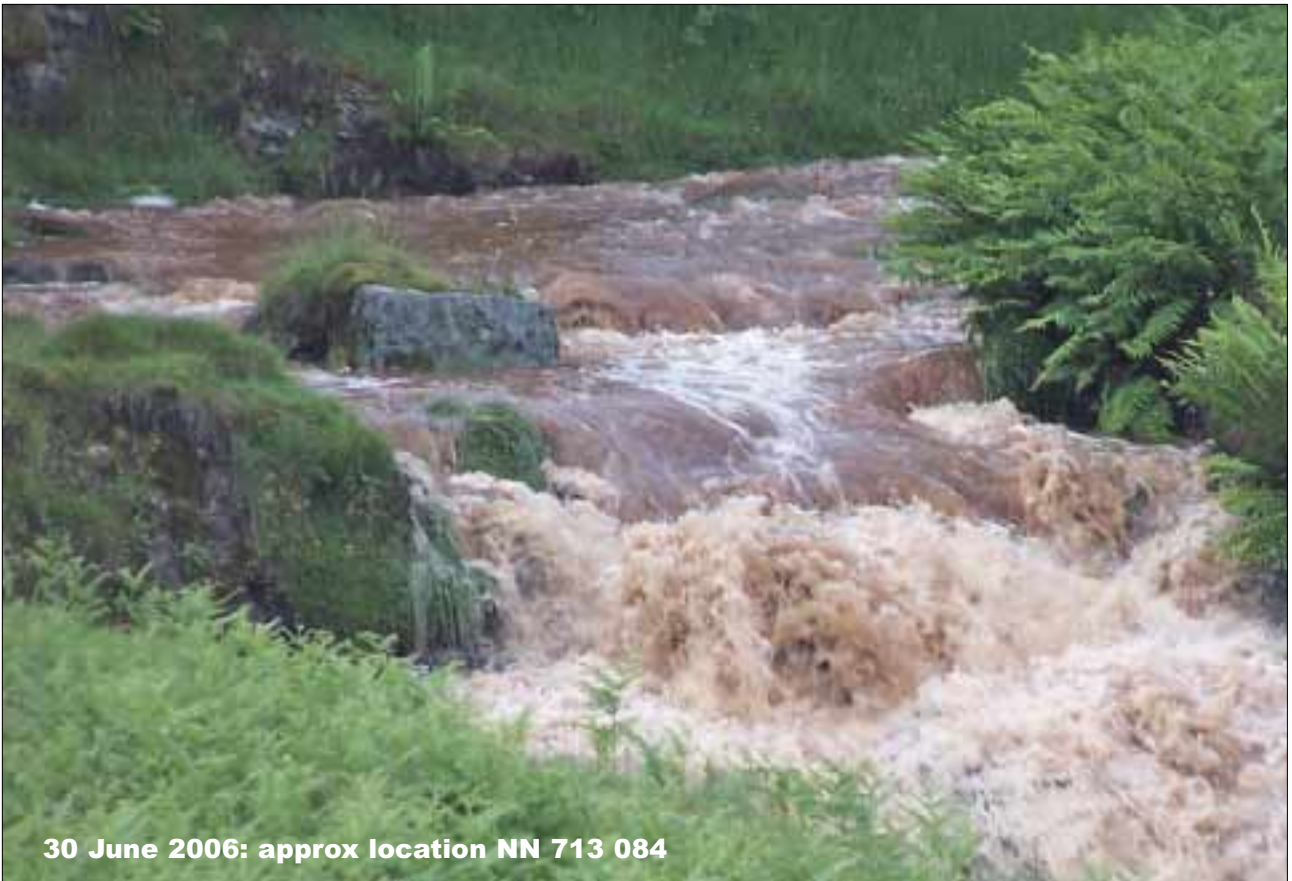
30 June 2006: approx location NN 713 084

The Garvald Burn after moderately heavy rain. This fall lies south of the northerly quarry but upstream of the second. (The grid reference is approximate.)

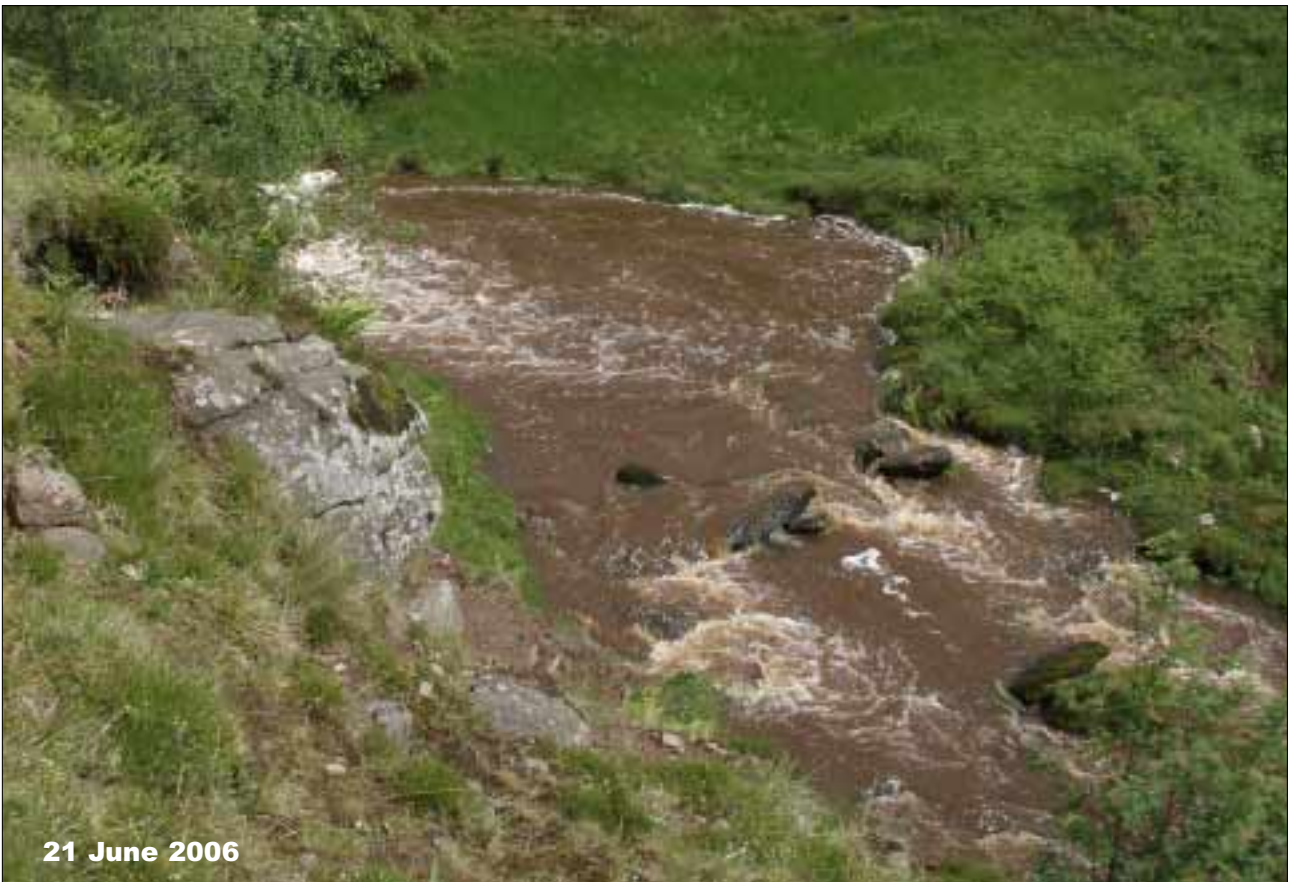
21 June 2006

A pool at the foot of the waterfall shown above, a few metres to the south.

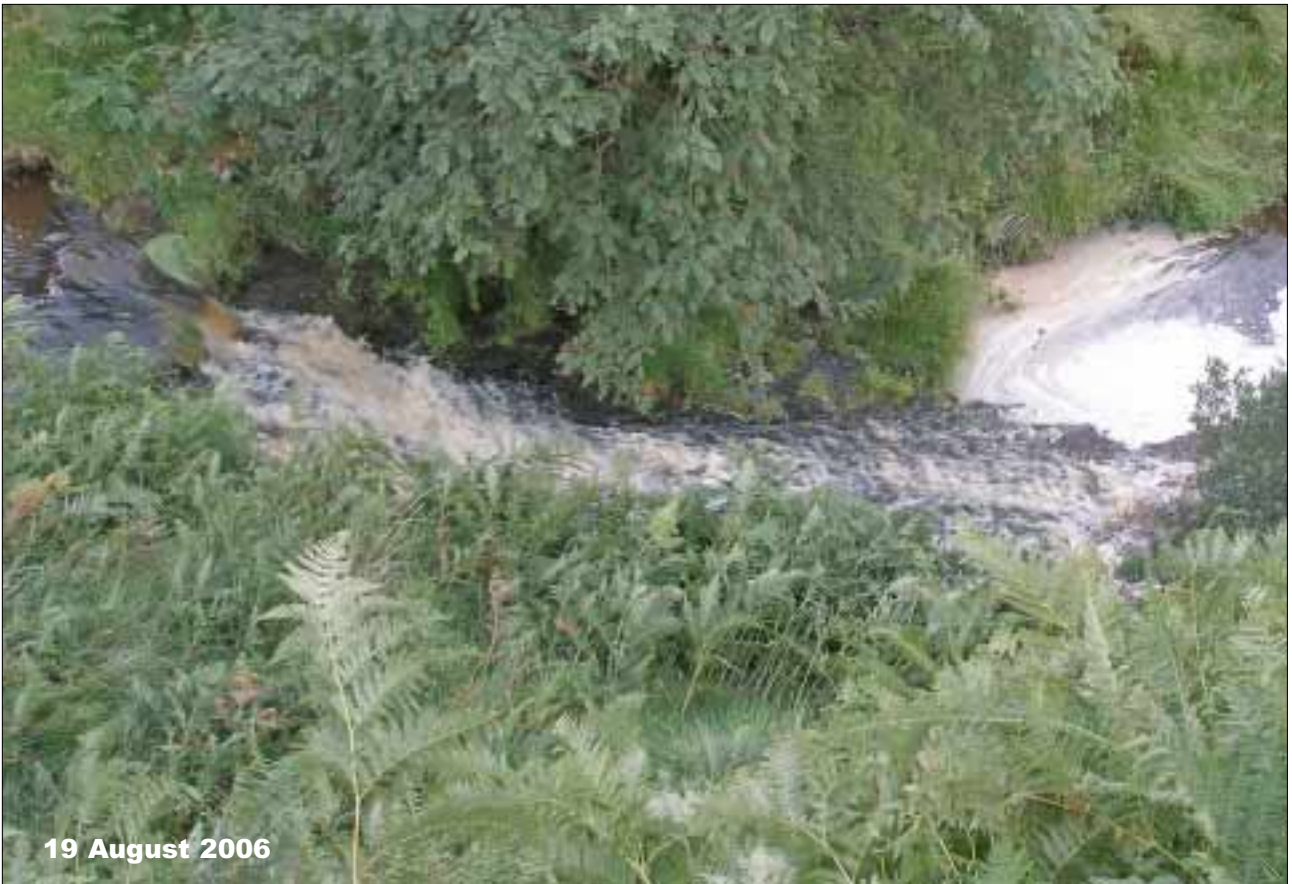
The same waterfall and pool ten weeks after the previous pictures. Pollution is still evident even after light showers and over a year since the developer reports the start of construction activity.

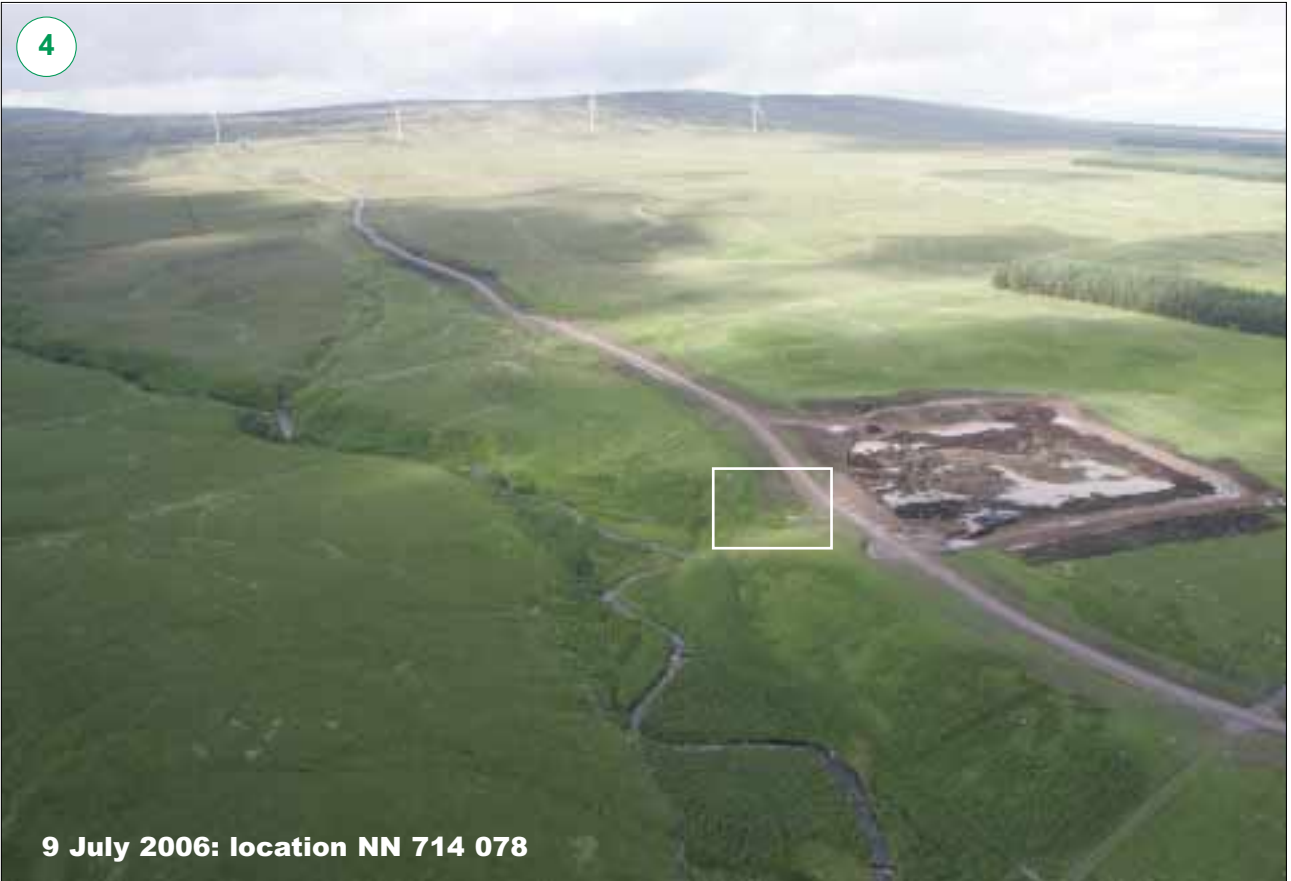
9 July 2006: location NN 714 078

A general view of the southerly quarry and peat lagoon showing how it drained into the Garvald Burn by design. The highlighted area is shown below. (It is possible that this arrangement has since been modified.)

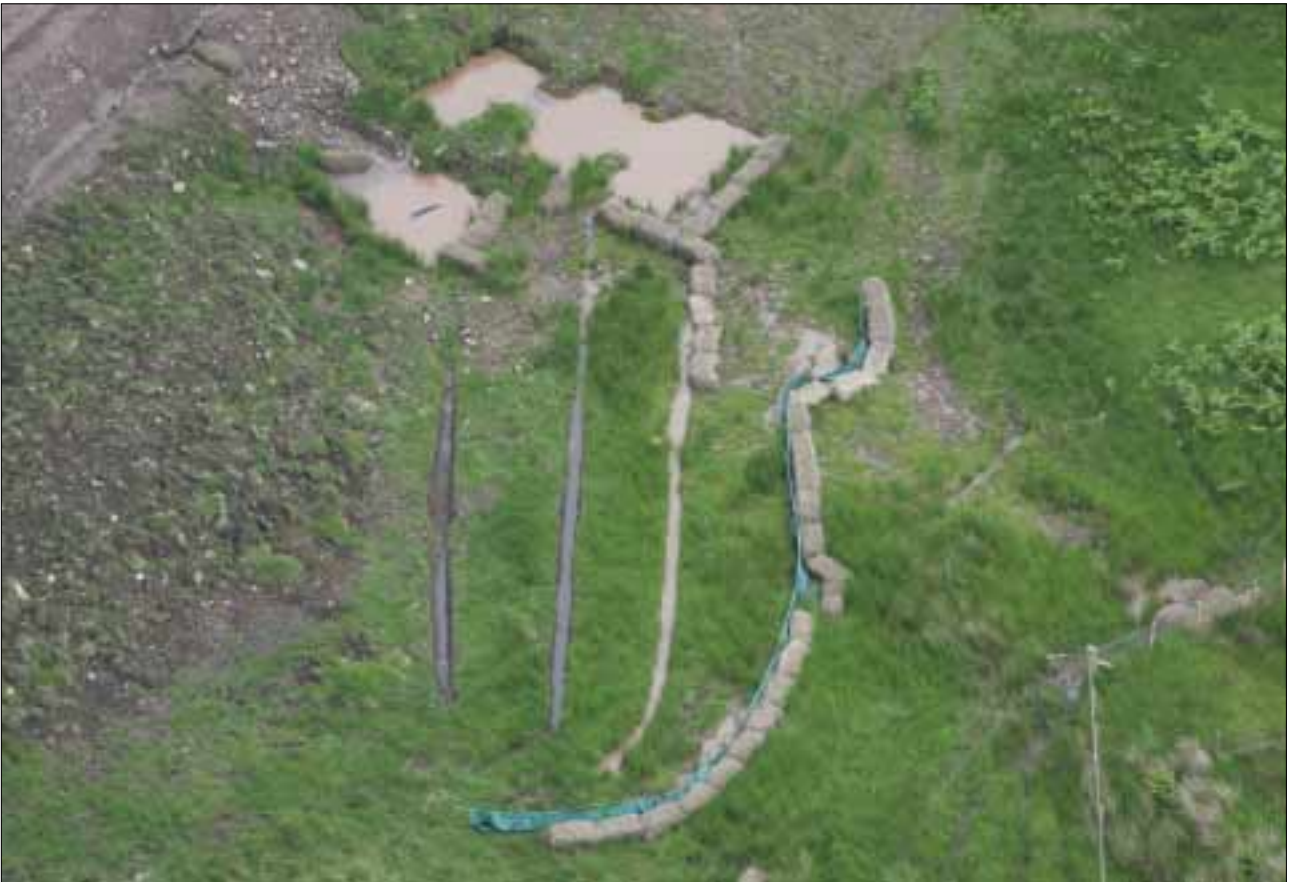
The drainage scheme for the peat dump where attempts have been made to arrest silt being carried off. The bales are manifestly ineffective and have, in places, been displaced.

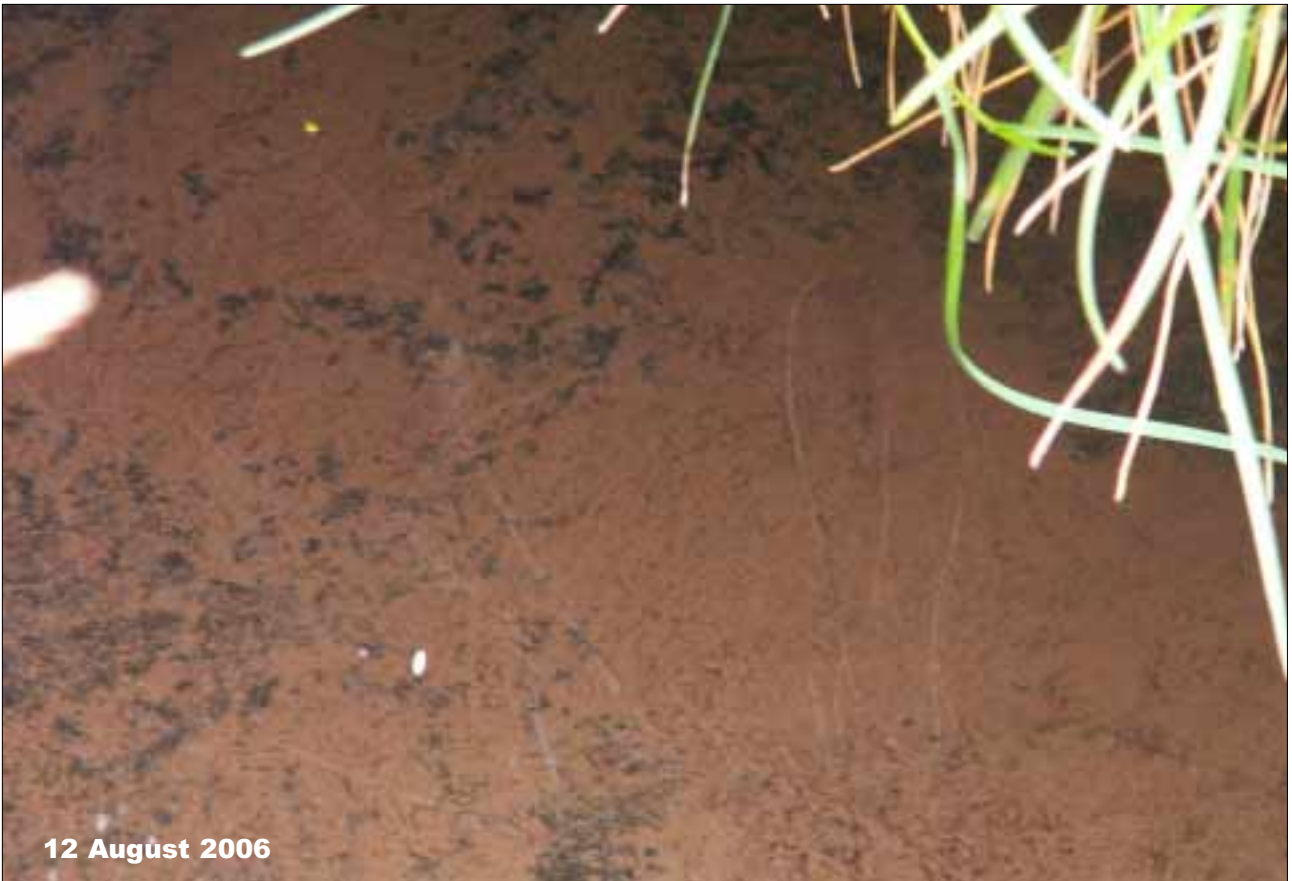
12 August 2006

Much of the bed of the burn is covered by a film of silt up to two mm deep. This was apparent to one degree or another for as far south as observers were able to inspect.

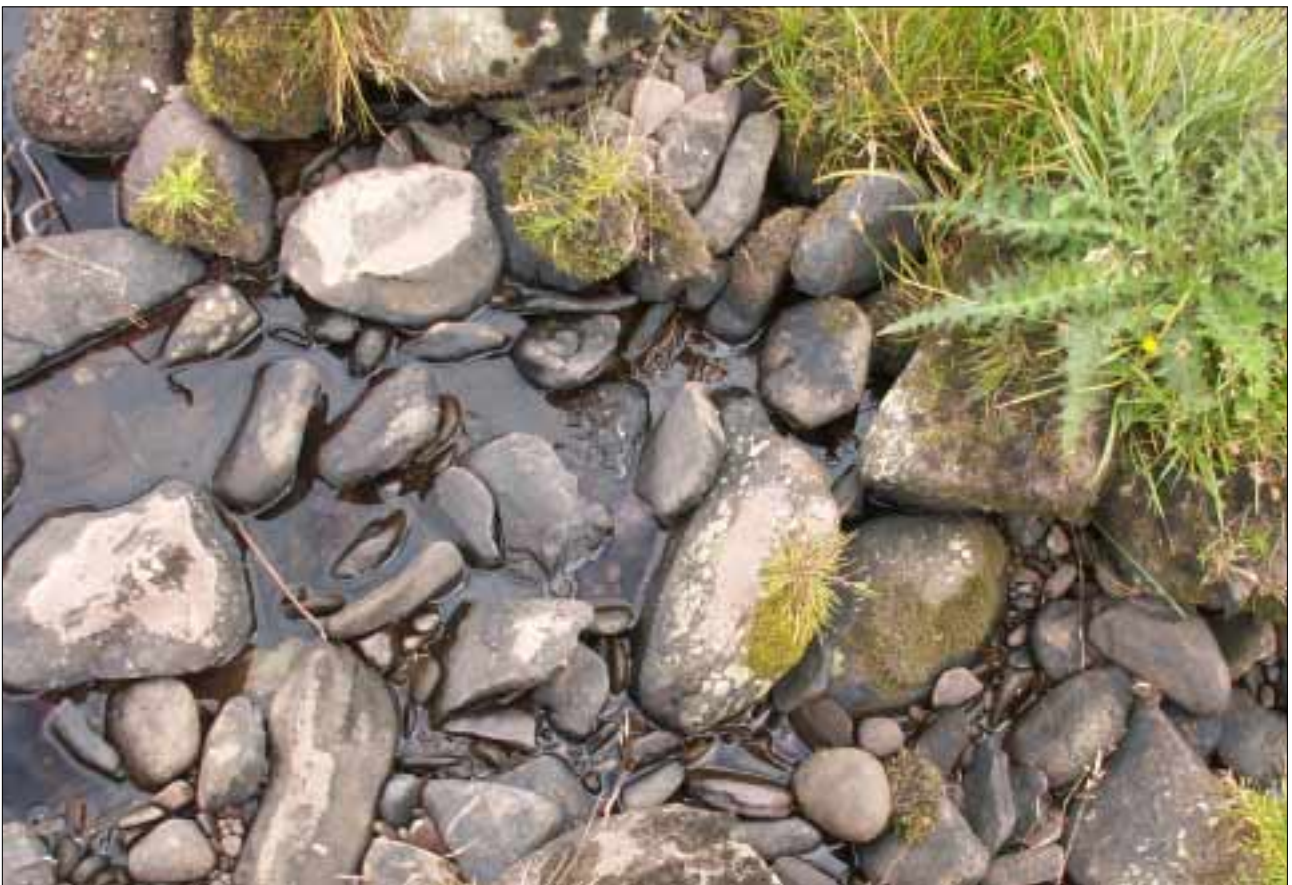
Pollution is evident at low water in the burn immediately below the quarry and peat dump pictured above.

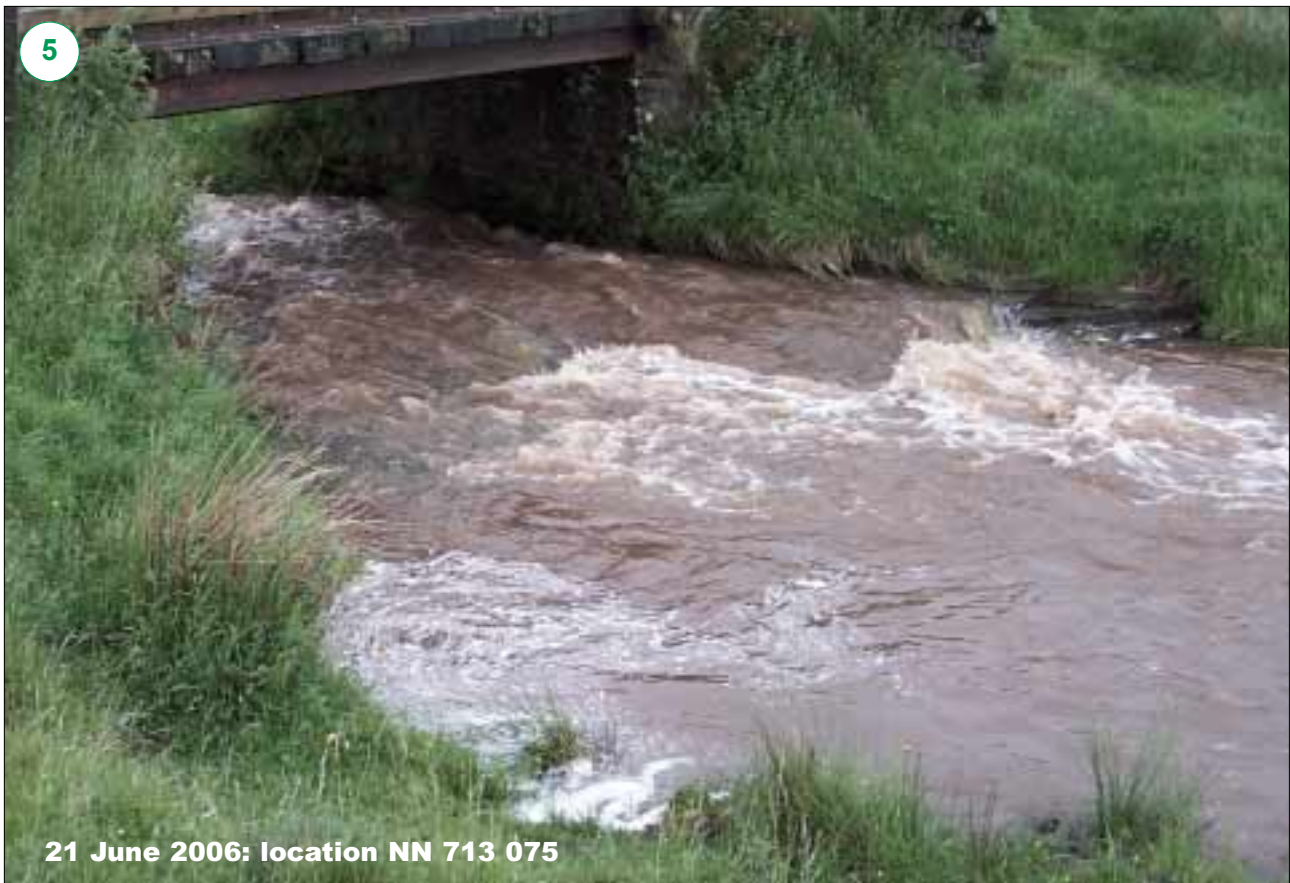
21 June 2006: location NN 713 075

The Garvald Burn, seen from the side of the bridge on Severie Farm on 21 June.

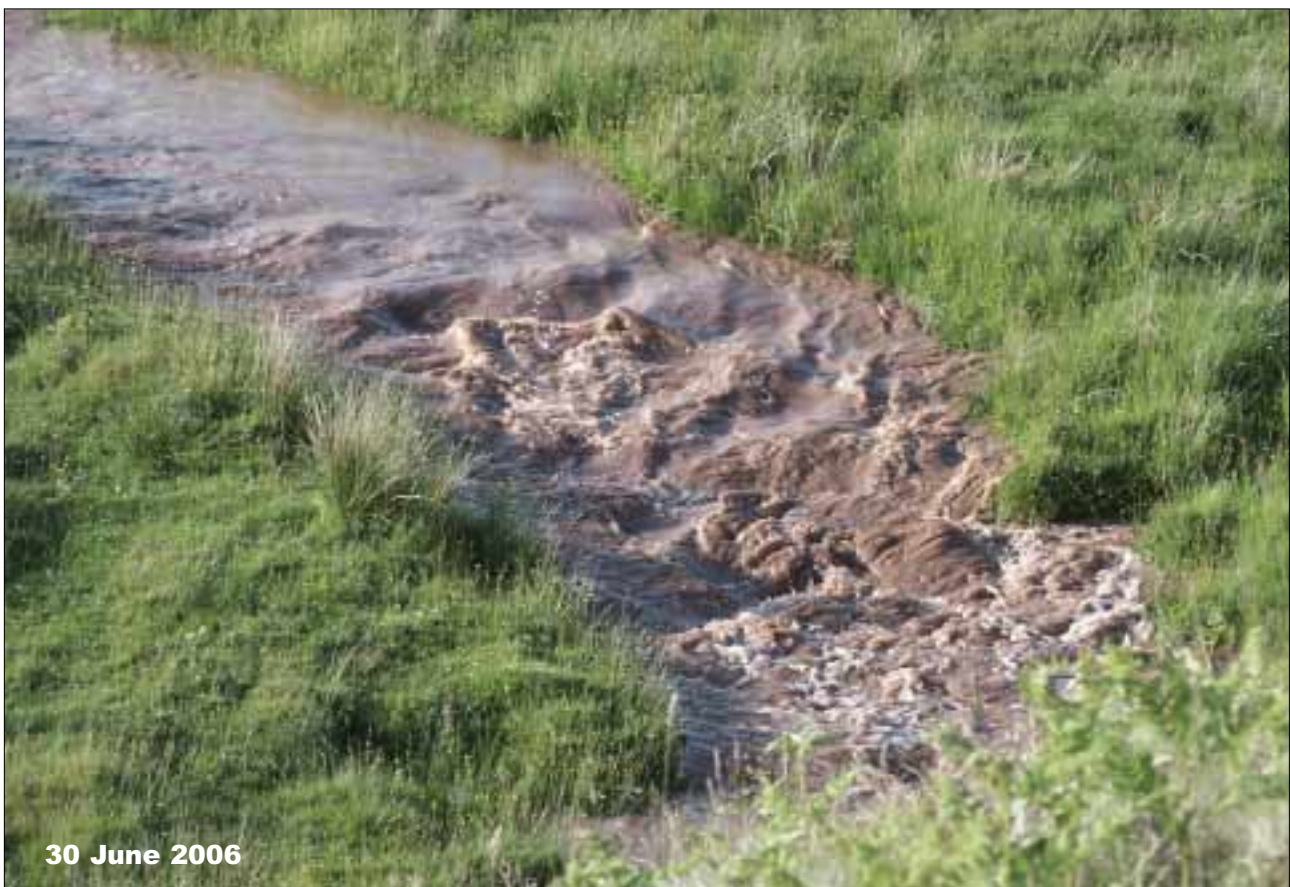
30 June 2006

Looking north up the Burn from the same bridge on 30 June.

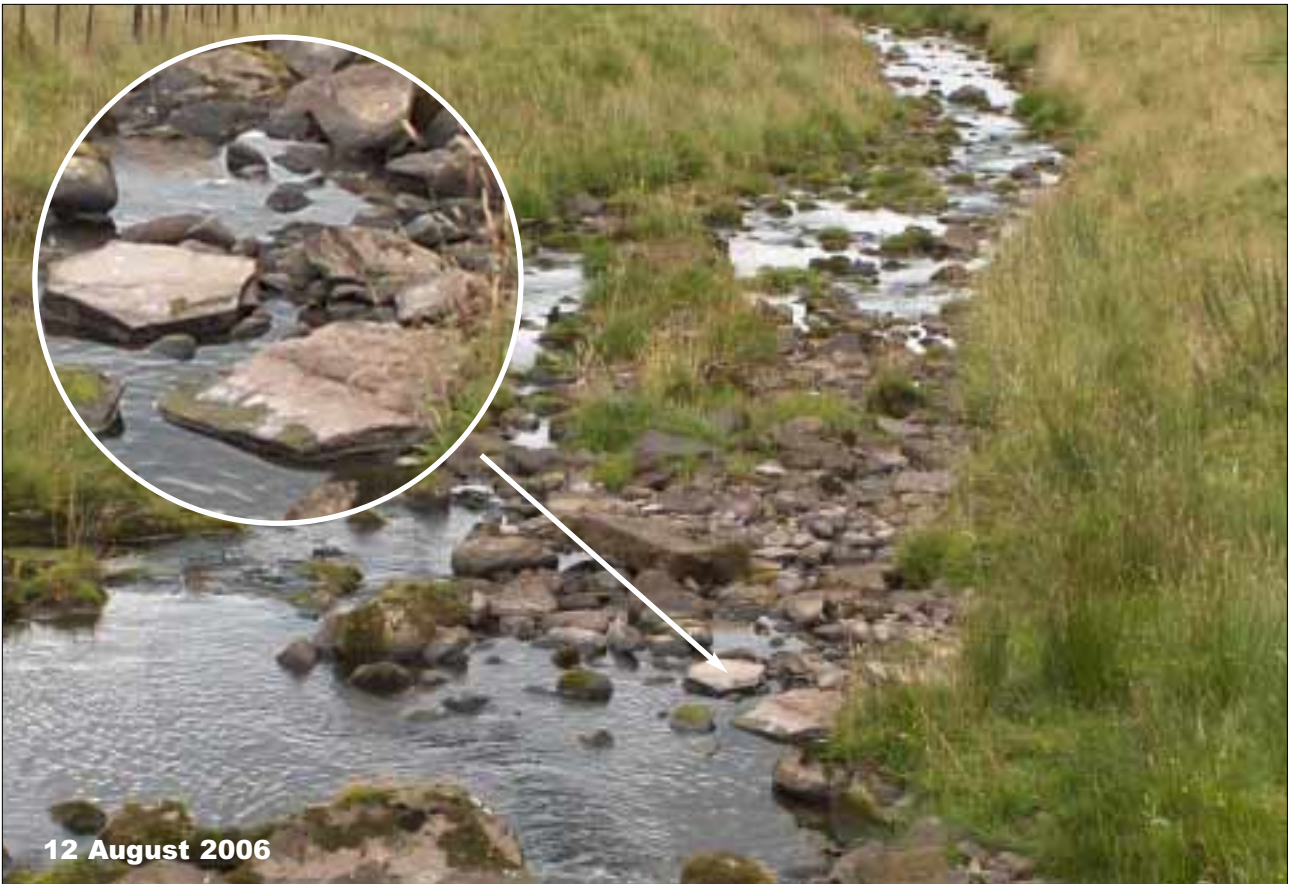
The same stretch of the burn photographed after a lengthy dry spell. Although the water is, for now, clean, dried sedimentation is evident on rocks clear of the water and the river bed is also contaminated.
