Environmental issues at the Braes of Doune wind farm

A report prepared by

John Phillips, MA, CBiol, MBiol

August 2006

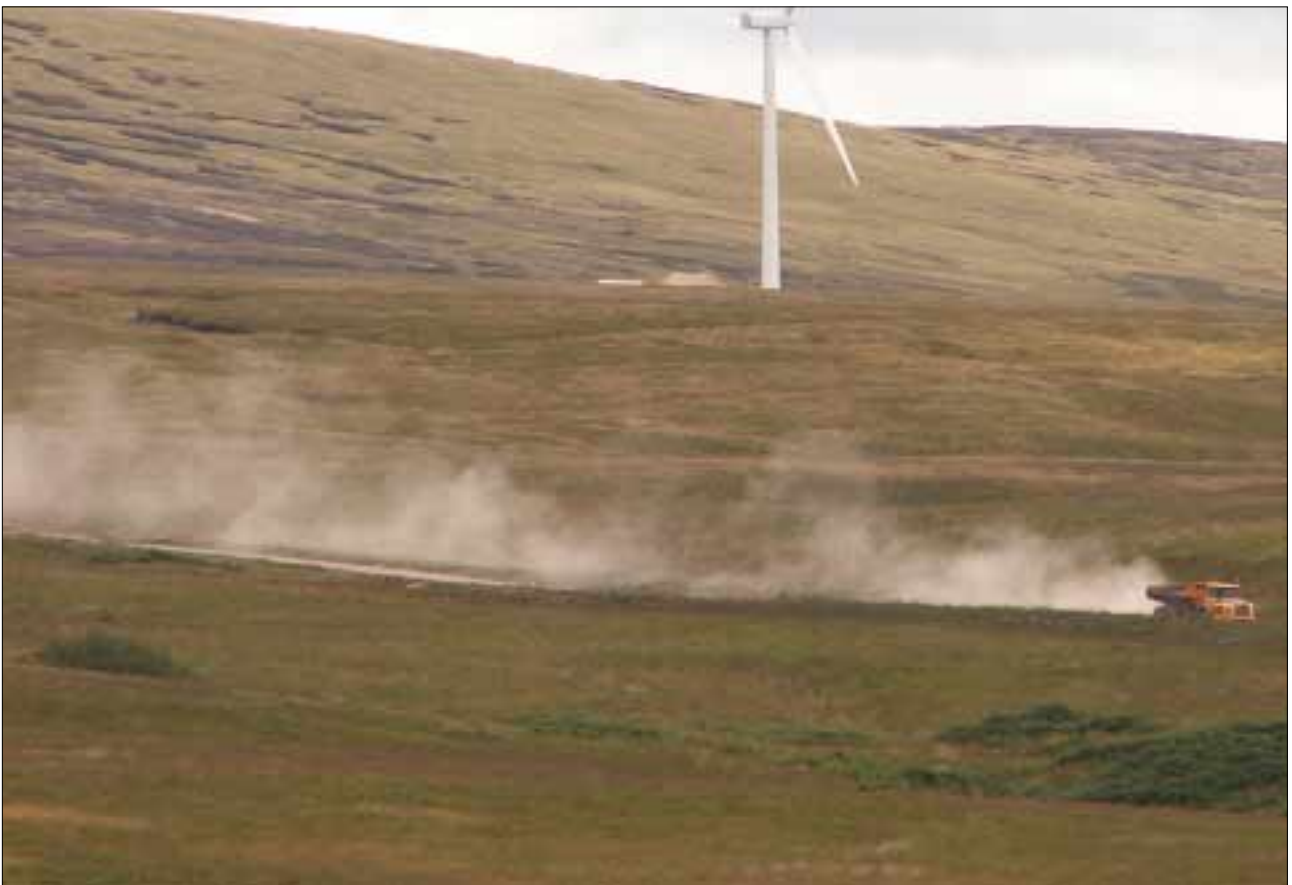
Site traffic, which passes nearby constantly, suggests the quantity of material that will eventually be washed down the local waterways.

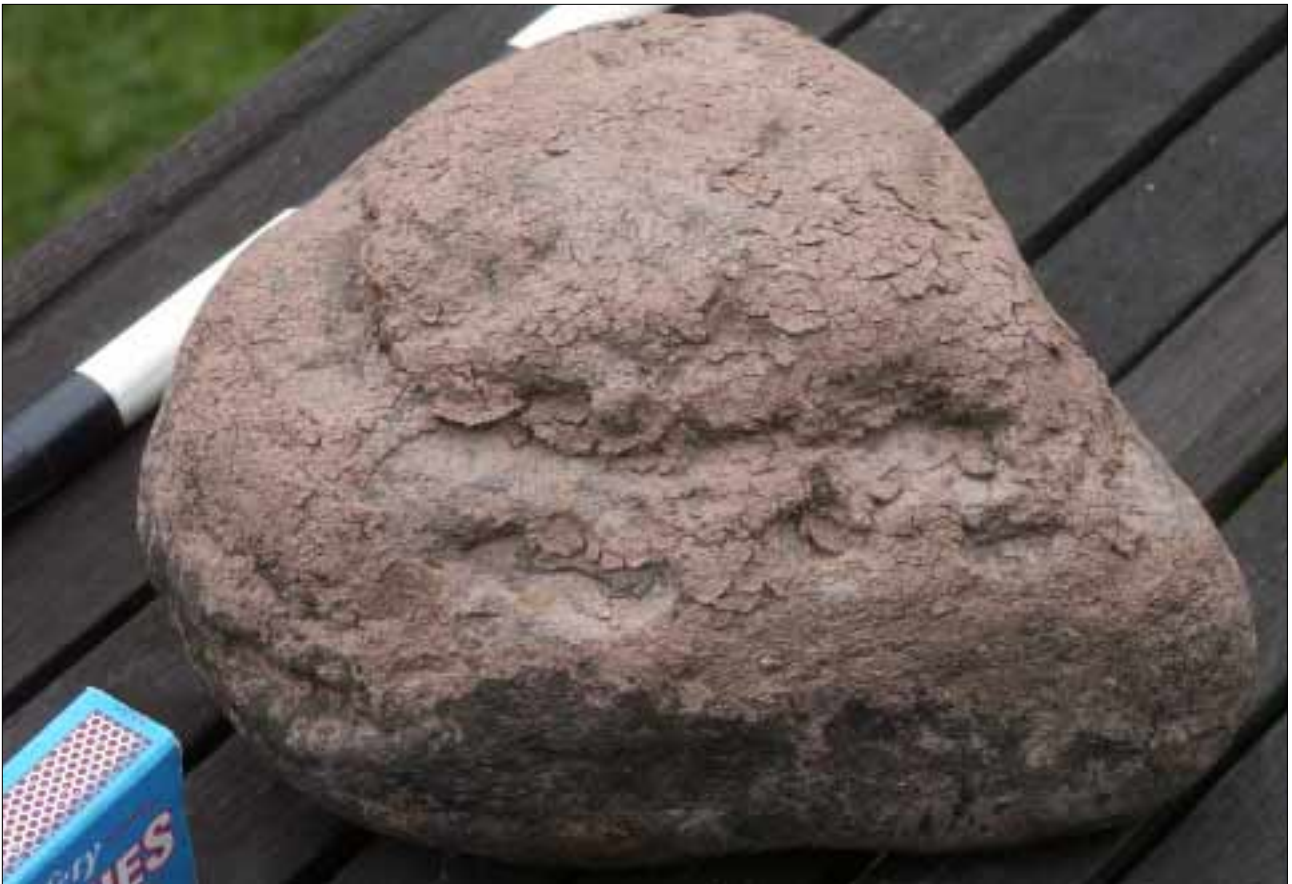
A stone lifted from the location on 12 August 2006: it was proud of the water at the time. Note the sedimentation left over from immersion at higher water levels. (The steps on the scaling rod are five cms long.)

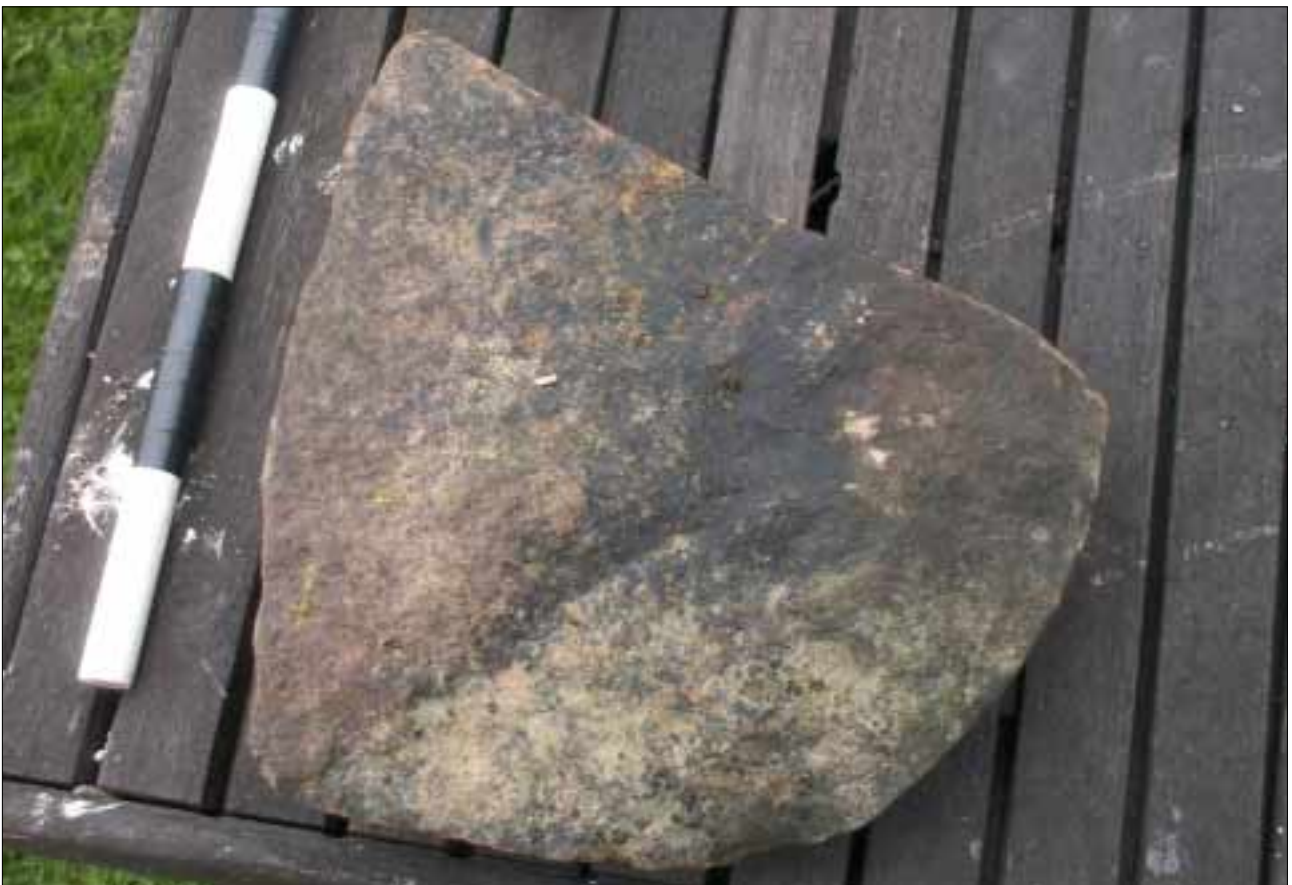
For comparison, a stone lifted from the Coldruich Burn which lies about 100 metres west of the Severie bridge. It appears to be unpolluted.

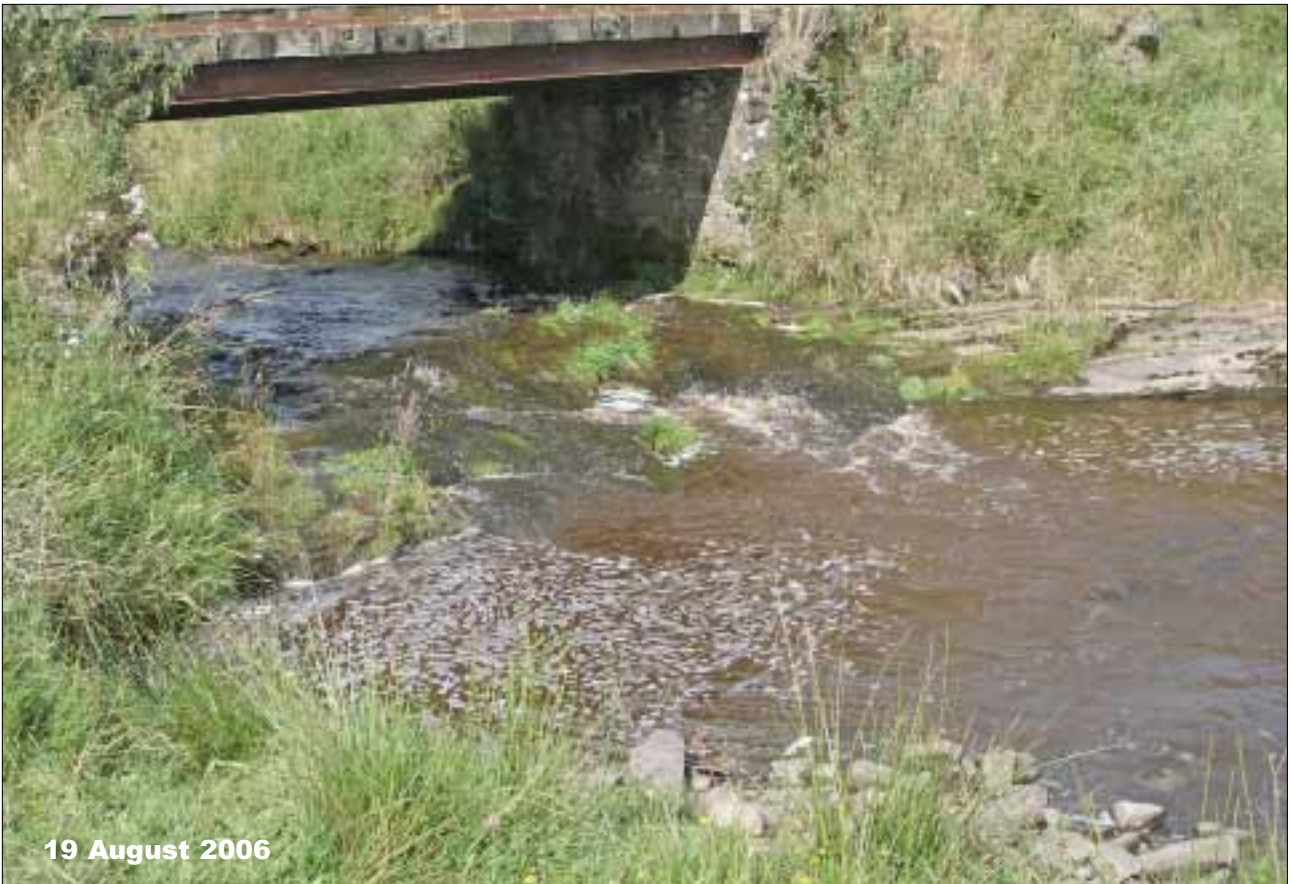
The Severie Bridge (cf page 21) seen here on 19 August, a week after the picture on page 22. Despite only light precedent rainfall, the burn is clearly loaded with silt.

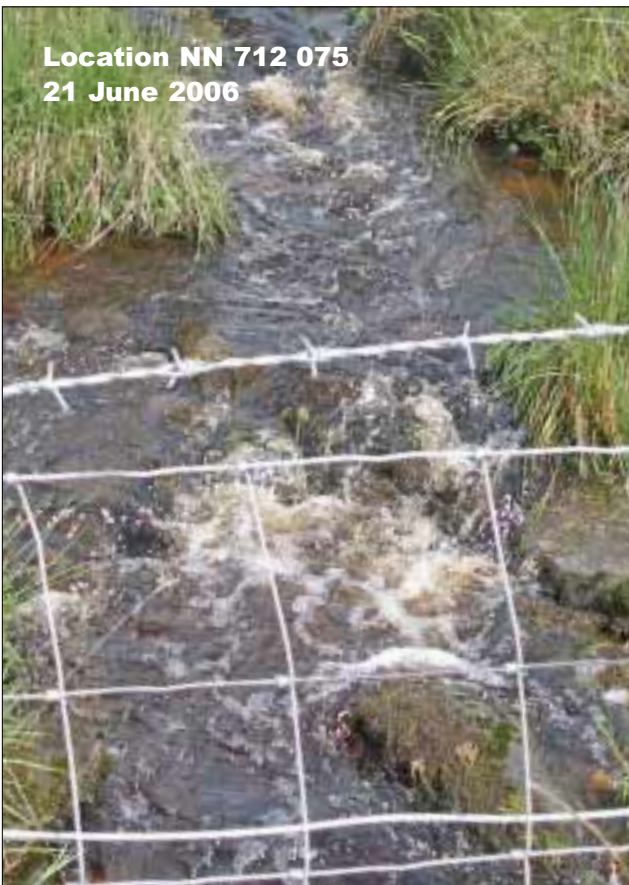
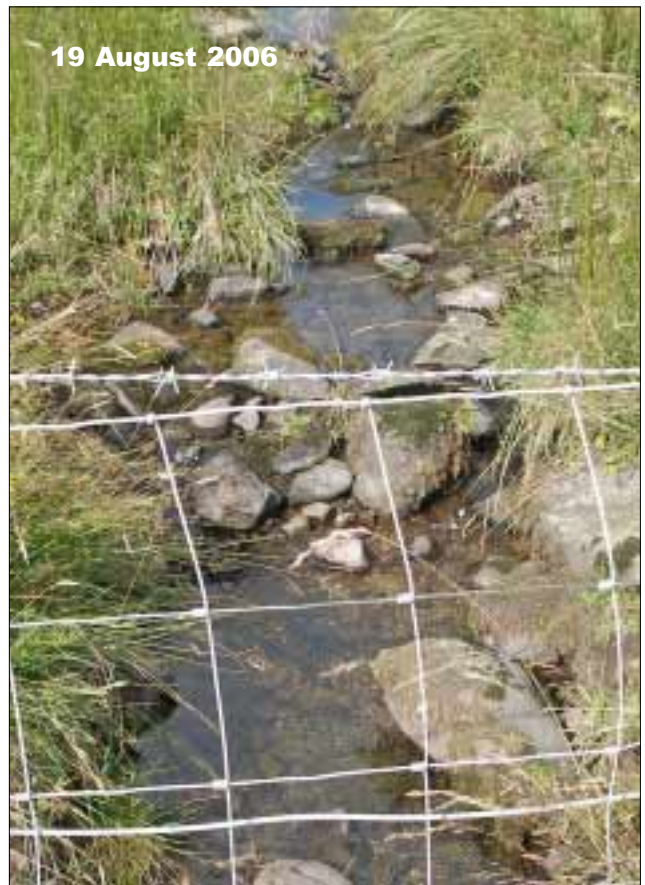
Left: the Coldruich Burn, about 100 metres west of the Garvald. Although it also ran high on June 21, its waters were characteristically clear, as they were on August 19 (right). This contrasts with the Garvald Burn on the same dates.

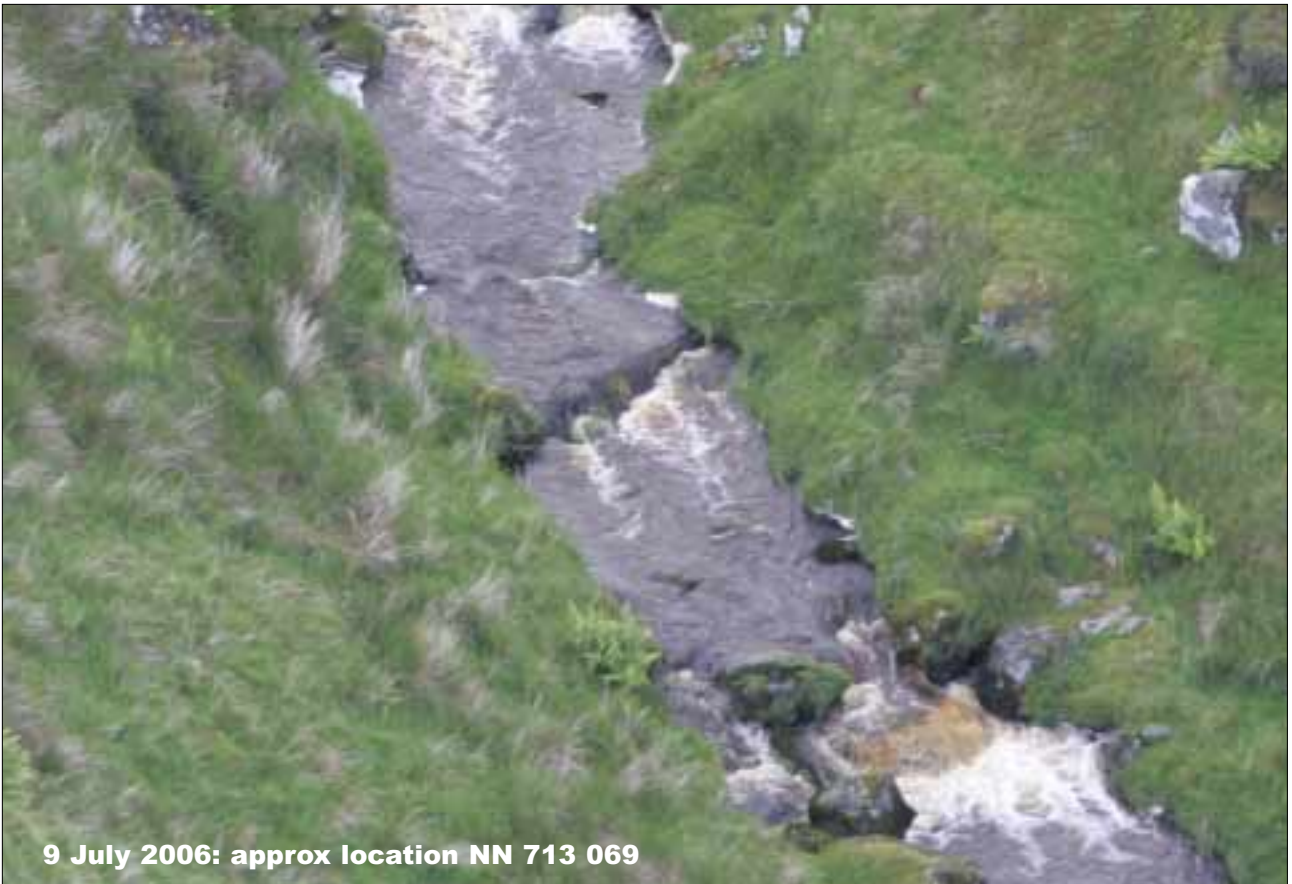
9 July 2006: approx location NN 713 069

The Garvald Burn as it approaches the Ardoch Burn confluence (between points 5 and 6).

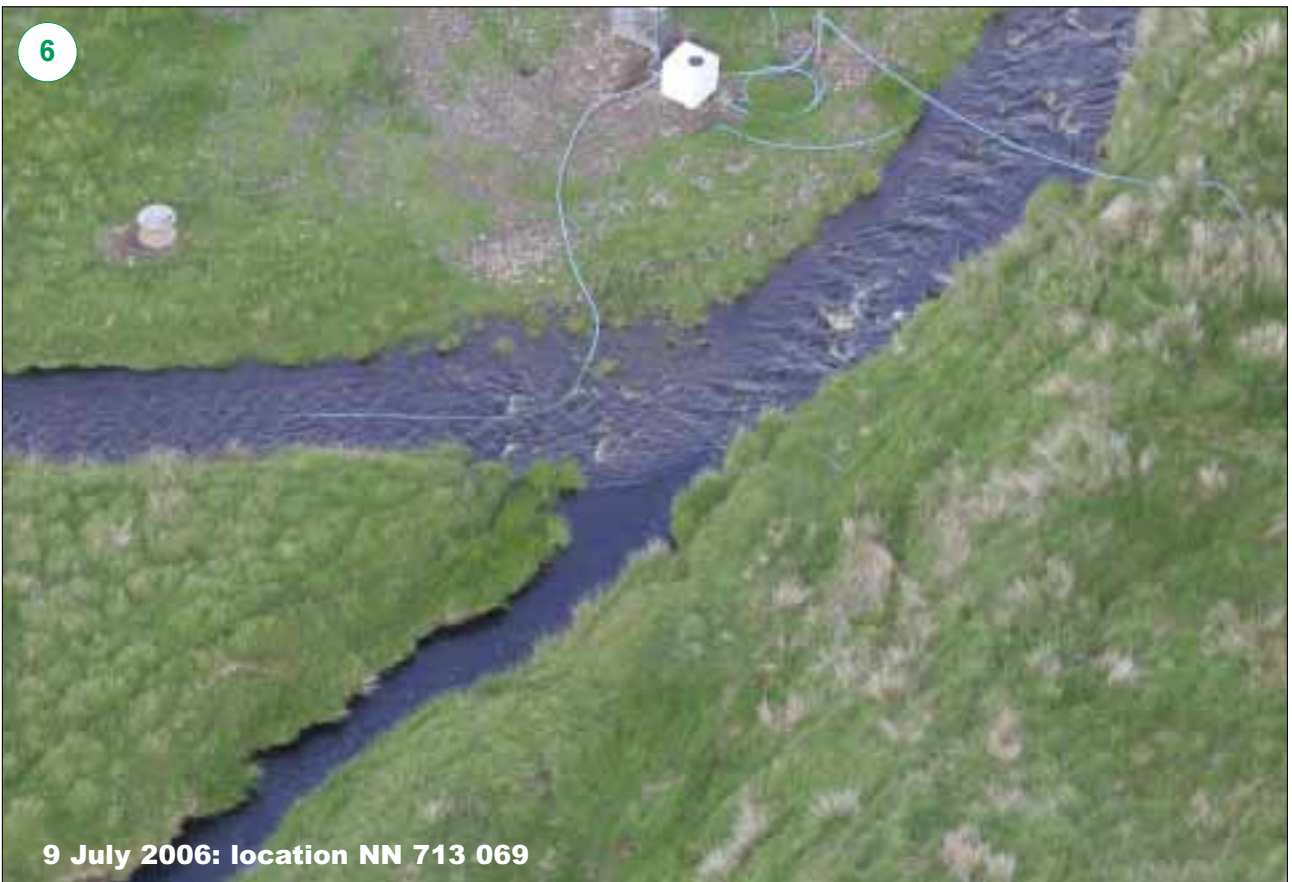
9 July 2006: location NN 713 069

And, flowing from the left, as it joins the Ardoch Burn. Silt load in the former is evident, despite light precedent rainfall.

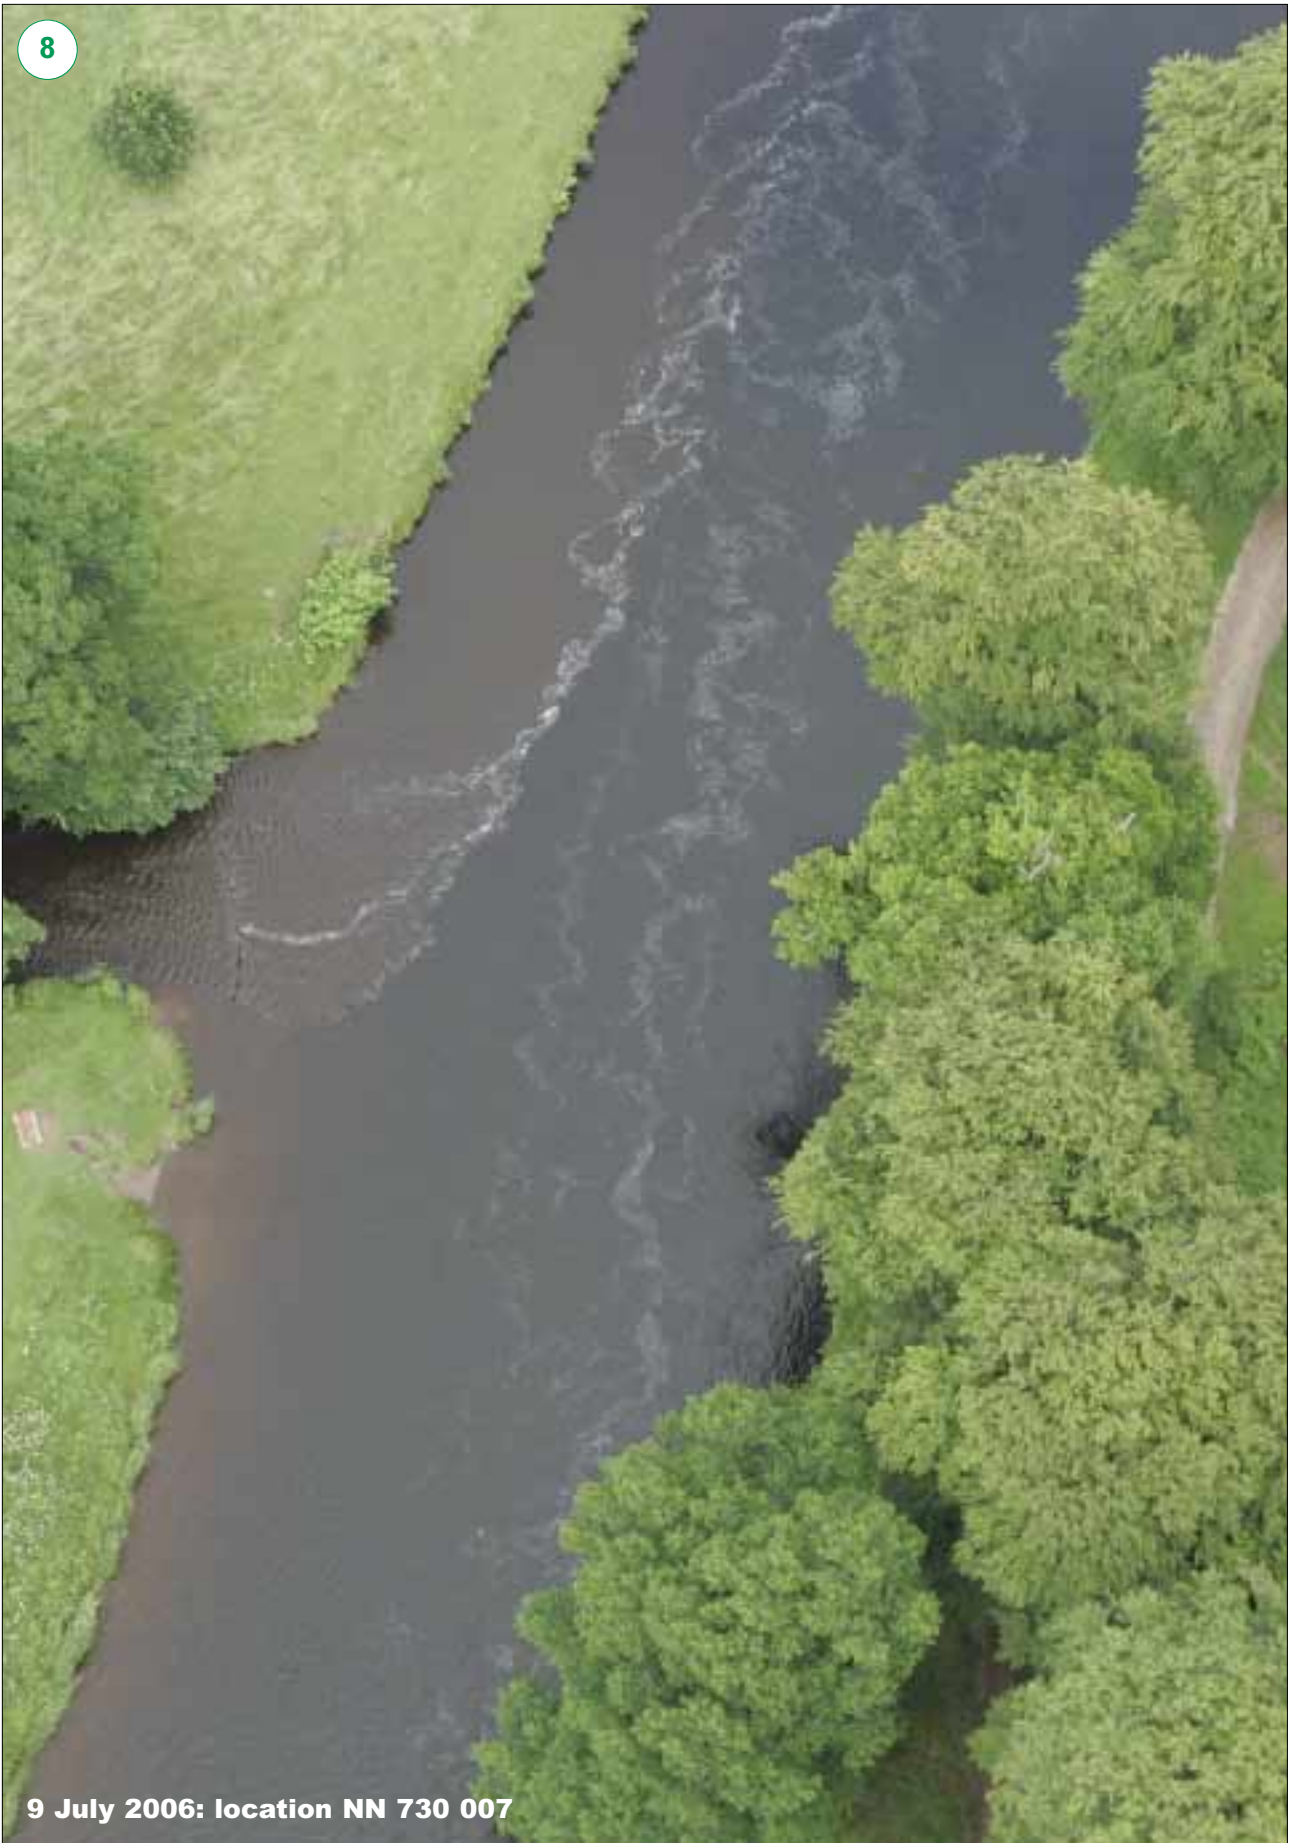
9 July 2006: location NN 730 007

The Ardoch Burn flows south into the River Teith. Turbidity is pronounced despite light precedent rainfall.

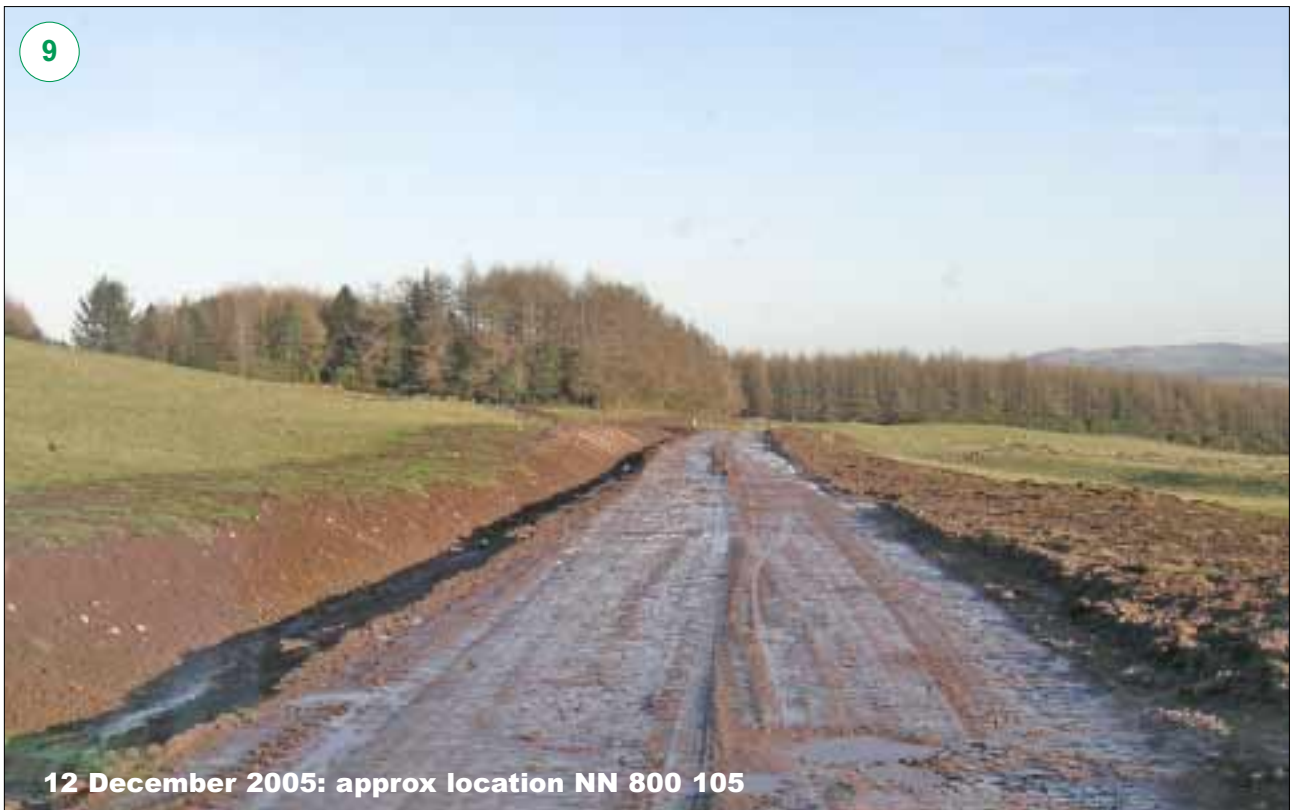
12 December 2005: approx location NN 800 105
Looking east from point 9. The design of the road is such that water is collected on the upslope side and runs via a deep ditch (with no silt barriers) into a natural water course. No effort was made to release water at intervals onto the downside grass and bracken area which would have acted as a natural silt trap. The results are shown below.

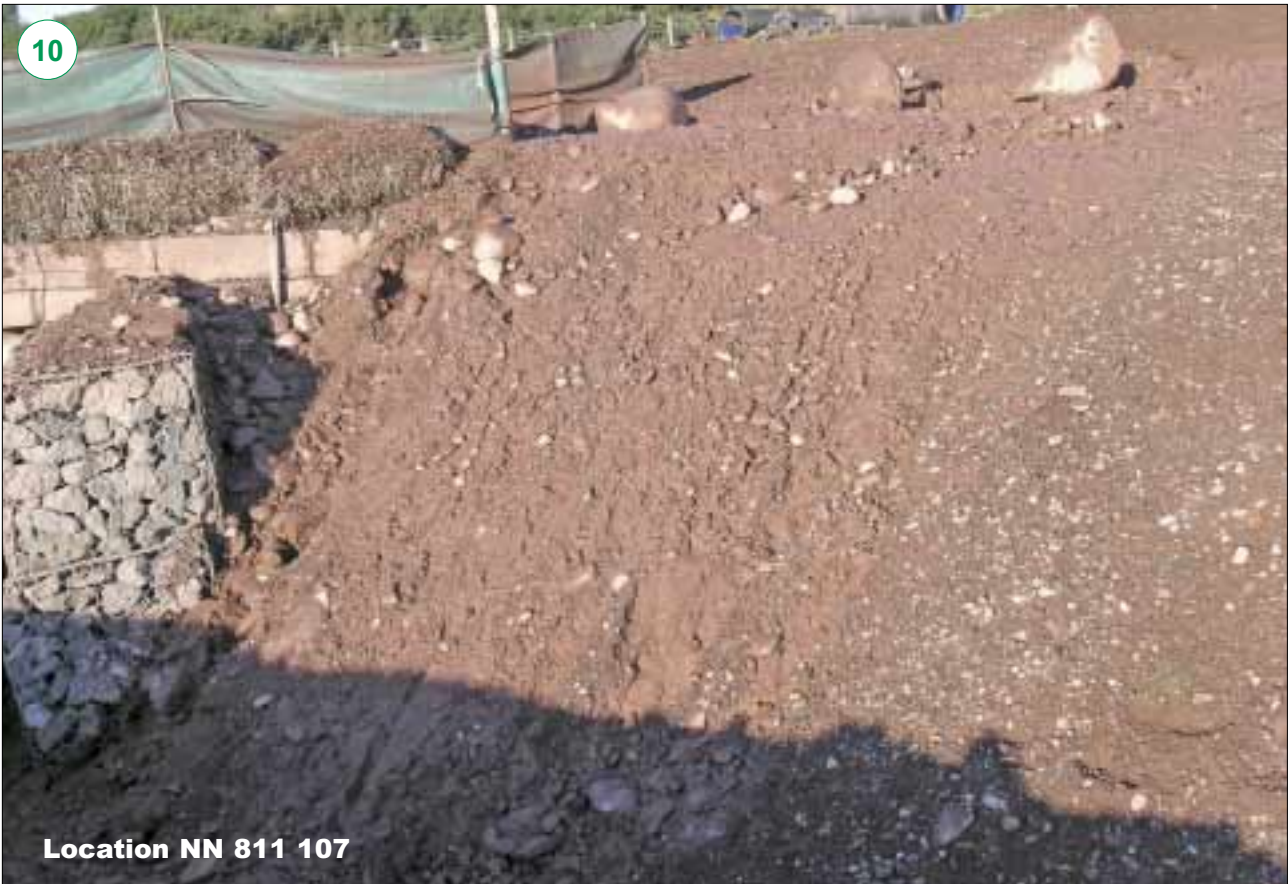
Location NN 811 107

The road crosses a burn at point 10. The evident scouring marks show that water runs from the road down the embankment into the burn.

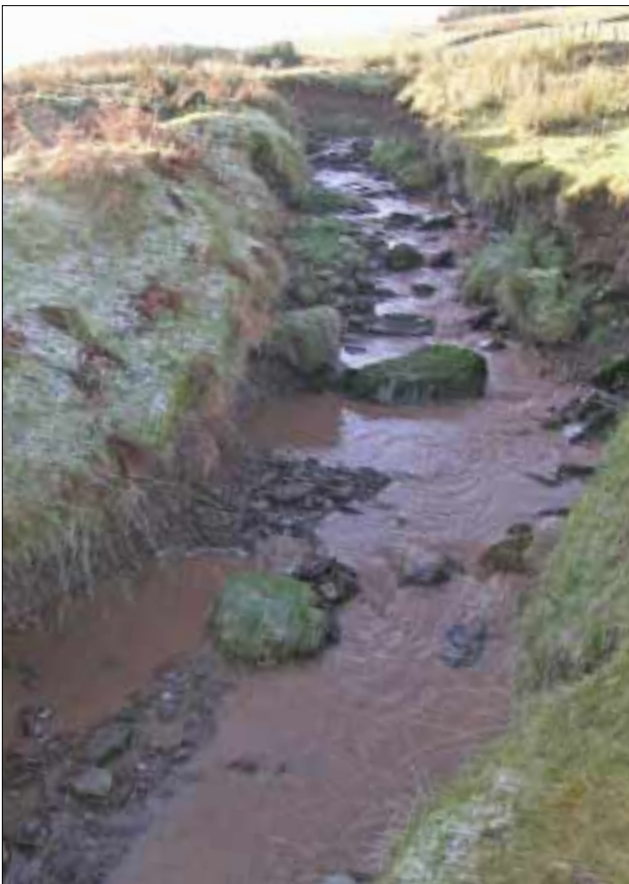
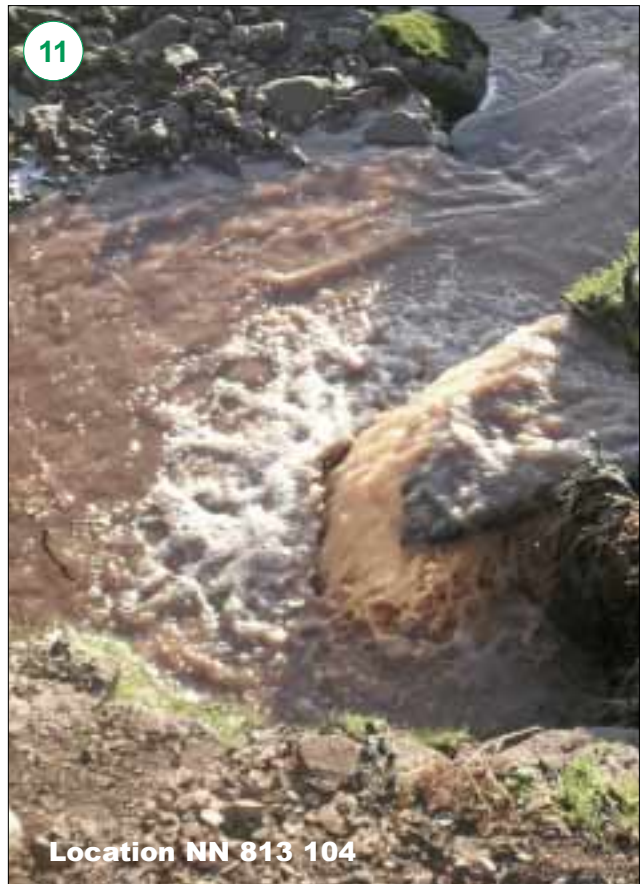
Location NN 813 104

Left: the burn as it continues past point 10 carrying now heavily silted water and (right) as it enters the Bullie Burn (point 11). It is recorded as a spawning burn.

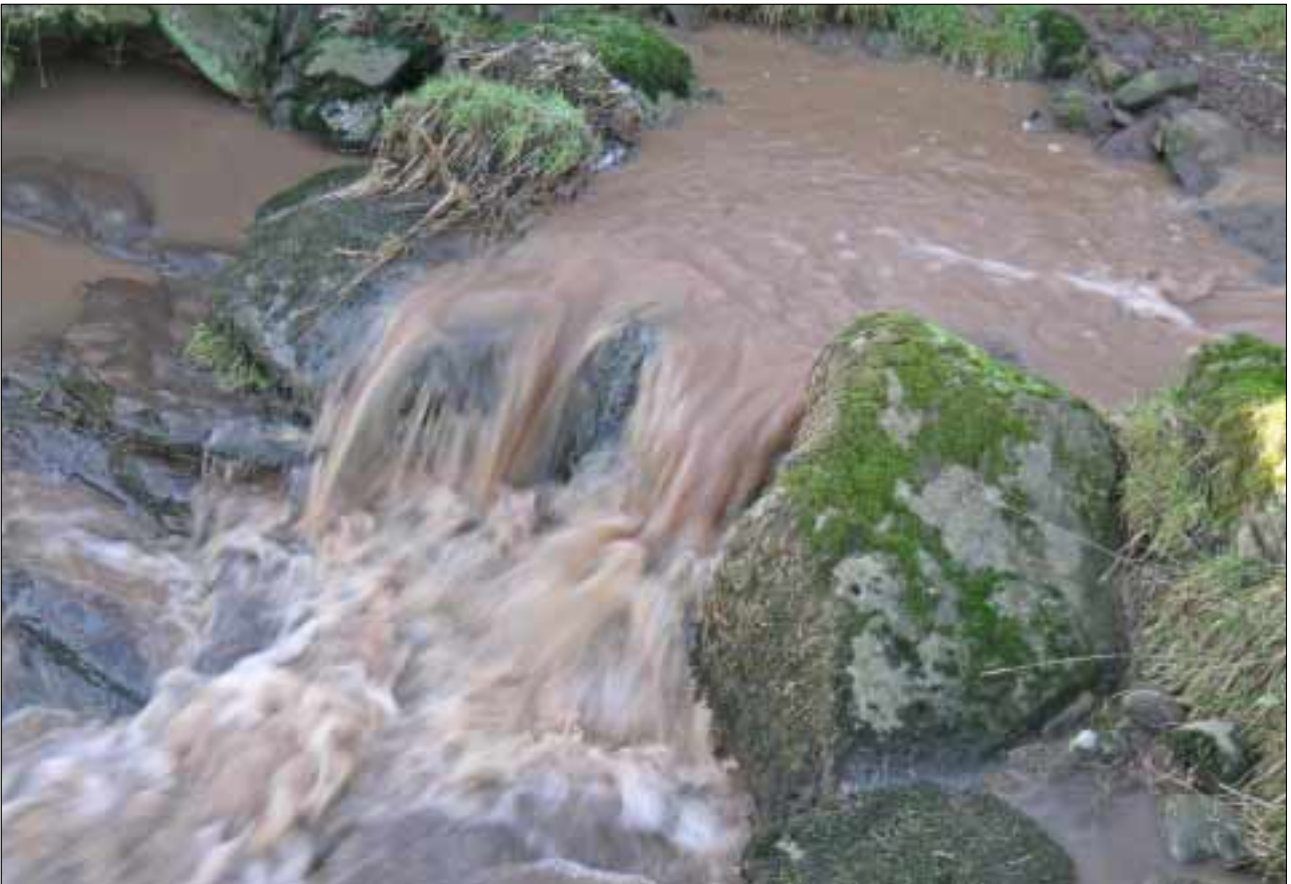
Looking back up the burn as it enters the Bullie Burn.

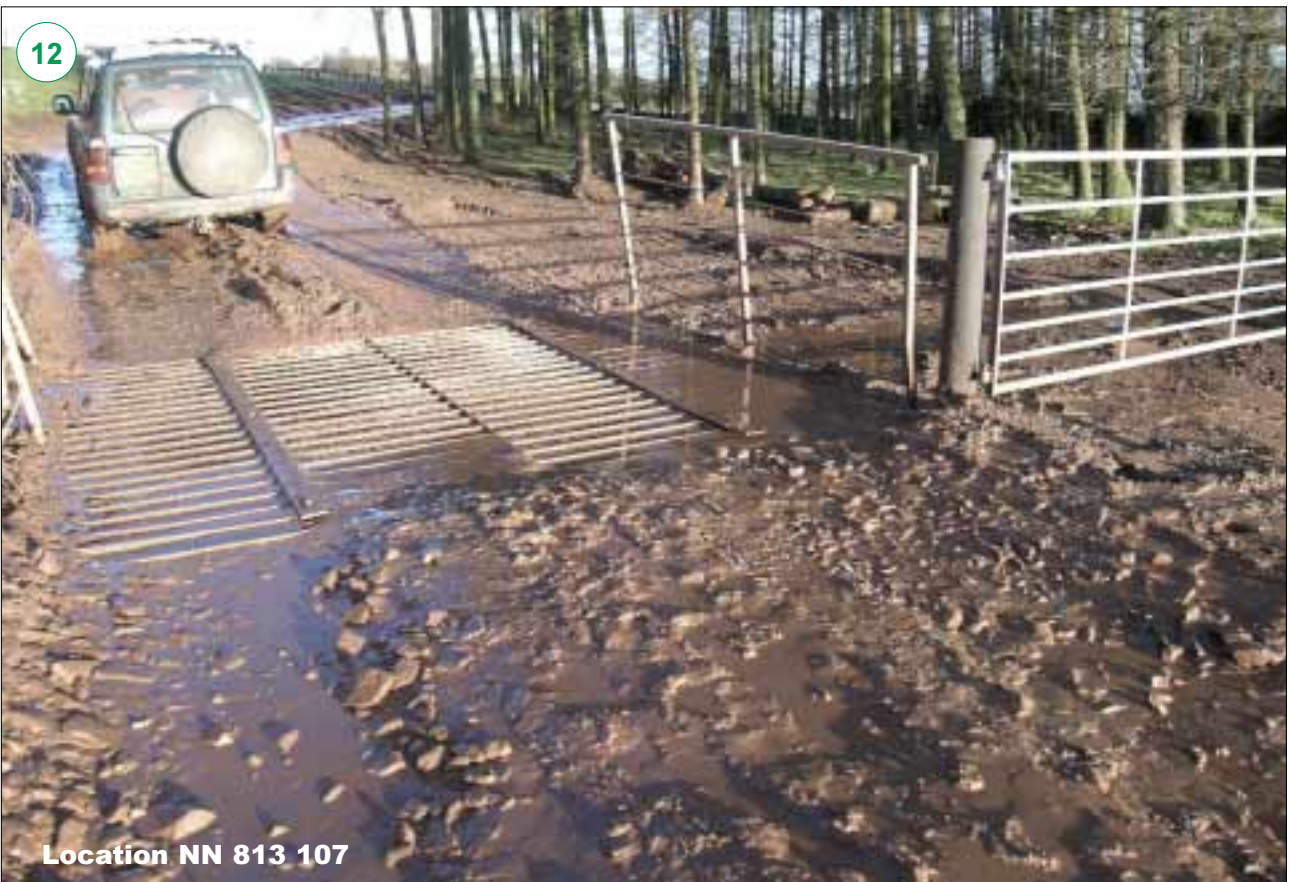
Location NN 813 107

Point 12. Just east of point 10, the road passes through a wood before descending for about a kilometre to point 13 where runoff channelled into ditches and pipes was collecting.

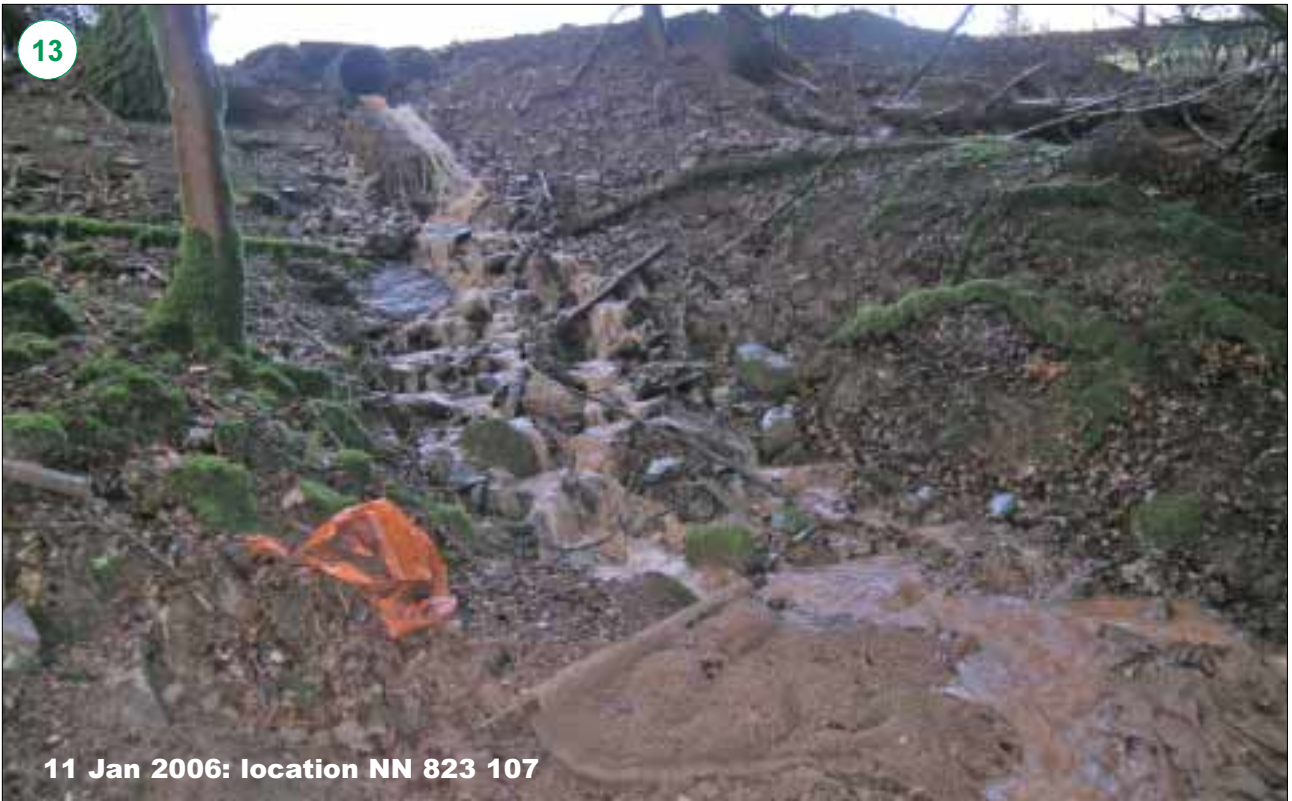
11 Jan 2006: location NN 823 107

Point 13: the road at this point is barely 20 metres from the Bullie Burn. The top picture shows silted water being discharged from the road through the intervening wood into a silt catching system (middle and bottom). At least on the day these pictures were taken, it was manifestly failing. All this water ends up in the Bullie Burn.

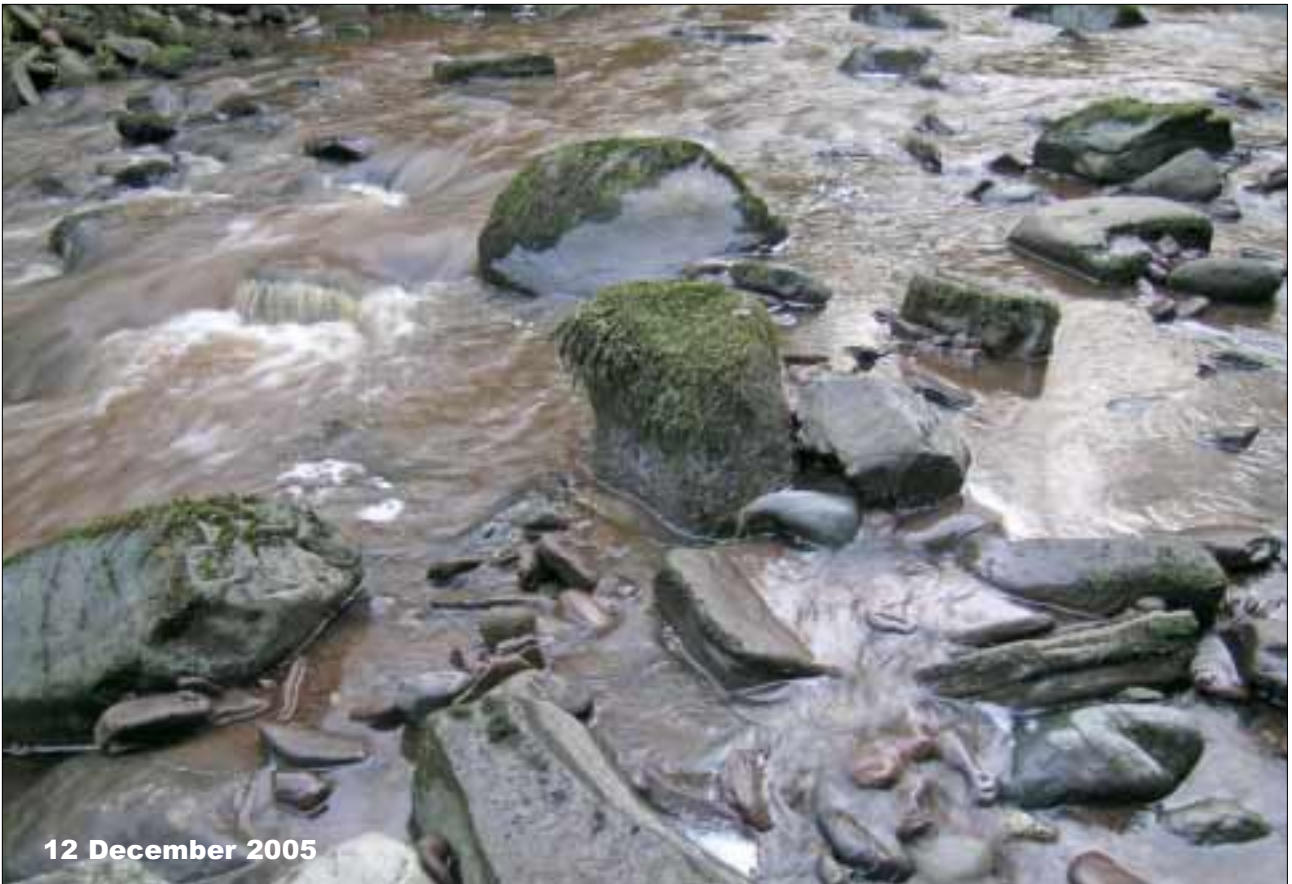
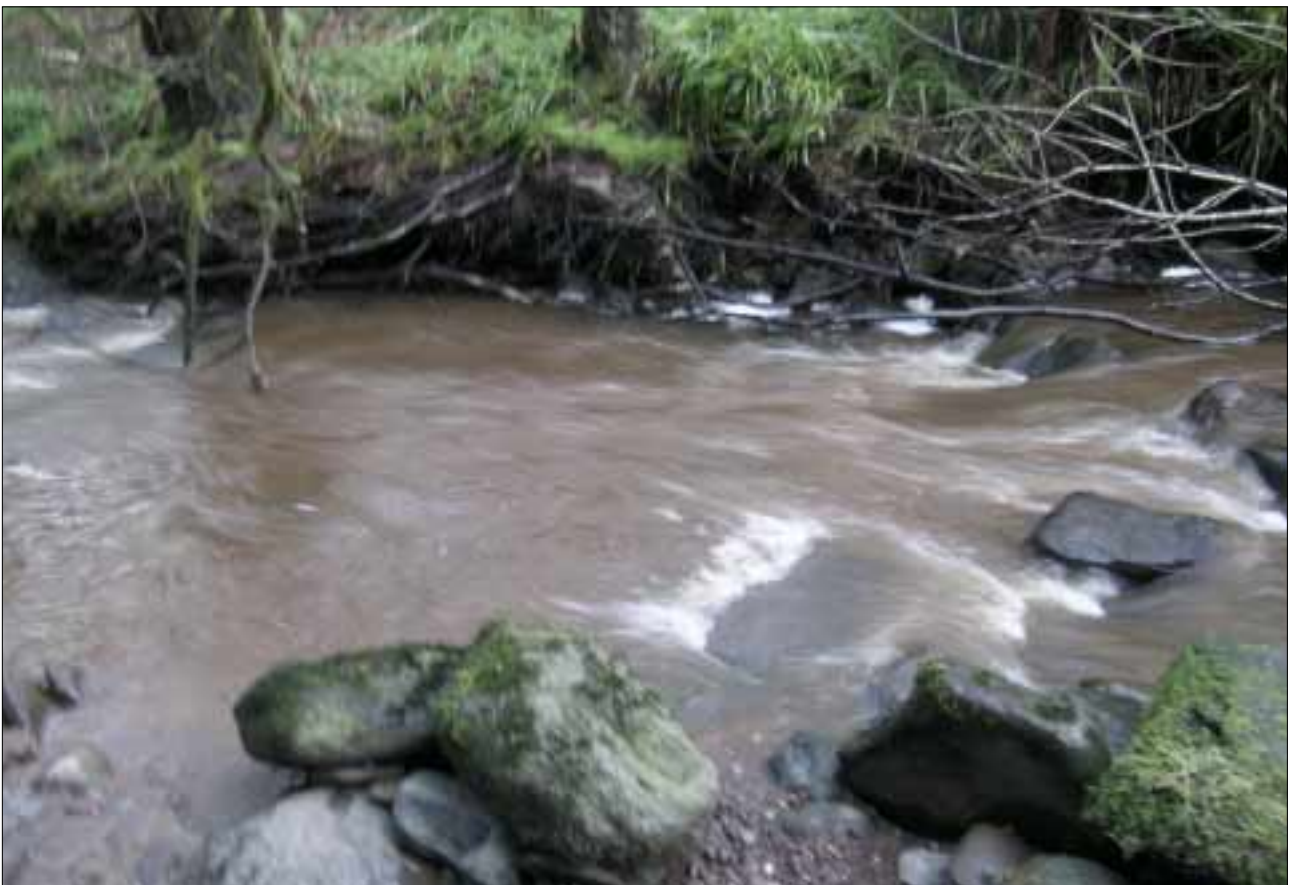
12 December 2005

Two shots of the Bullie Burn taken close to point 13 show pronounced colour even at low water.

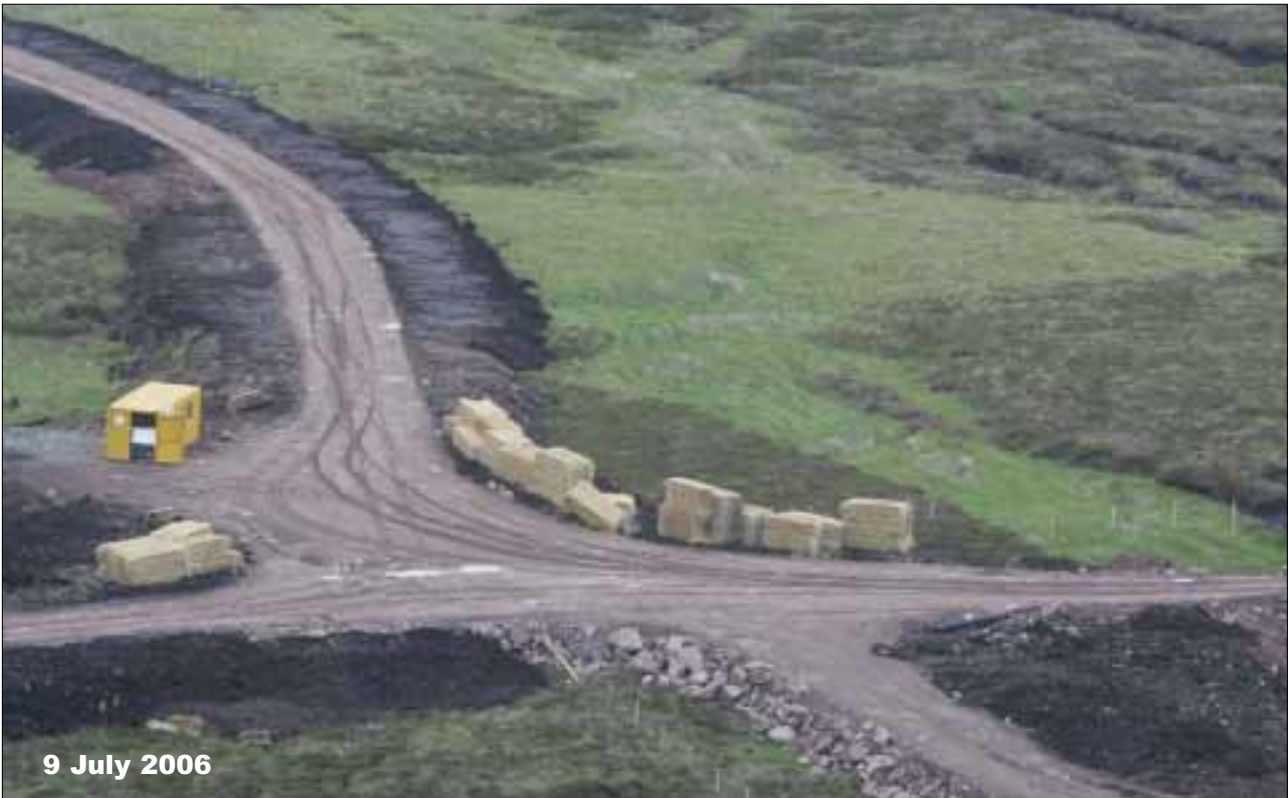
The developer is known to have been importing many tonnes of straw bales onto the site continuously since last year. The picture shows a temporary depot for storing large bales to be used as silt traps. Note how peat excavated during construction is disposed of by deposition alongside access tracks. These will oxidise and emit CO₂ over time.

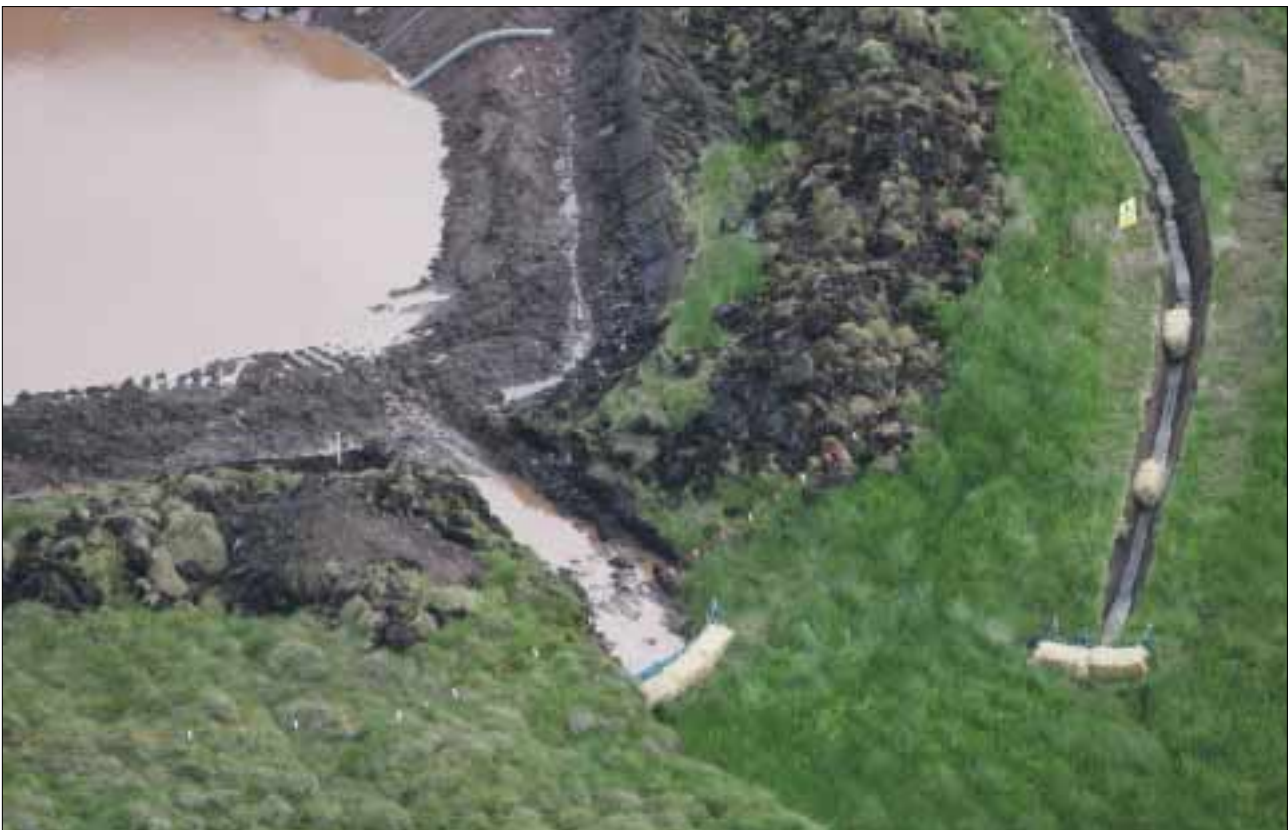
Attempts to arrest silt with bales. The area of bare ground above ensure that these measures are overwhelmed as soon as there is heavy rain.
