Environmental issues at the Braes of Doune wind farm

A report prepared by

John Phillips, MA, CBiol, MBiol

August 2006

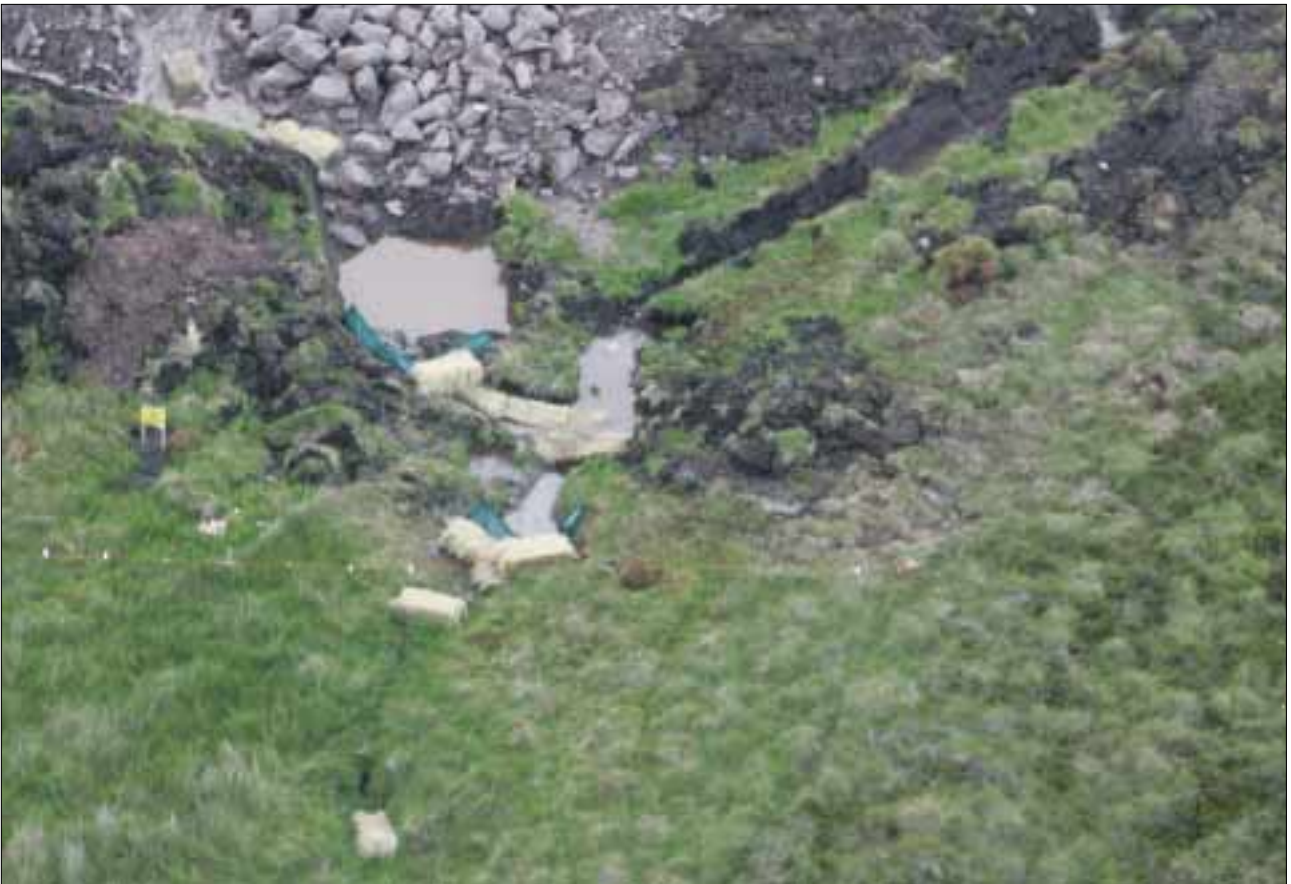
Attempts to arrest silt with bales. The area of bare ground above ensure that these measures are overwhelmed as soon as there is heavy rain.

As above.

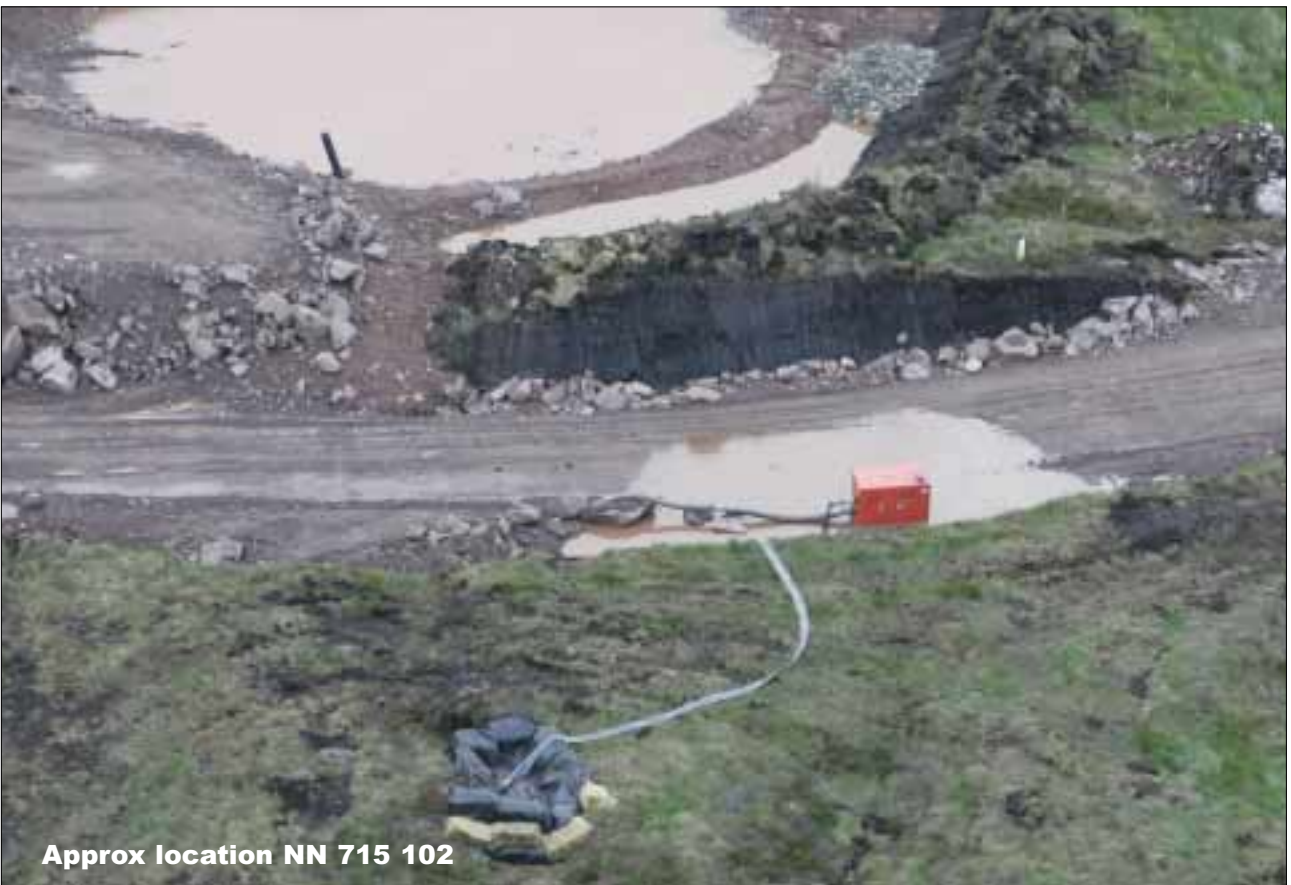
Approx location NN 715 102

The excavation for a turbine base and the adjacent access road. The red box is a pump moving turbid water into a terram dam with small bales intended to catch silt downstream.
