The politics of peat

**Lessons from the
Derrybrien
landslide**

**The
Scottish Wind Assessment Project**

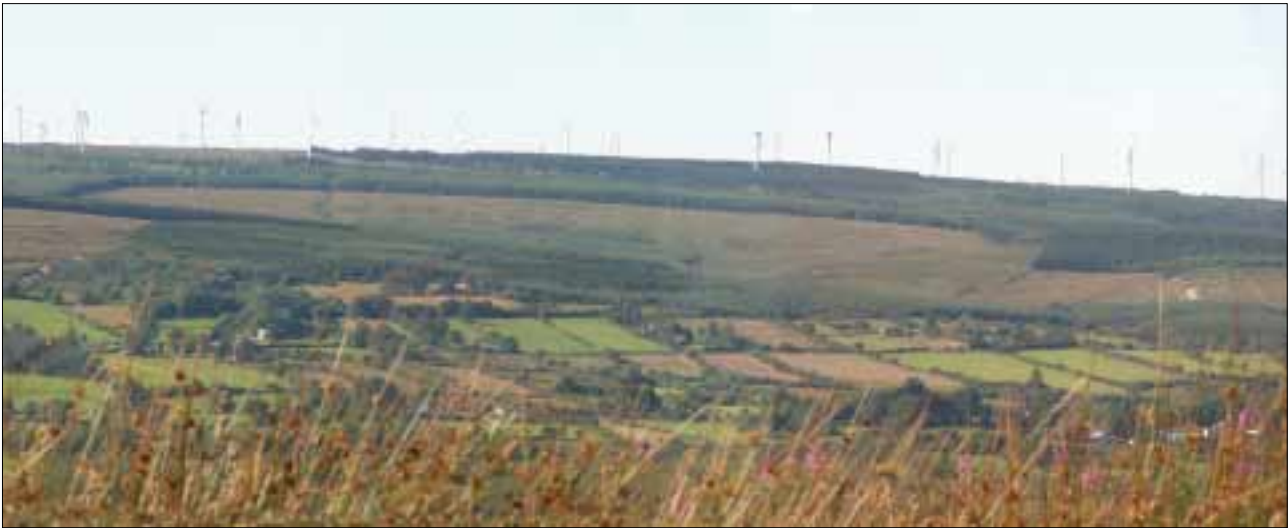
Plate 1: Cashlaundrumlahan from the south. The Gort-Potrumna road (see page 6) runs through the middle of the cultivation at the foot of the mountain (left to right in this picture). The slide occurred to the east of the village.

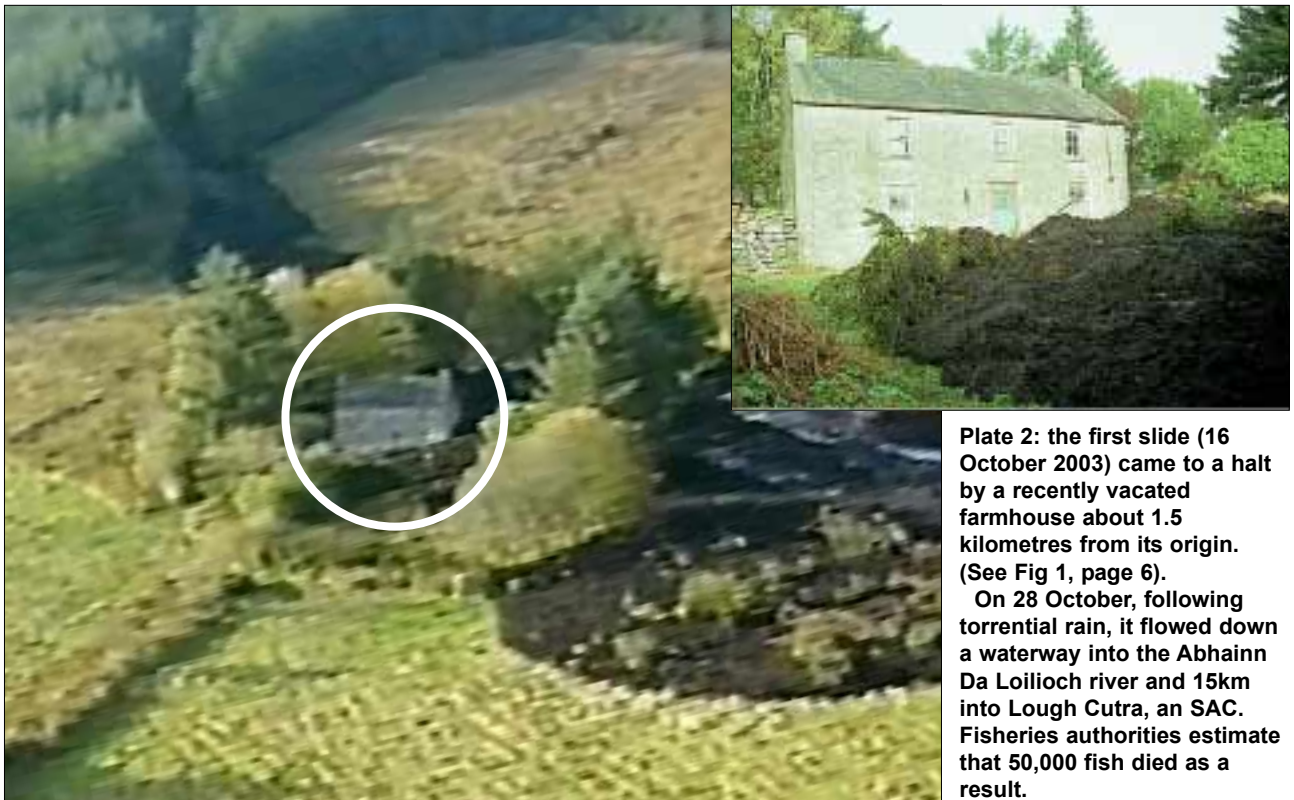
Plate 2: the first slide (16 October 2003) came to a halt by a recently vacated farmhouse about 1.5 kilometres from its origin. (See Fig 1, page 6).

On 28 October, following torrential rain, it flowed down a waterway into the Abhainn Da Loilíoch river and 15km into Lough Cutra, an SAC. Fisheries authorities estimate that 50,000 fish died as a result.

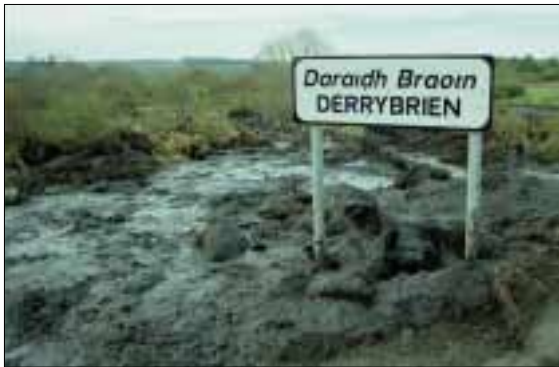
Plate 3. Below: peat from the bog slide, by now a thixotropic slurry, pressing on the Flaggy Bridge just east of Derrybrien on 29 October 2003. The watercourse is normally three to four metres below the road level. In the event, damage to the bridge was minor. Left: a road sign just east of the bridge. See also plate 12.

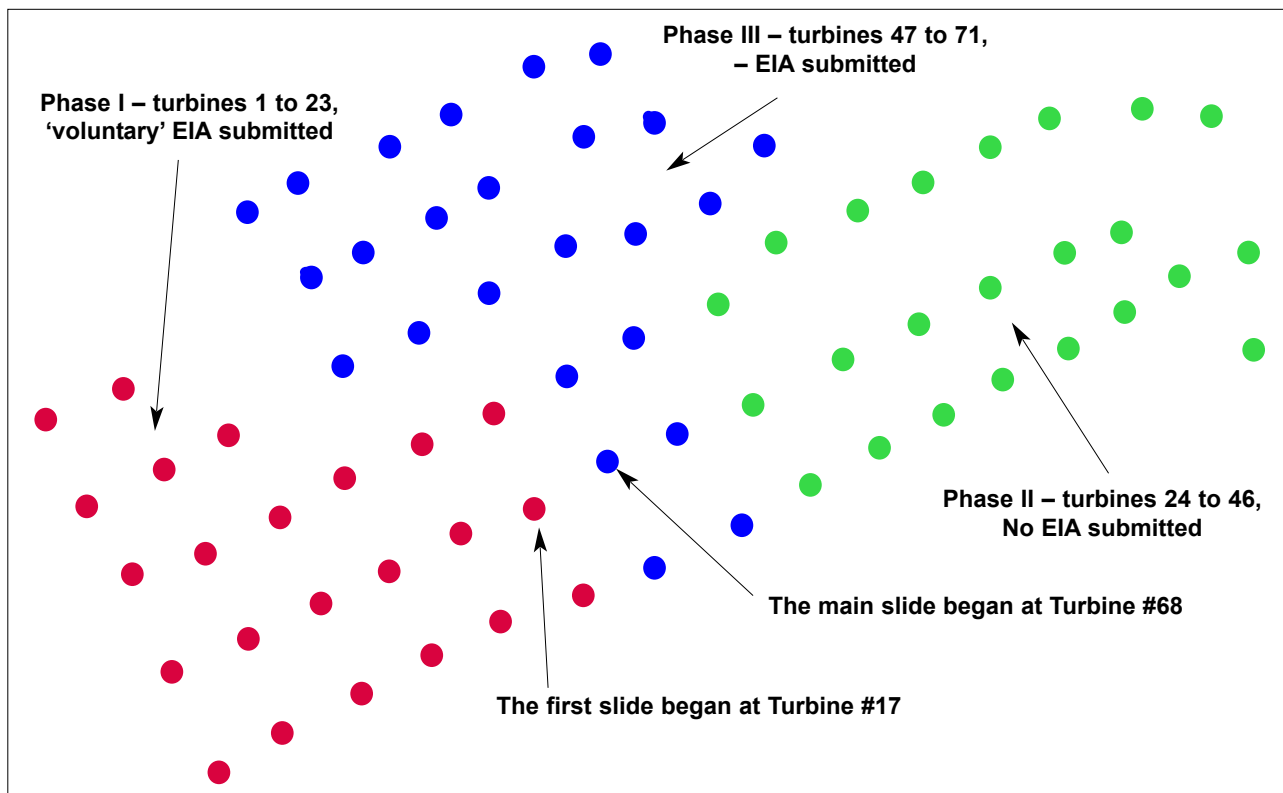
Figure 2: turbine layout for the Derrybrien site showing the three 'phases' by which planning consent was secured for an otherwise unitary 71-turbine project. Construction began with Phase III in July 2003 and the slides occurred the following October. Consent extensions were granted for Phases I and II in November just before the developer and the local authority received geotechnical reports on the incident. The project, now complete, was constructed in a continuous campaign.

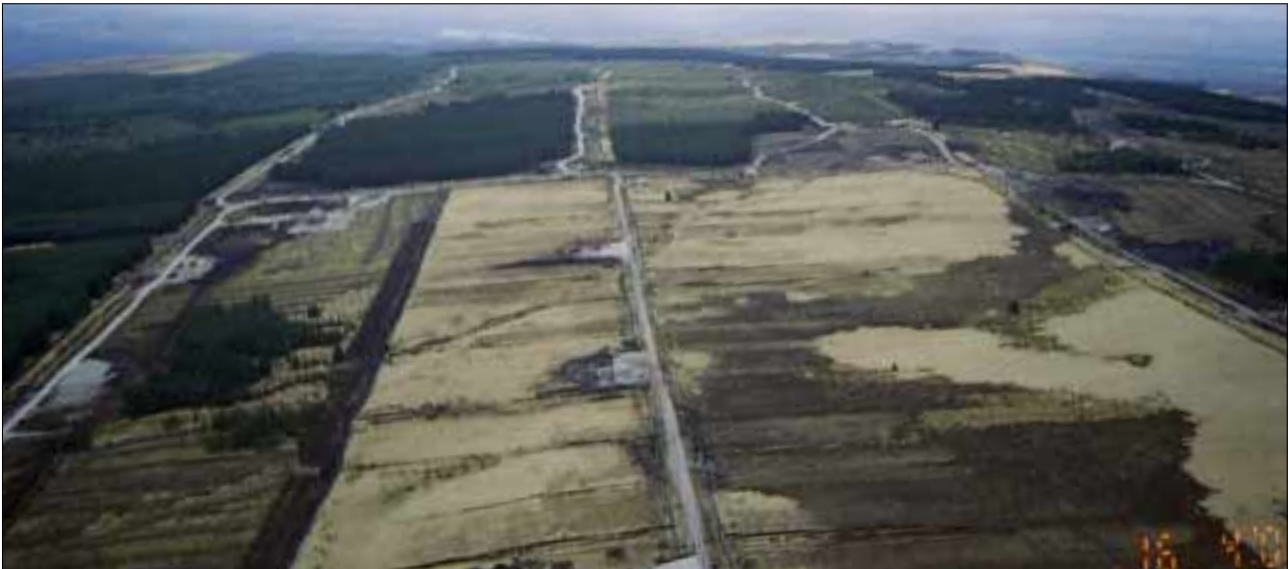
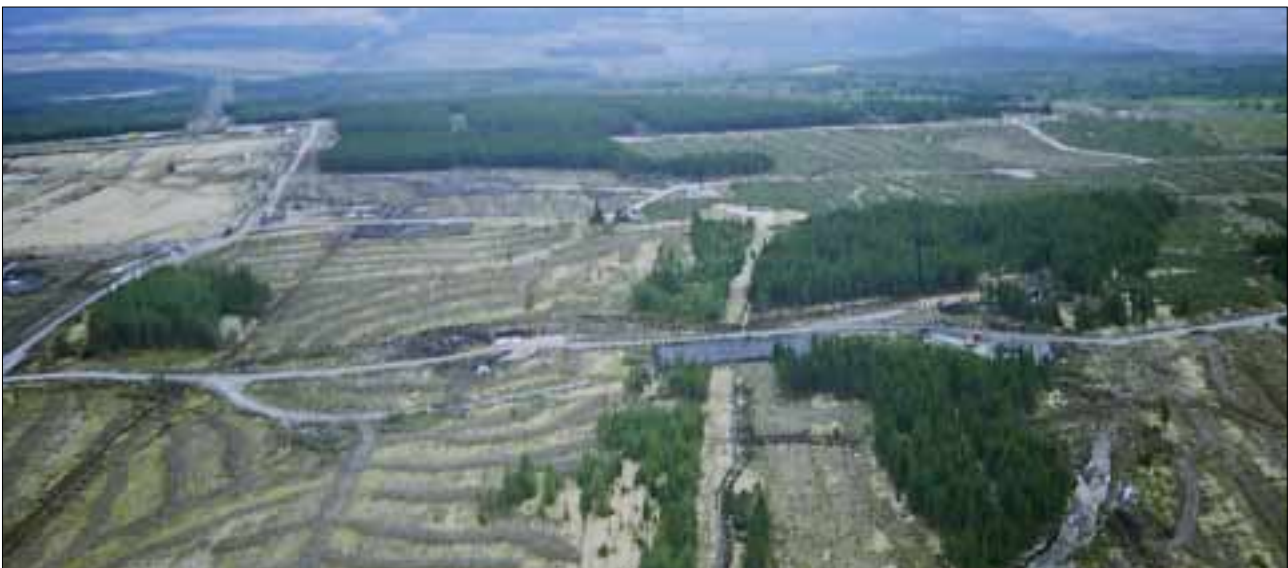
Plate 4: aerial views of the site showing the degradation caused by deforestation, ‘floating’ roads and peat excavation.

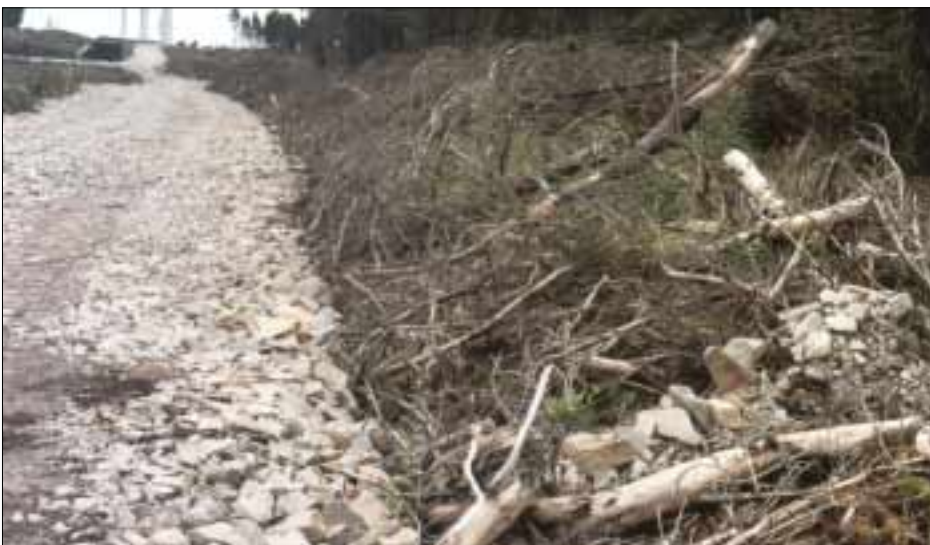
Plate 5: a ‘floating’ road sinking quite rapidly into the bog and prone to flooding in heavy rains.

It comprises a layer of pole material covered with 150mm of broken stone (reportedly for drainage), a geosynthetic membrane and 500 mm of crushed rock finished with fines. About 800 mm thick, it weighs over three tonnes per running metre.

As these roads became waterlogged in places, their level was raised by adding more aggregate. This increases the risk of failure of the acrotelm.

There are ‘floating’ roads throughout the site. The standard construction practice was to place a layer of felled trees in an interlocking mat on top of the acrotelm with 150mm of broken stone placed on top, purportedly to allow water to seep between the acrotelm and the layers above.¹ A sheet of geogrid/terram synthetic material was laid on top of the broken stone, followed by 400 to 500mm of crushed stone. Finally, it was faced with fines to create a smooth surface. The depth of imported material is thus about 800mm. Although an ancient turbarry road on the site is of similar construction, it has been regularly faced over many decades and is now capable of carrying heavy traffic. In contrast, a length of road constructed in this way early in the project now lies a full metre below the surrounding bog (plate 5). As the road became waterlogged in places, the contractor had piled on more rock to raise its surface above the water-table, which increased the loading. The side-drains which have been dug beside the floating roads to remove waterlogging inevitably slice through the acrotelm, thereby removing this important protective layer and exposing the catotelm peat directly to the atmosphere. The first (October 2) landslide occurred alongside a floating road where the acrotelm had failed.

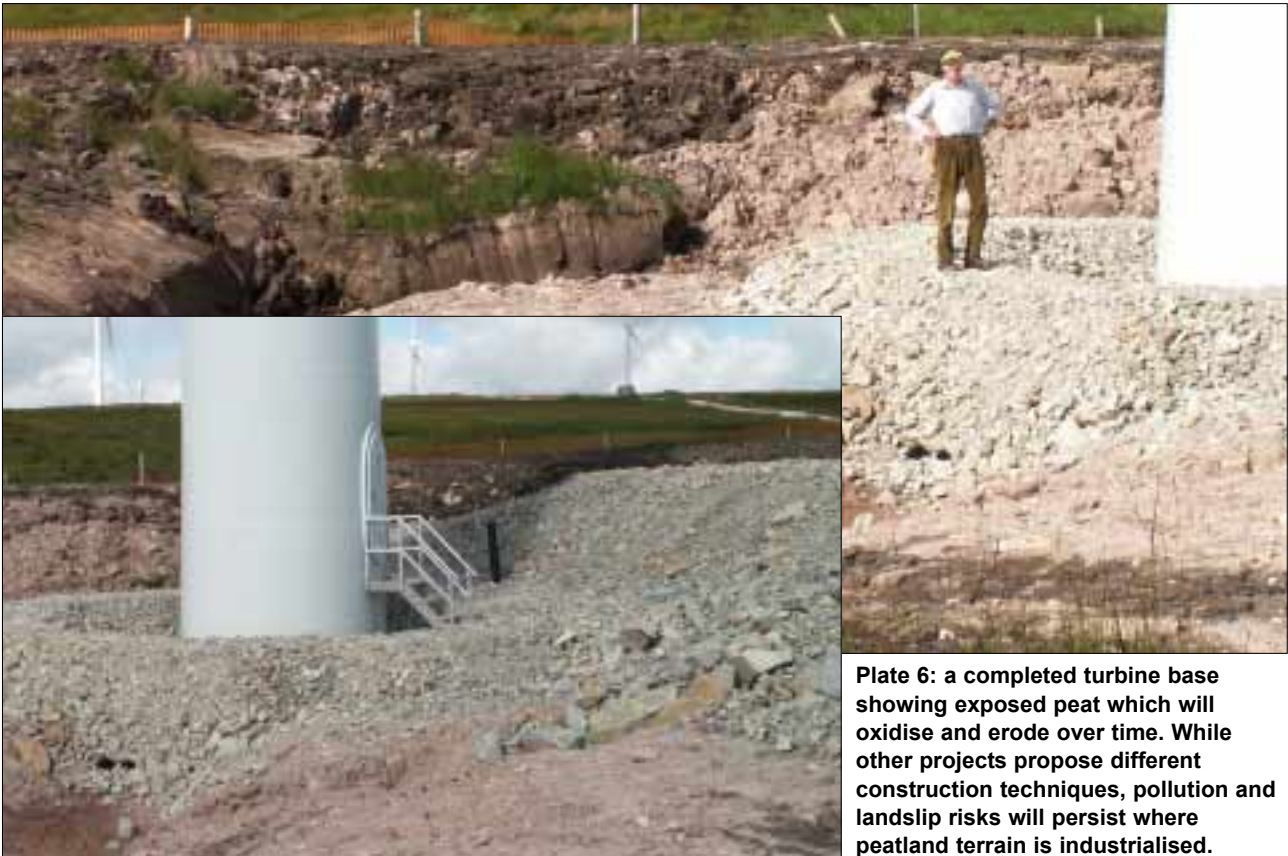
Plate 6: a completed turbine base showing exposed peat which will oxidise and erode over time. While other projects propose different construction techniques, pollution and landslip risks will persist where peatland terrain is industrialised.

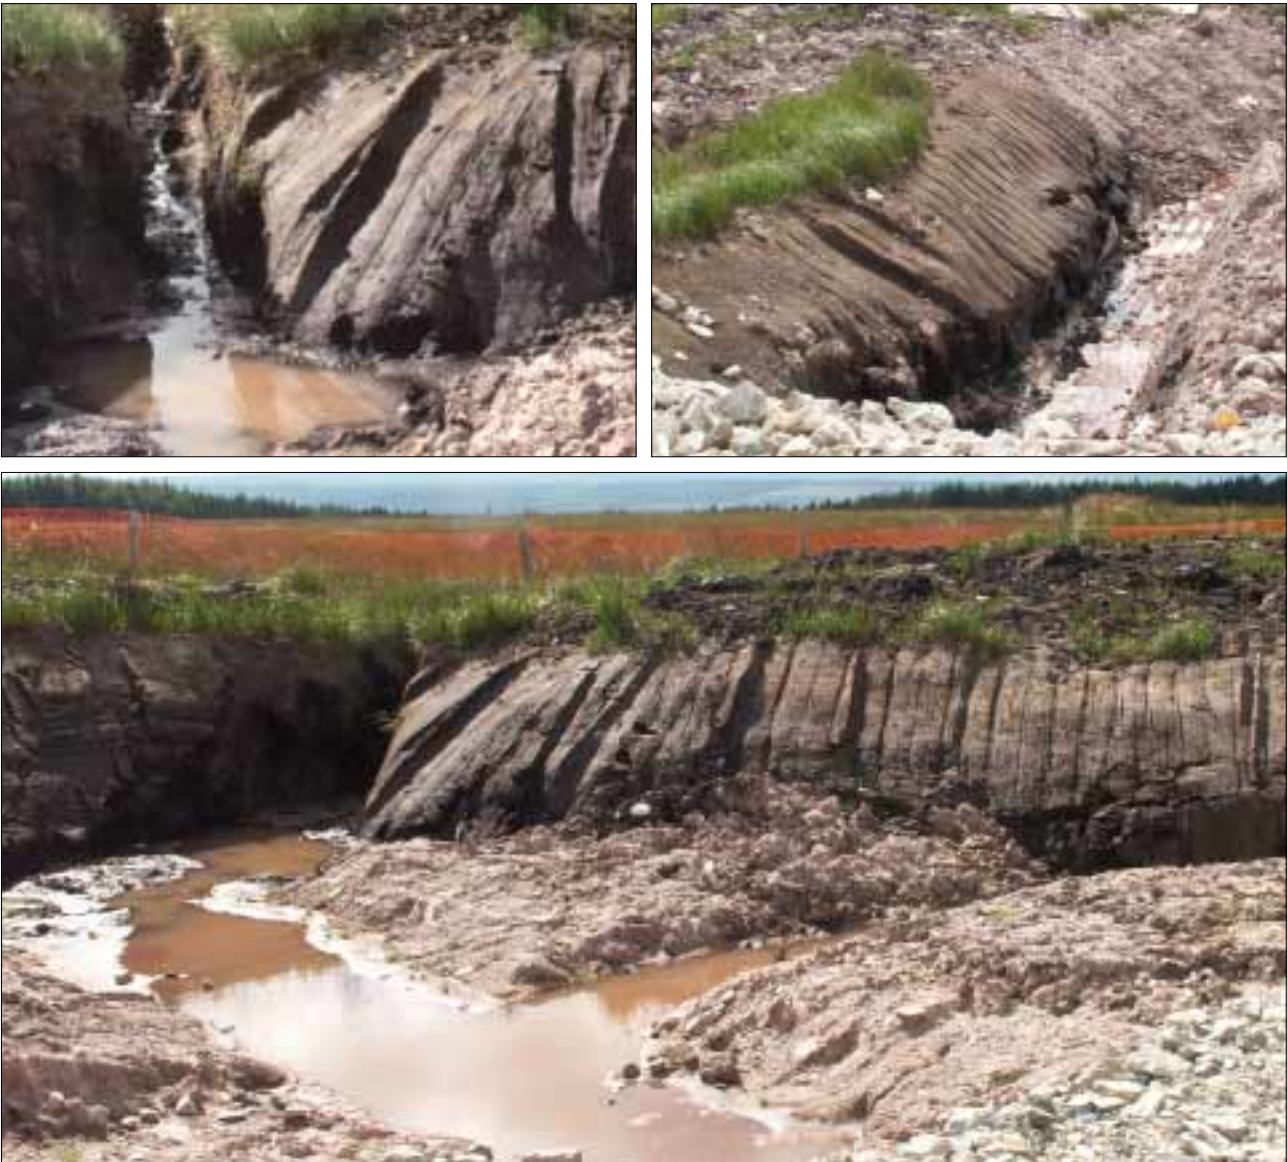
Plate 7. Top left: the drainage channel for a turbine base; the boulder clay under the peat is clearly visible. Top right: in several places on the site, boulder clay exposed in this manner is already eroding, leaving peat high and dry. Above: the drainage arrangement for turbine bases. Silt in the stagnant pools is to be trapped by silt beds (see pages 14 and 29).

The tower bases give the appearance of the work being only half-finished with a mass of crushed limestone on top of the concrete plinth dished into the foot of the steel work. The angle of repose of much of this material is inadequate and in places it is actively moving (plate 6). The same can be said for the surrounding peat banks. Although these have been battered to an angle of around 45 degrees, they are crumbling into the base drains. These have often been drawn in soft boulder clay, have no sound foundation and have eroded, leaving the peat bank undercut. The implications are serious: unless the tower bases are back-filled and sealed up with peat and the surfaces re-vegetated, the surrounding peat will dry out, break away from the parent mass and oxidise. Carbon dioxide will be released in large amounts (plate 7).

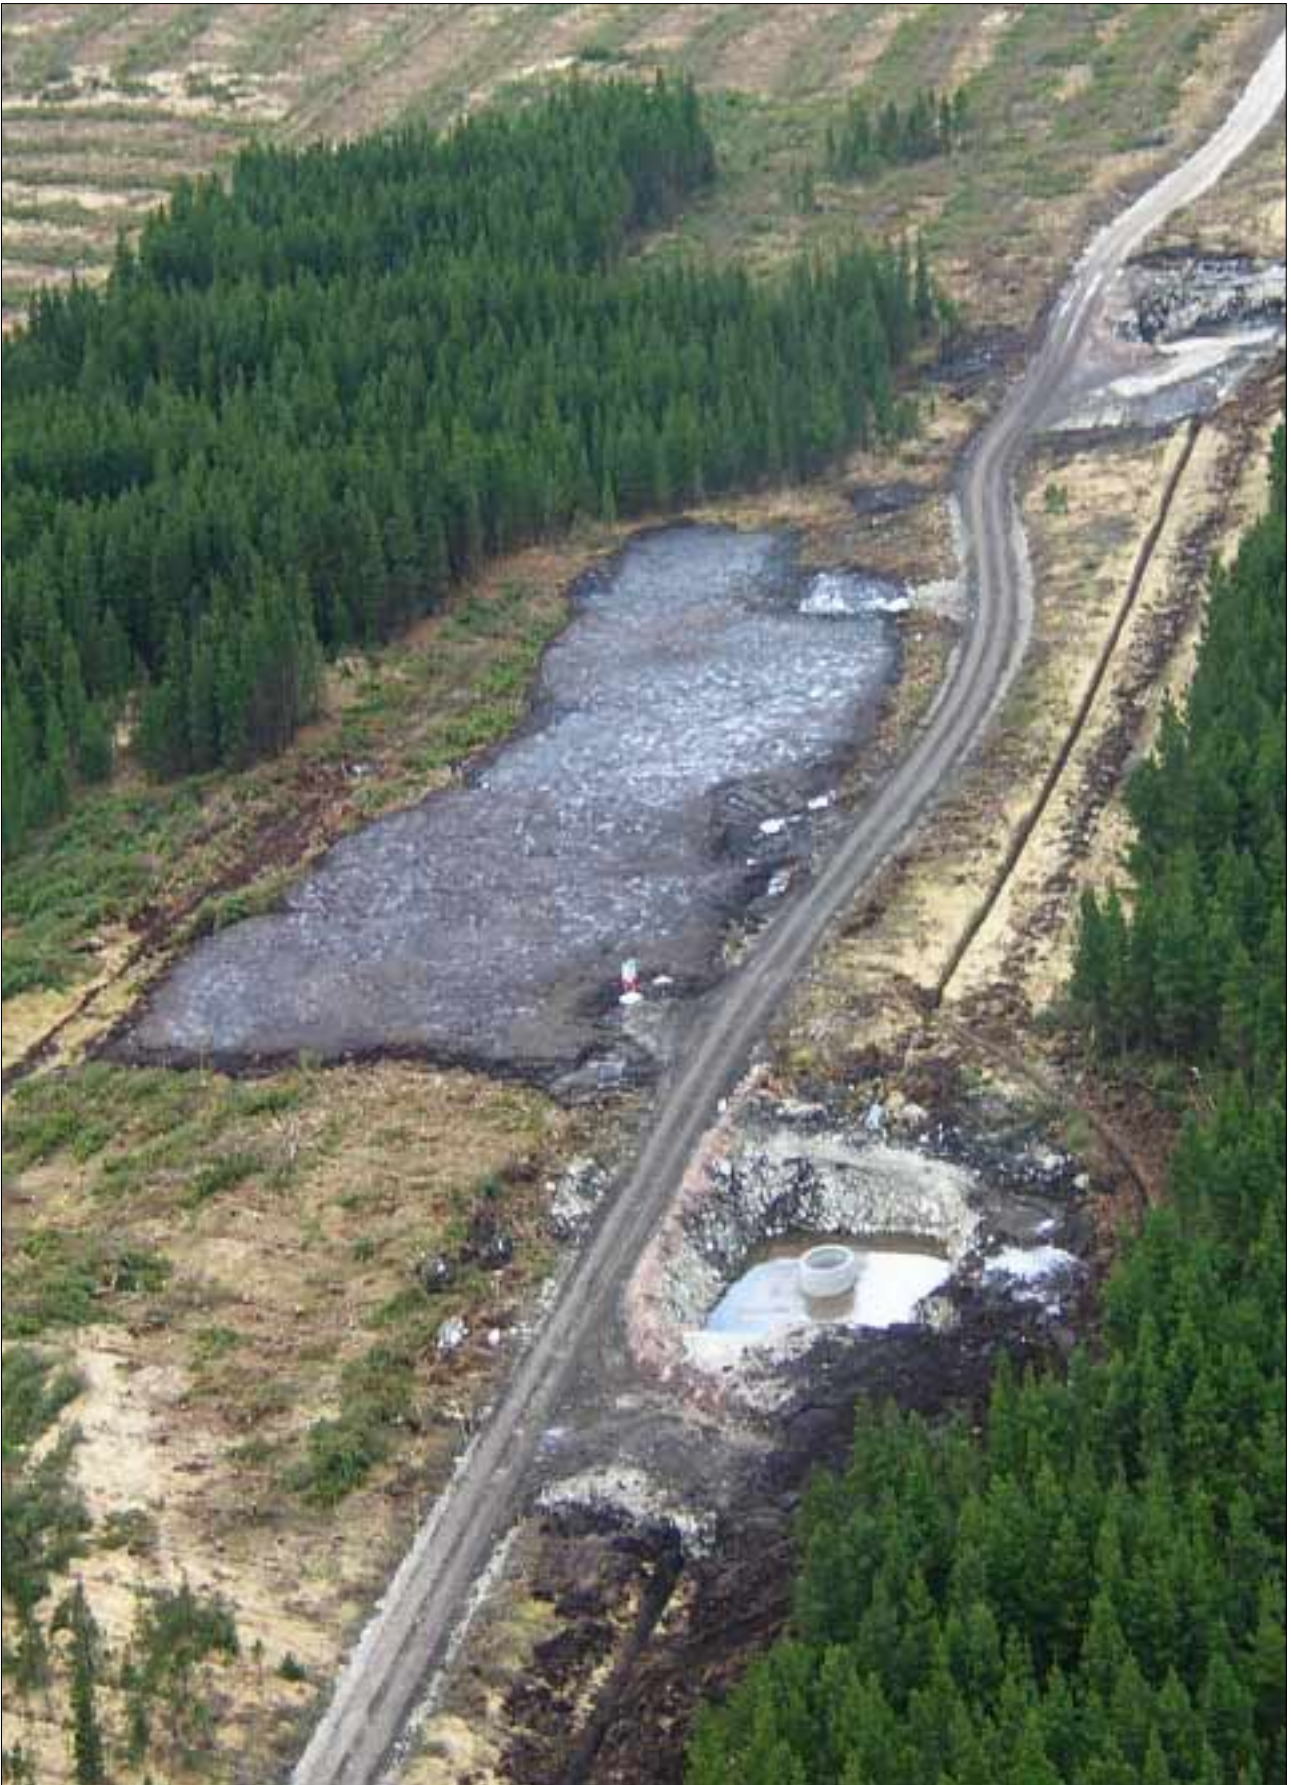
Plate 8: two turbine bases at Derrybrien (middle foreground and top right) awaiting mineral backfill. Note the ‘floating’ access track, mineral-filled drainage, cable trenches and extracted peat laid on top of intact blanket bog, where it will dry out and oxidise over time. The remaining conifers have since been felled.

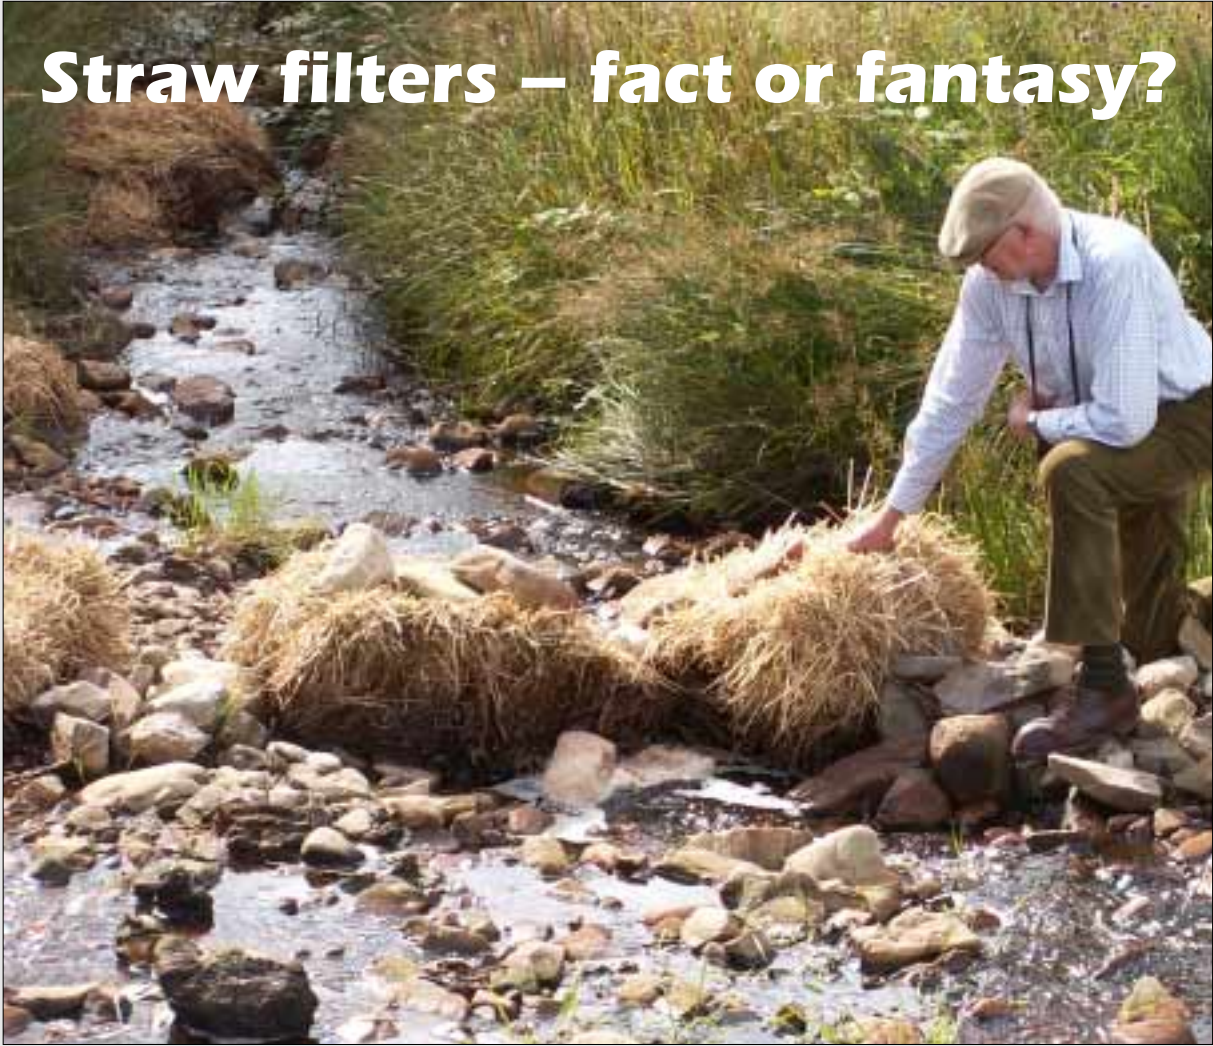
Plate 9: a 'silt trap' at Derrybrien made from barley-straw bales. These are, and always will be, demonstrably ineffective. Water at the low current flow prevailing on the day of the visit was running through the stones in the stream-bed with little, if any, running through the straw. None of the considerable amounts of suspended matter being carried downstream even at this low flow was being trapped.

When flow levels are significantly higher, the bales will be pushed out of the way by the weight of water and the increased load of suspended matter from upstream will again go straight down the watercourse. Two displaced bales can be seen on the top left of the picture.

Two important points about using straw as a filtration medium are a) that regard must be paid to eutrophication caused by decomposition of the straw used in the beds and b) that, to maintain effectiveness, the straw would have to be renewed at least every eight weeks even under normal rainfall patterns and the regime needs to be maintained more or less indefinitely and certainly at least until decommissioning.

Flow levels in Scotland's streams regularly vary by a factor of 300 within a season. It is self-evident that straw beds, however large or numerous within a catchment, will not cope with run-off generated by storm rainfall where several centimetres of rain can fall in a matter of hours. There is, quite simply, no way that straw-filled lagoons and filtration beds will cope with the quantity of suspended matter carried downstream off disturbed ground under storm conditions such as these.

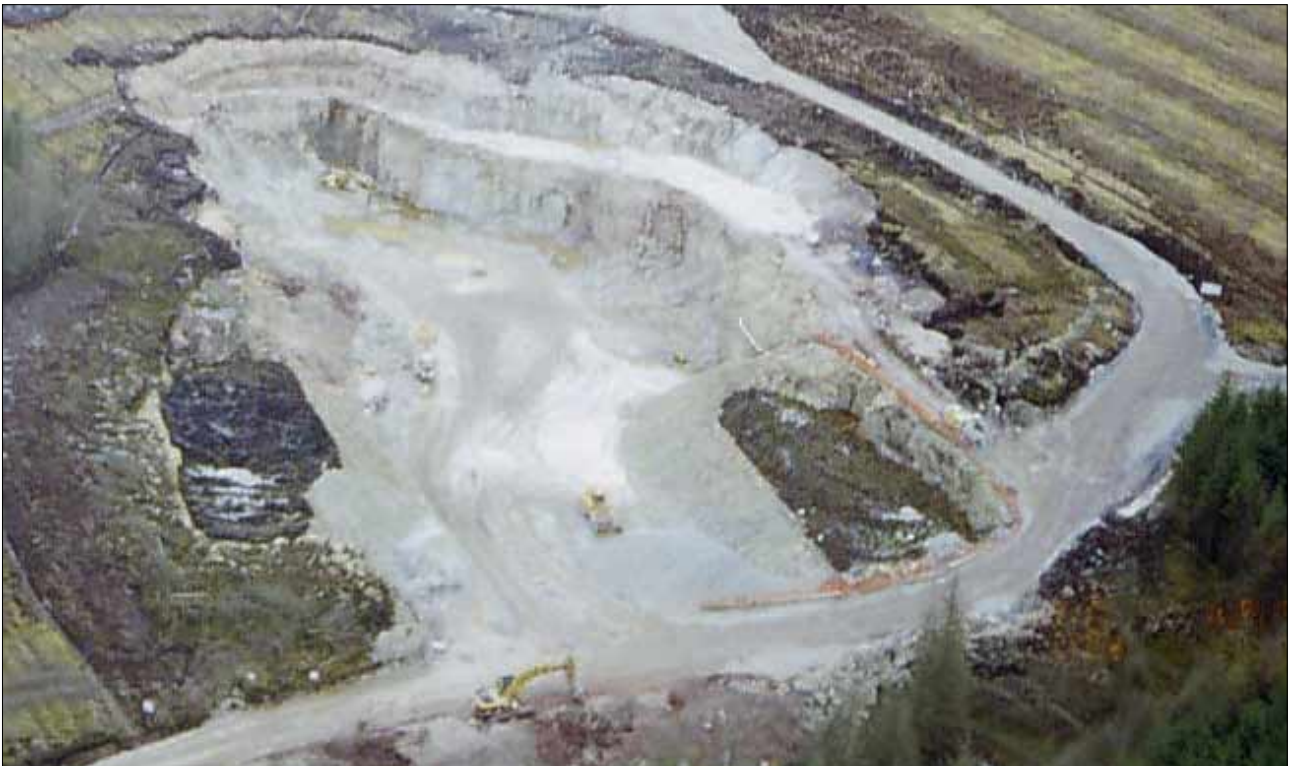
Plate 10: a 'borrow' pit used for quarrying rock for access tracks and turbine bases. This one lies a kilometre to the north-east of T68, the point of origin of the slide. Note the peat 'lagoons' on the top and left of the picture.

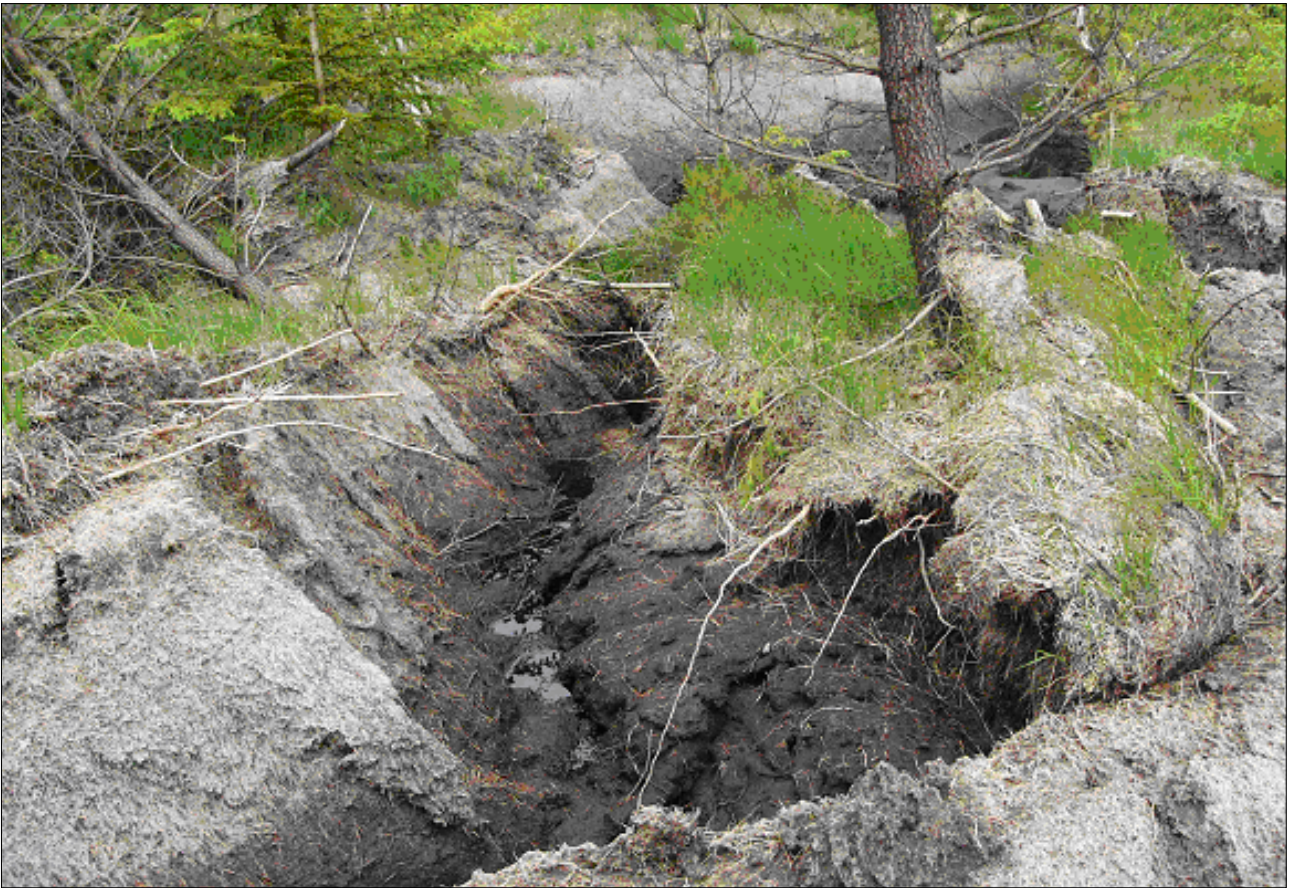
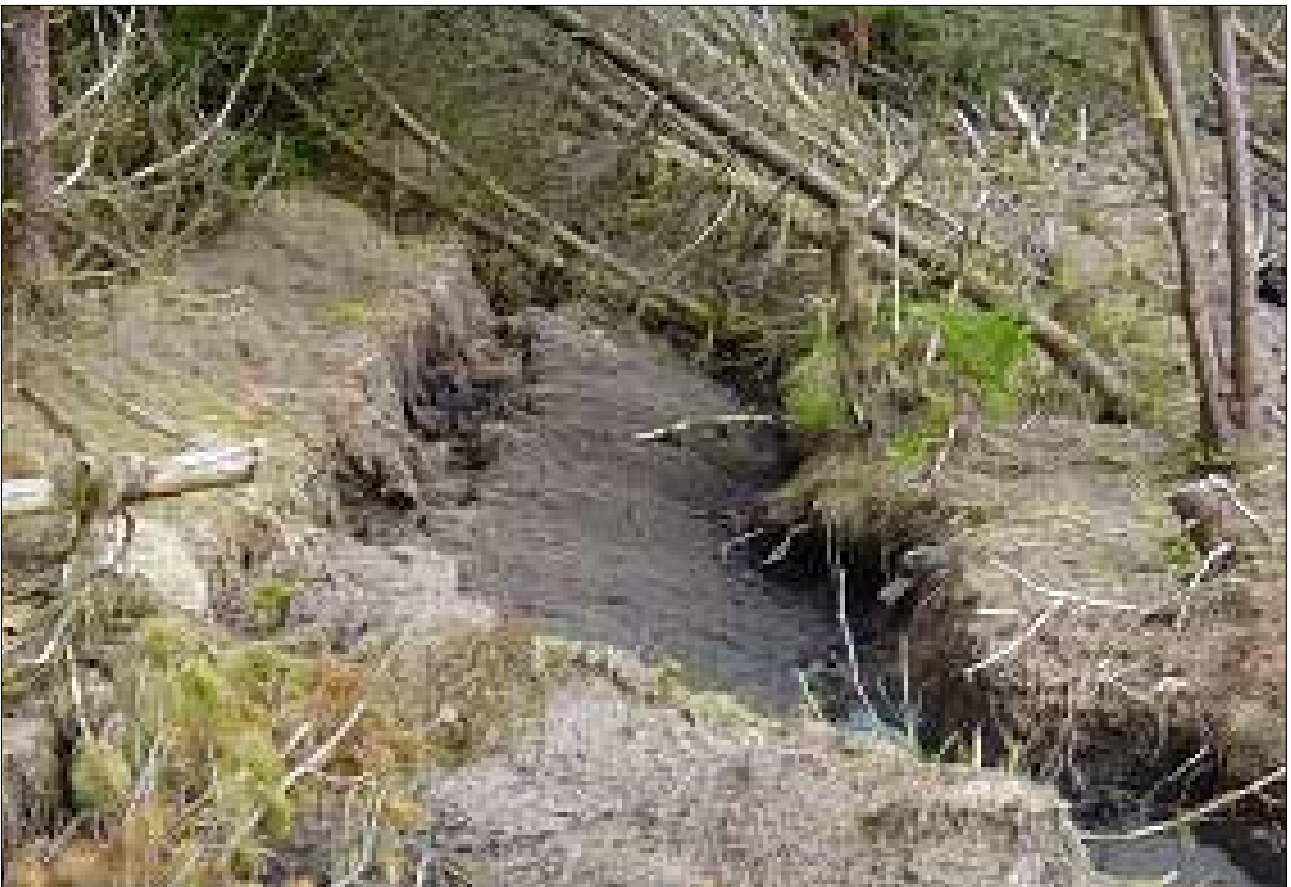
Plate 11: the effect of afforestation on the site. Top: delaminated ribbons of peat at the edge of the area where the slide occurred – there are few protruding roots. Above: just below T68, at the west side of the slide site. Rafts of surface vegetation detach along forestry plough lines.

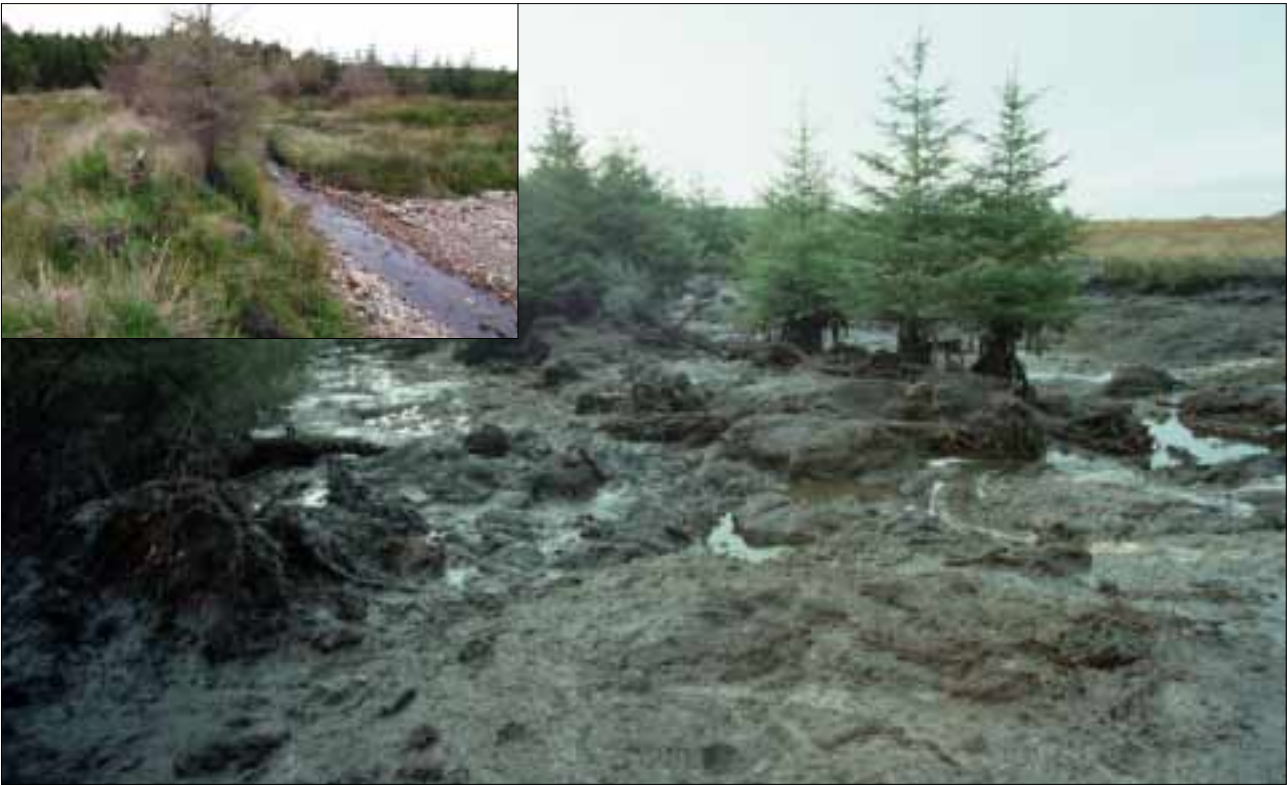
Plate 12: downstream from the Flaggy Bridge just east of Derrybrien two days after the second slide. Inset: the same view two years later. The contrasting pictures suggest the scale of pollution caused by the bog slide.

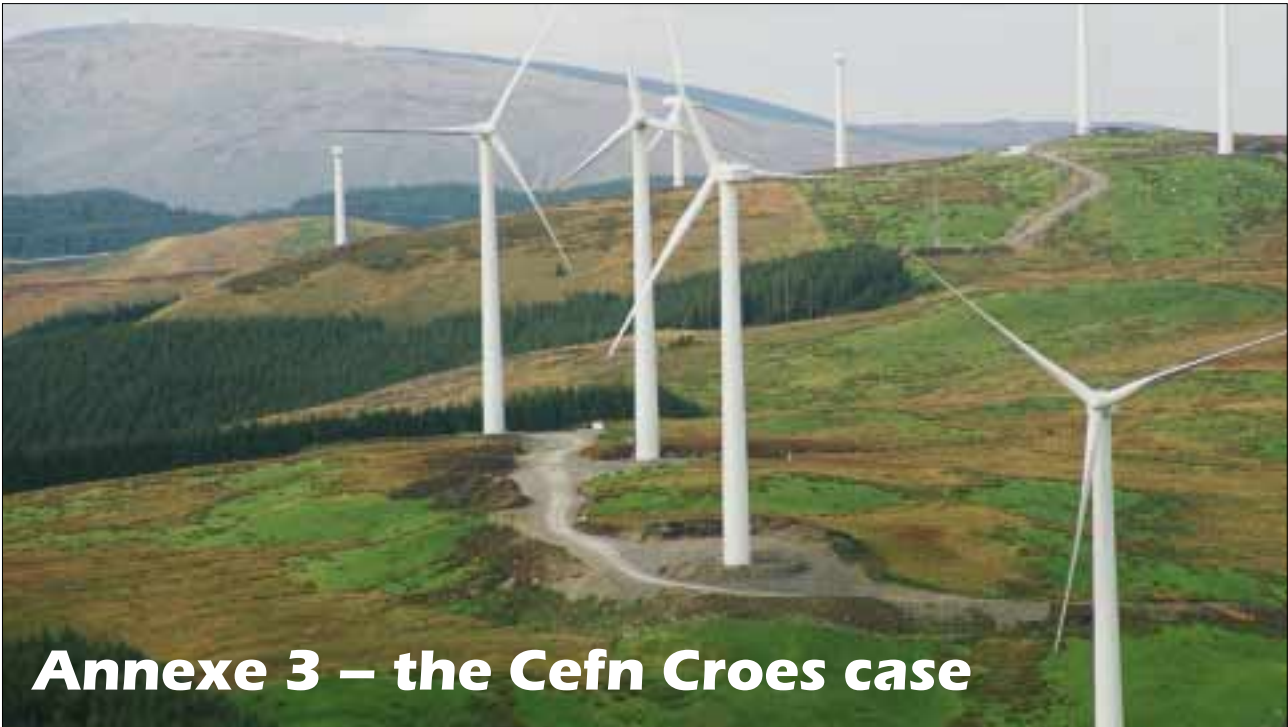
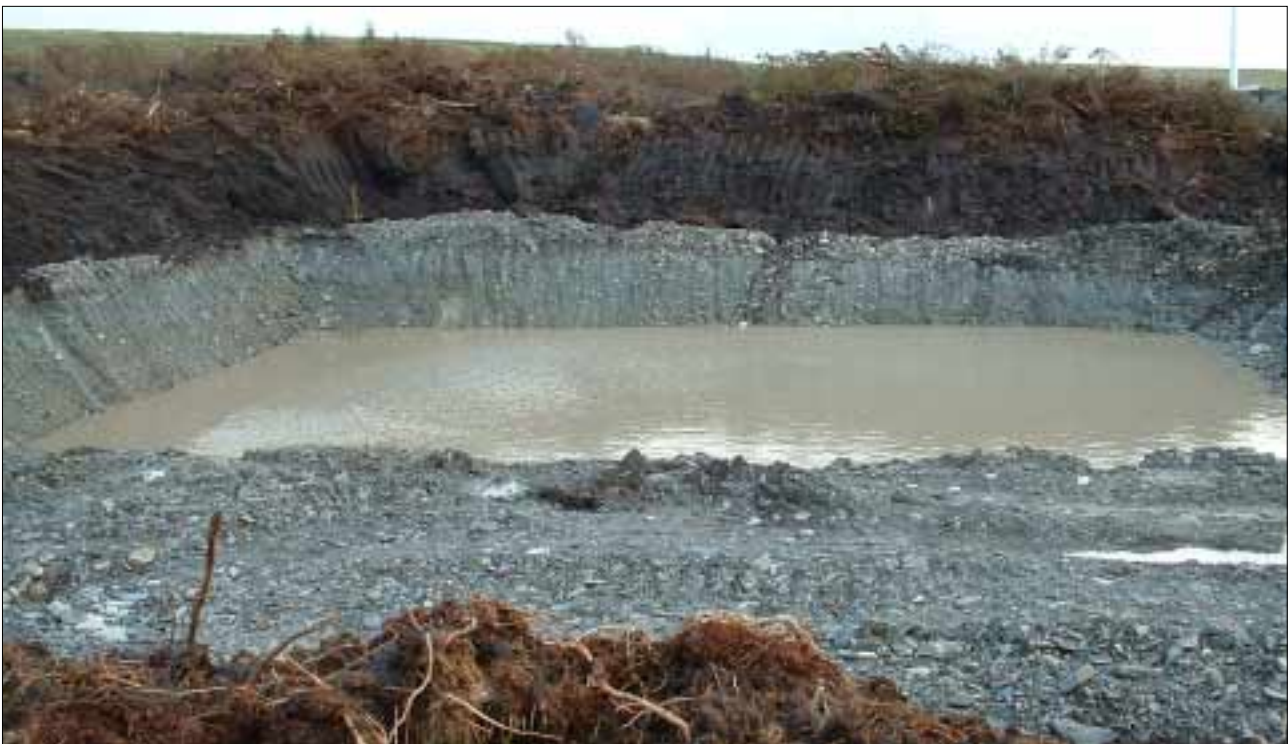
Plate 13a, above, is a view of the project as it neared completion in August 2004 and 13b (below) shows a waterlogged base excavation. Plate 14 suggests the extent of the drainage cut on the site and plate 15 shows steps taken to prevent excessive drainage and some of the measures adopted to prevent downstream siltation.

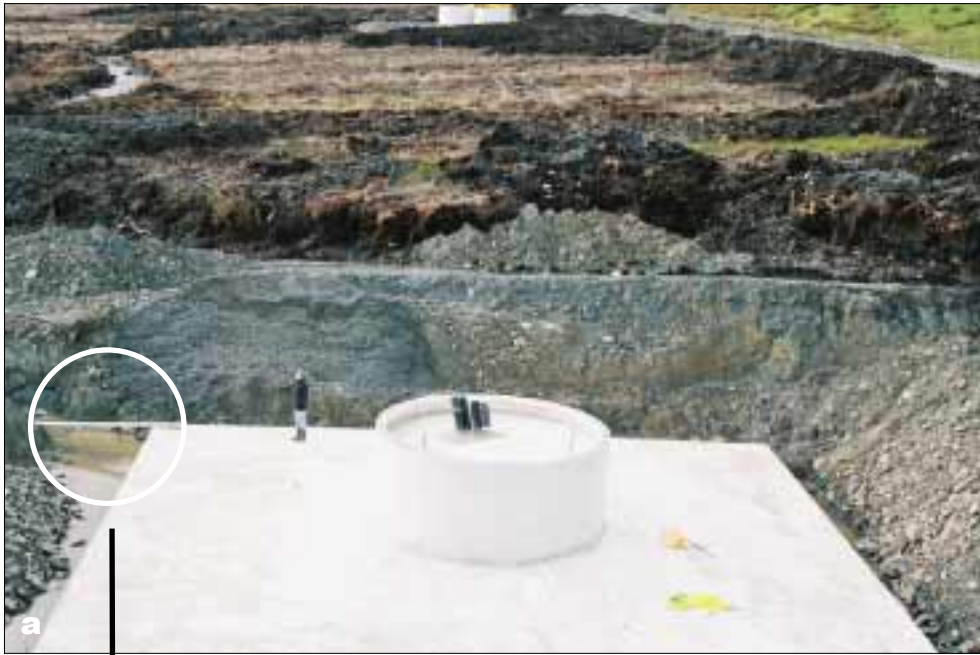
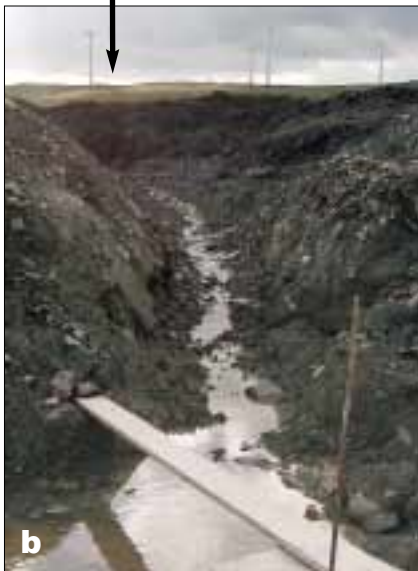
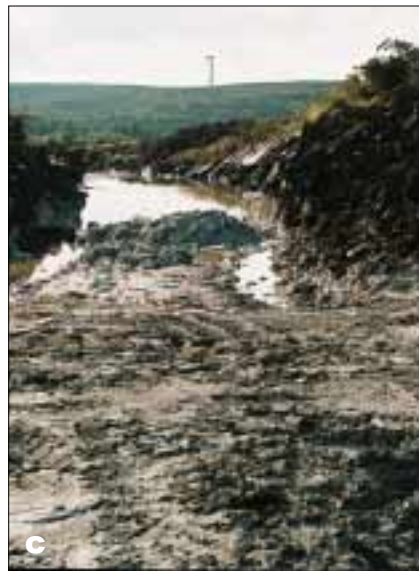
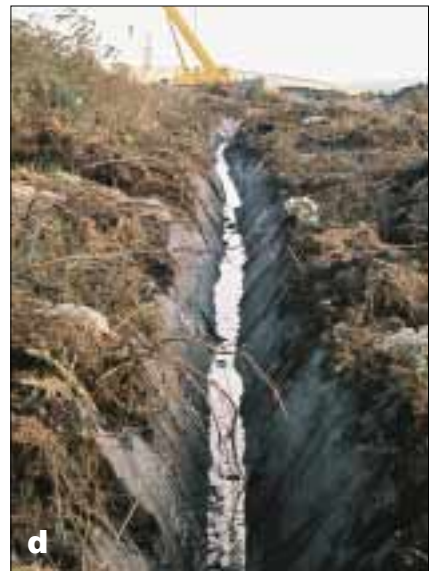
Plate 14a: the excavation for base 28. Even if this is back-filled with 'borrowed' mineral, the adjacent peat will dry out and oxidise over time. The drain runs into a waterway visible in the top left of the picture. b: the view down the channel draining turbine 25.

c: the drainage channel for turbine 25;
d: drainage by the access track between turbines 25 and 26;
e: drainage north-east of turbine 25, on the north-eastern edge of the site (August 2004).
