The politics of peat

**Lessons from the
Derrybrien
landslide**

**The
Scottish Wind Assessment Project**

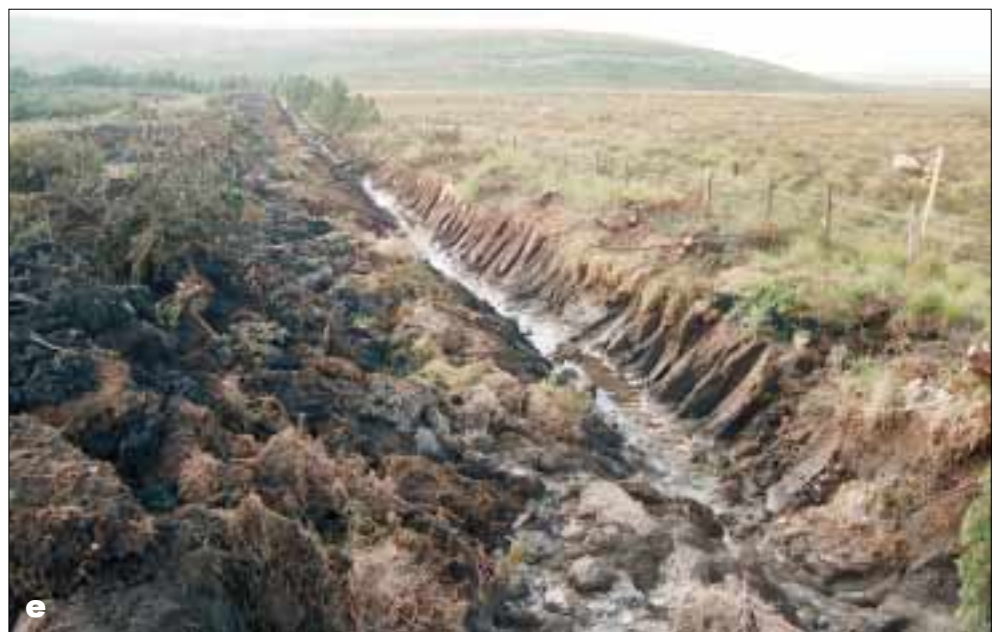
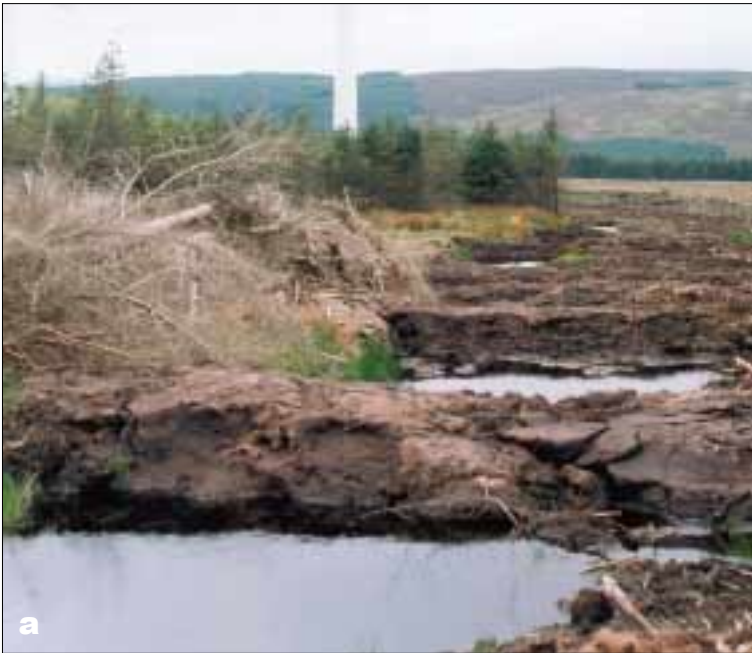
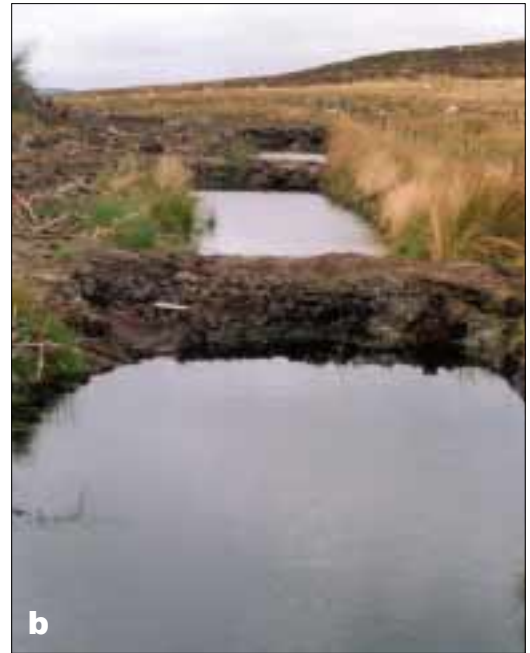
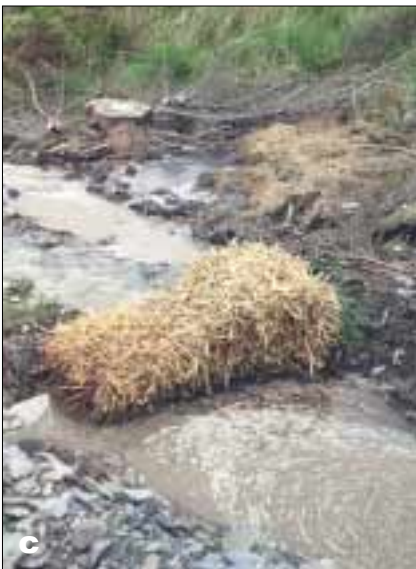
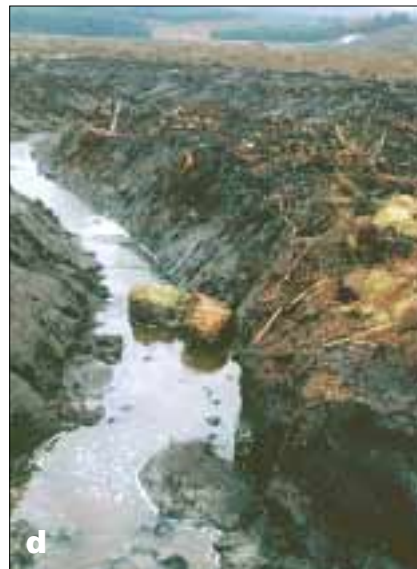
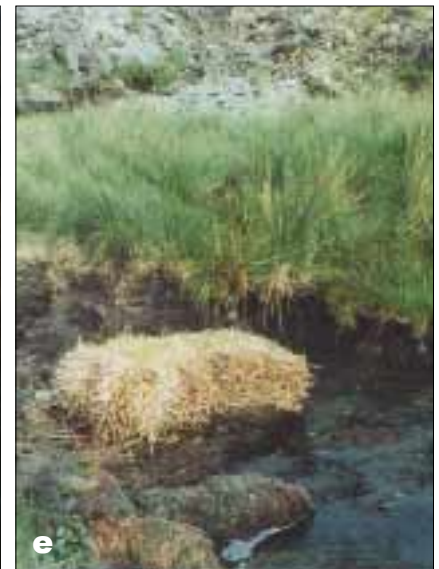
Plate 15a, b: a series of 12 'lagoons' has been dug near turbines 25 to 30, apparently to reduce the drainage of peat on the site. The dams between them are reportedly made with railway sleepers but the methodology is unclear. (August 2005). The pictures show three of them.

c-e: straw bales were laid to prevent downstream pollution (August 2004).
