Richmond Road Turbine Spatters

Ken Bell
Rondeau Watershed, March 11th 2008

FINAL REPORT

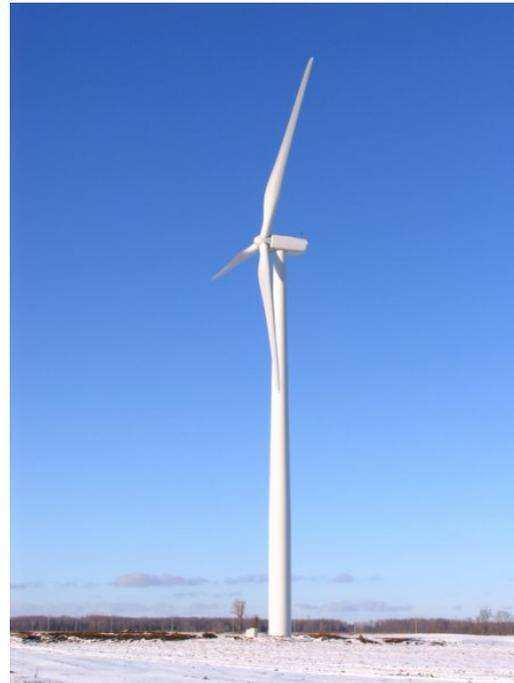
Richmond Road turbine, post construction 2006

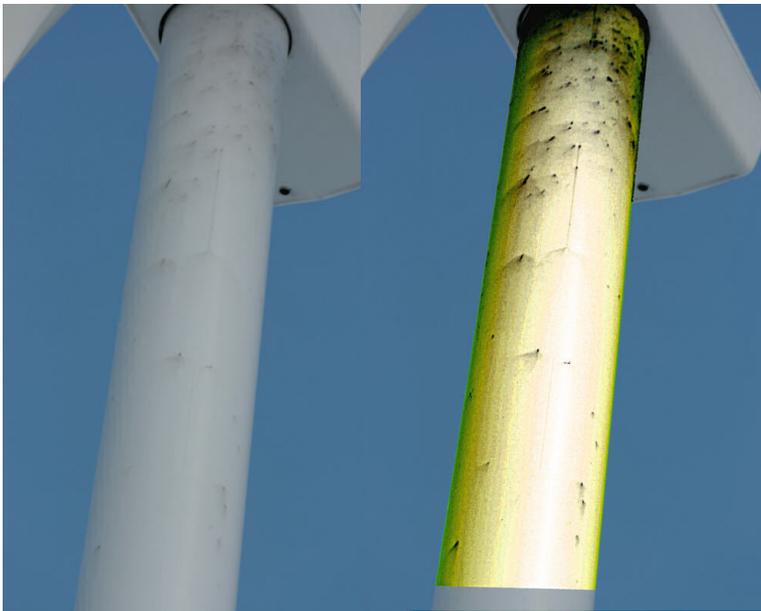
Below is a copy of the original and on the right, a digitally enhanced version that clarifies the spatters. All image functions were applied evenly to the column

*Richmond Road turbine, March 1st 2008
Image enhancement used to clarify the spatters*

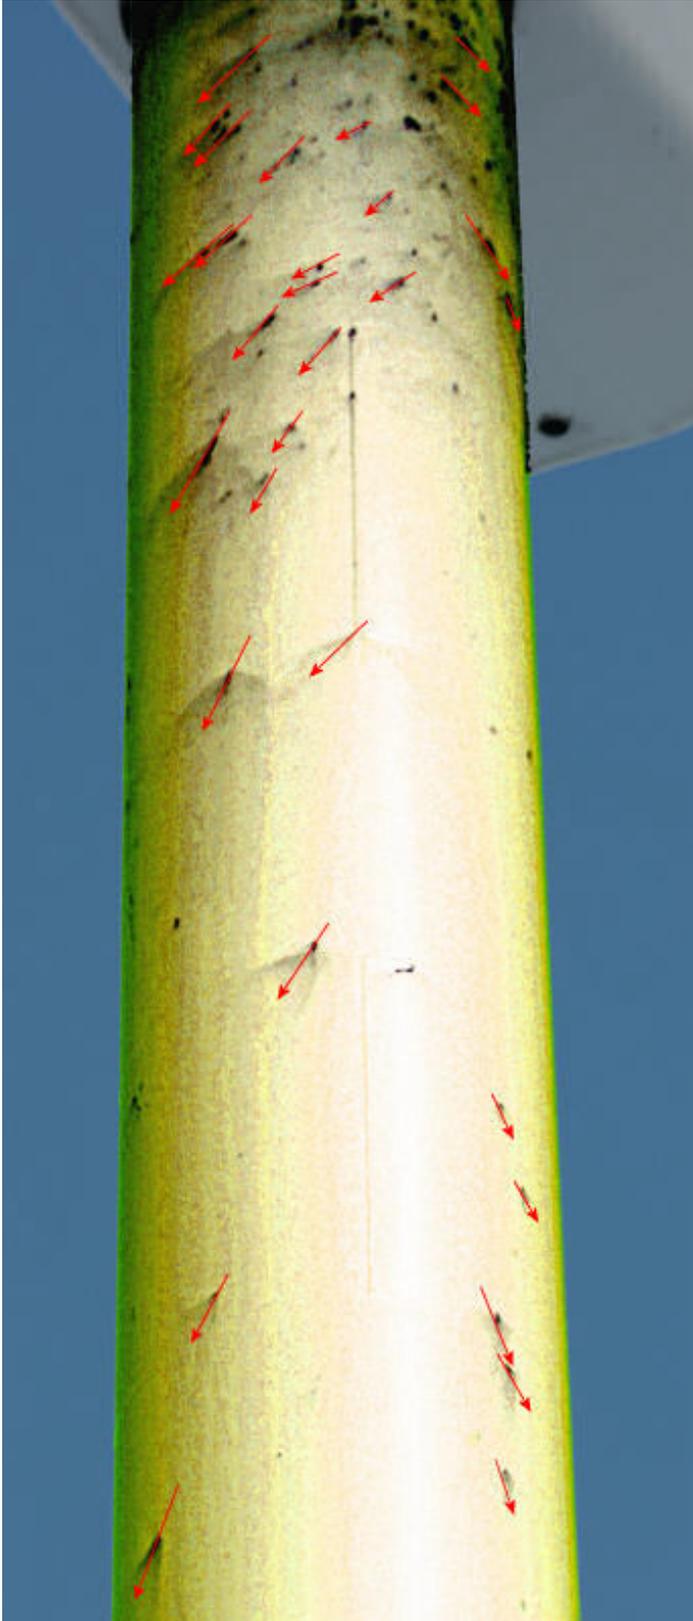
From the direction and distribution of the spatters it appears that individual tracks were moving a high velocity, from the South-southwest. Parabolic spatter patterns indicate a direction of impact. Notice on the lower spatter vectors, the angle of impact is quite high indicating something falling. The lower density of spatters further down the column is probably correlated and would indicate bodies either losing forward momentum or being thrown at a descending angle.

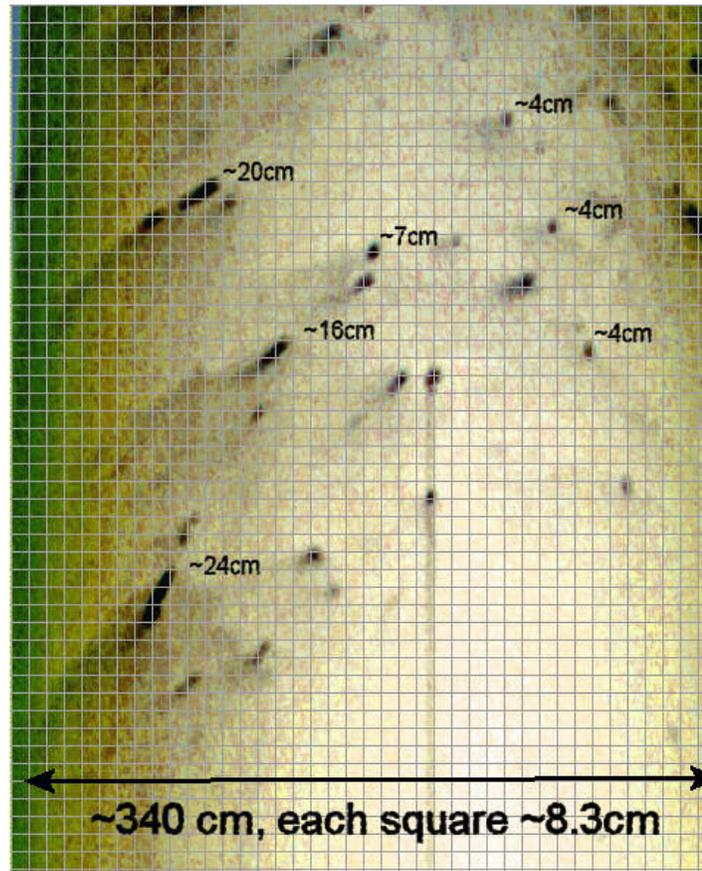
Below, in this photo smaller spatters are 16% the size of larger ones.

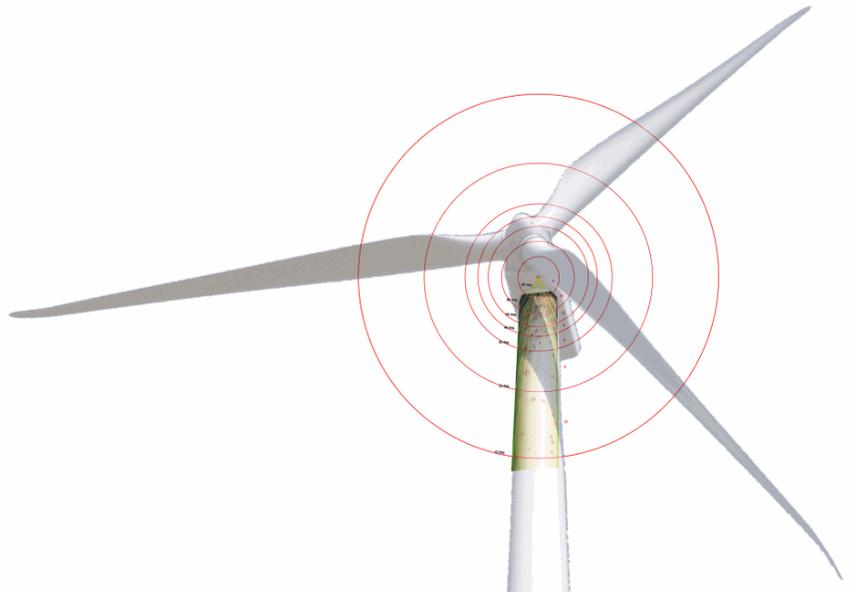
With this overlay one can see that the spatter width is just over 1/3rd of the 38.5m blade width.

I selected areas where the spatters began at the bottom.

Using concentric rings I defined areas, (*transects*) to isolate groups of spatters.

Within each transect individual spatters were circled and counted.

The degree width of each transect was measured with a protractor.

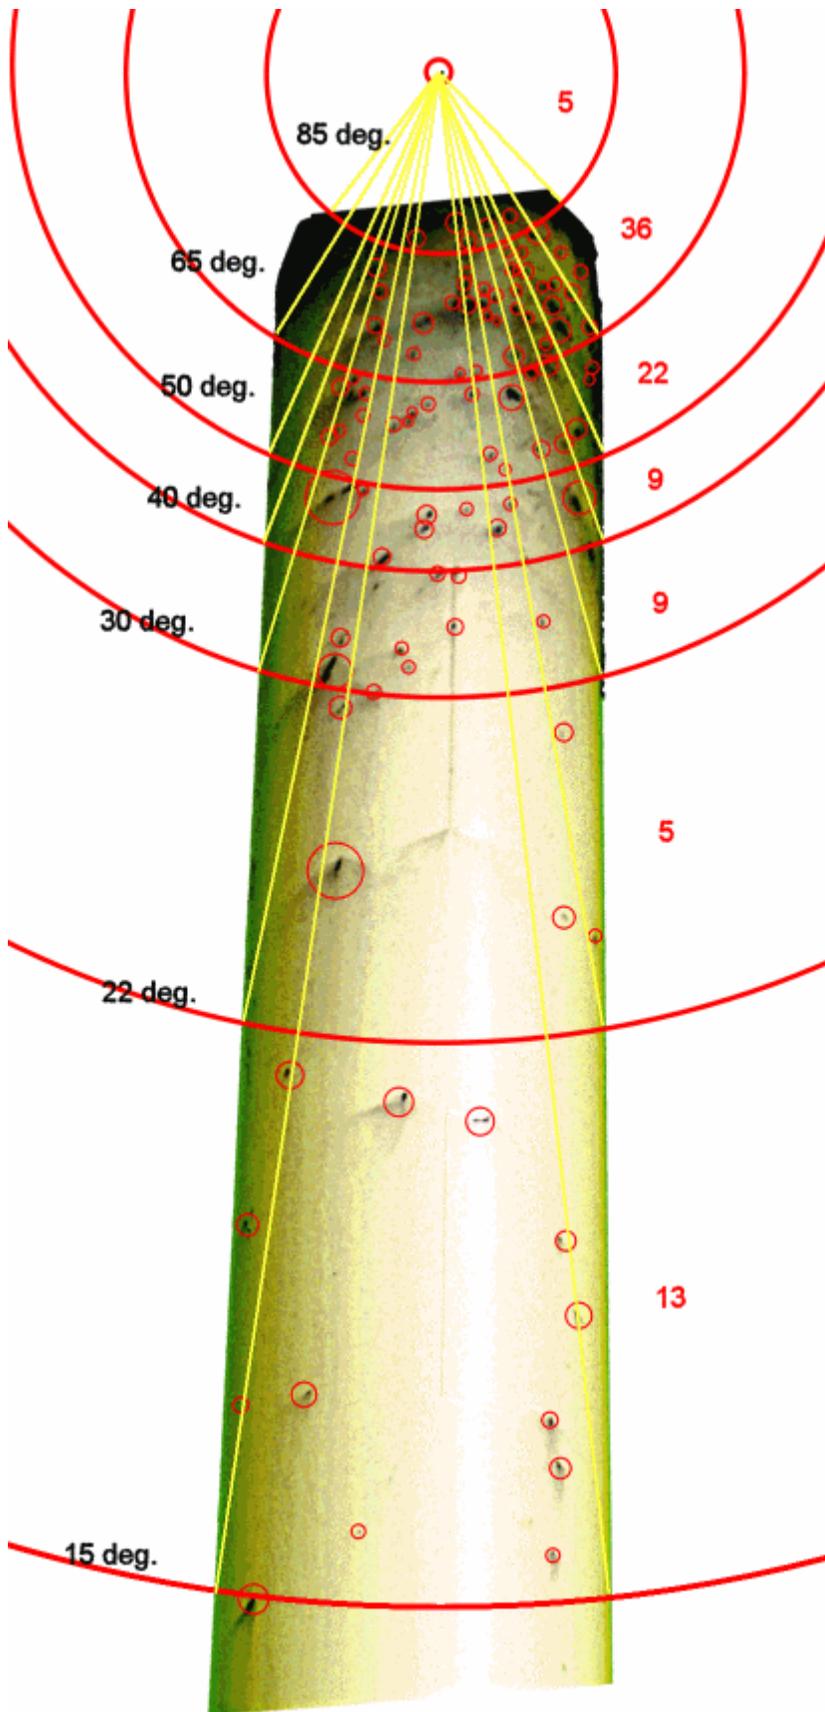
Below is an image enhanced cutout of the column of the North Richmond Road turbine. The red arcs define an area within which a transect count is made. Counts are numbered along the right of the column. The yellow radiating lines from the top center define the transect angles that are used to determine the proportion of the swept ring that each transect occupies. Counts are projected throughout the transect ring in proportion to the sector area.

From top to bottom: Rounded off to the nearest whole number
 Ring widths are averaged for sake of simplicity.

Transect 1	360	/85	x5	=	21
Transect 2	360	/((85+65)/2)	x36	=	173
Transect 3	360	/((65+50)/2)	x22	=	138
Transect 4	360	/((50+40)/2)	x9	=	72
Transect 5	360	/((40+30)/2)	x9	=	93
Transect 6	360	/((30+22)/2)	x5	=	69
Transect 7	360	/((22+15)/2)	x13	=	253

TOTAL calculated over swept area 819

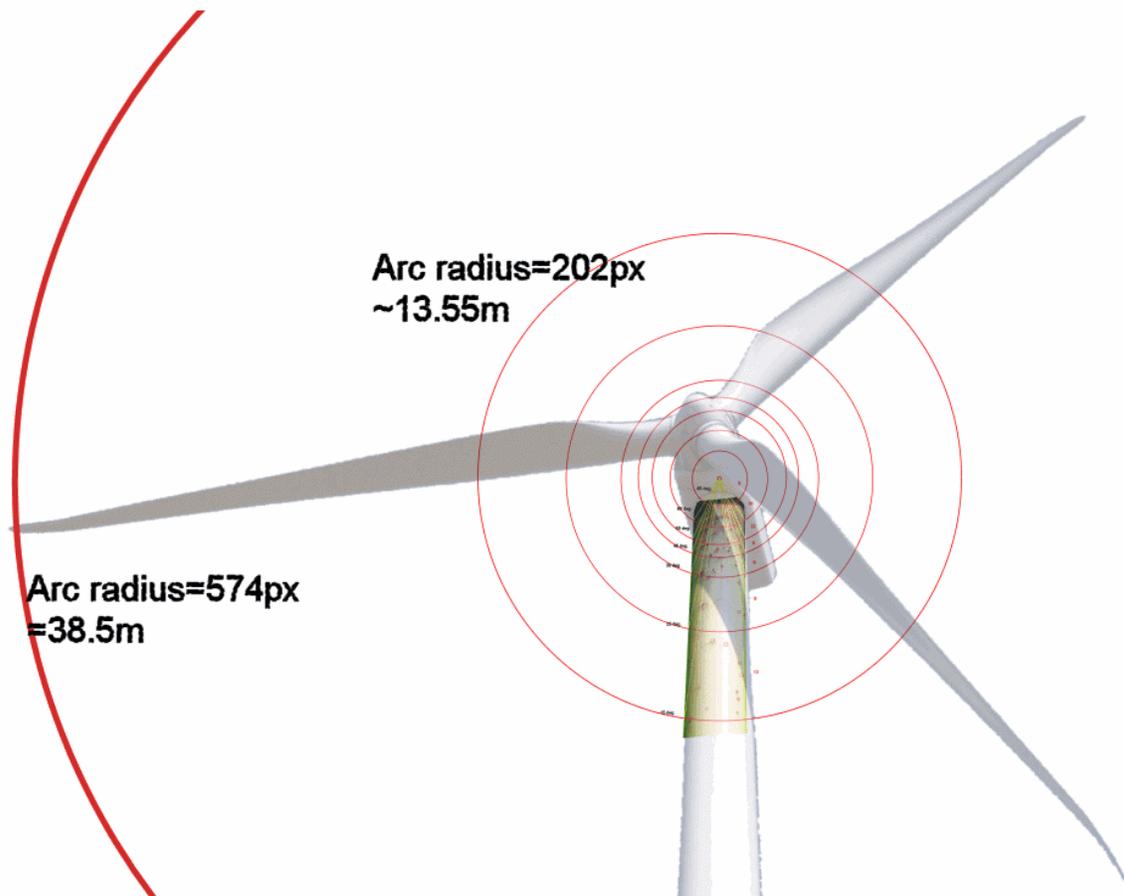
Using the 13.55m arc radius estimation, spatters were recounted at 1m intervals and plotted to derive a density function. This will be used to extrapolate a spatter count over the remaining 4080 sq. m ring (**A-A1**). A1 was estimated using the ratio of pixel radii of the Arcs. The left, (orthogonal) blade was referenced to minimize perspective distortion.

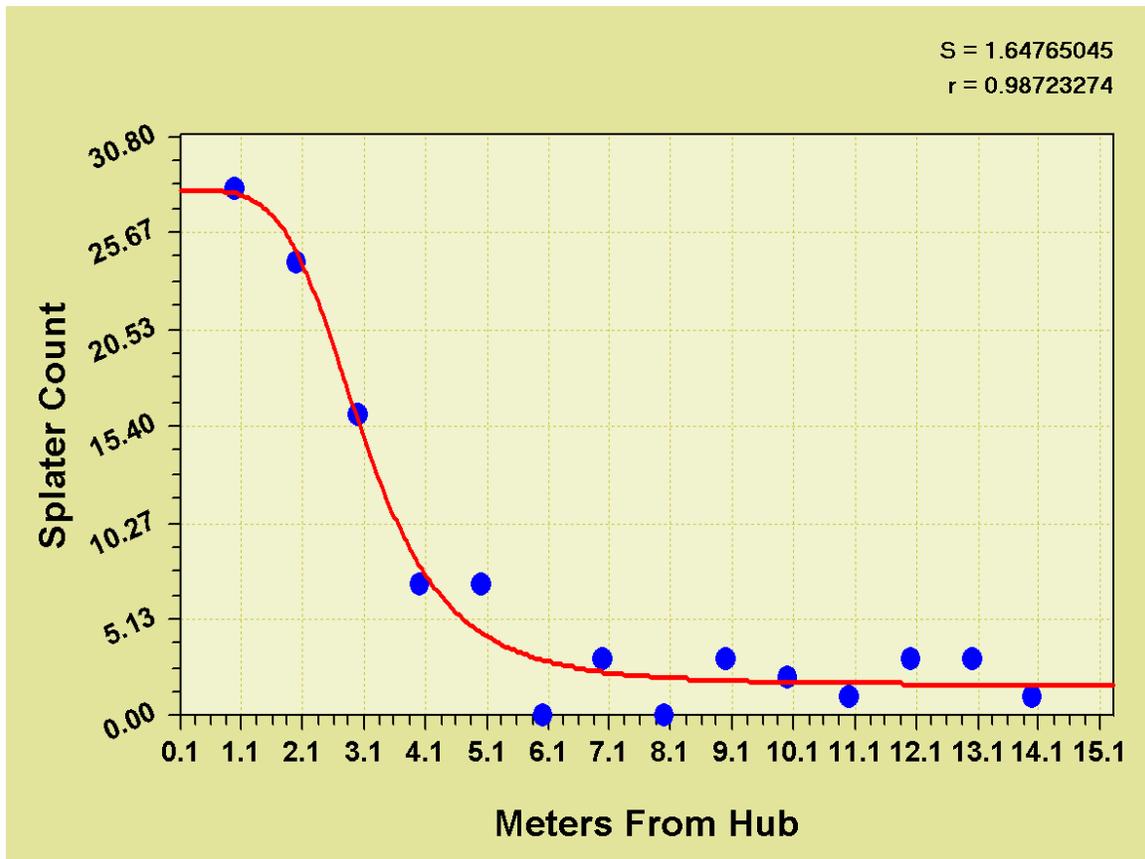
MMF Model: $y=(a*b+c*x^d)/(b+x^d)$

At 38.5m this model integrates to 149.06 splatters. Subtracting the initial 99 splatters, the model estimates 50 splatters over the remaining 24.95 meters.

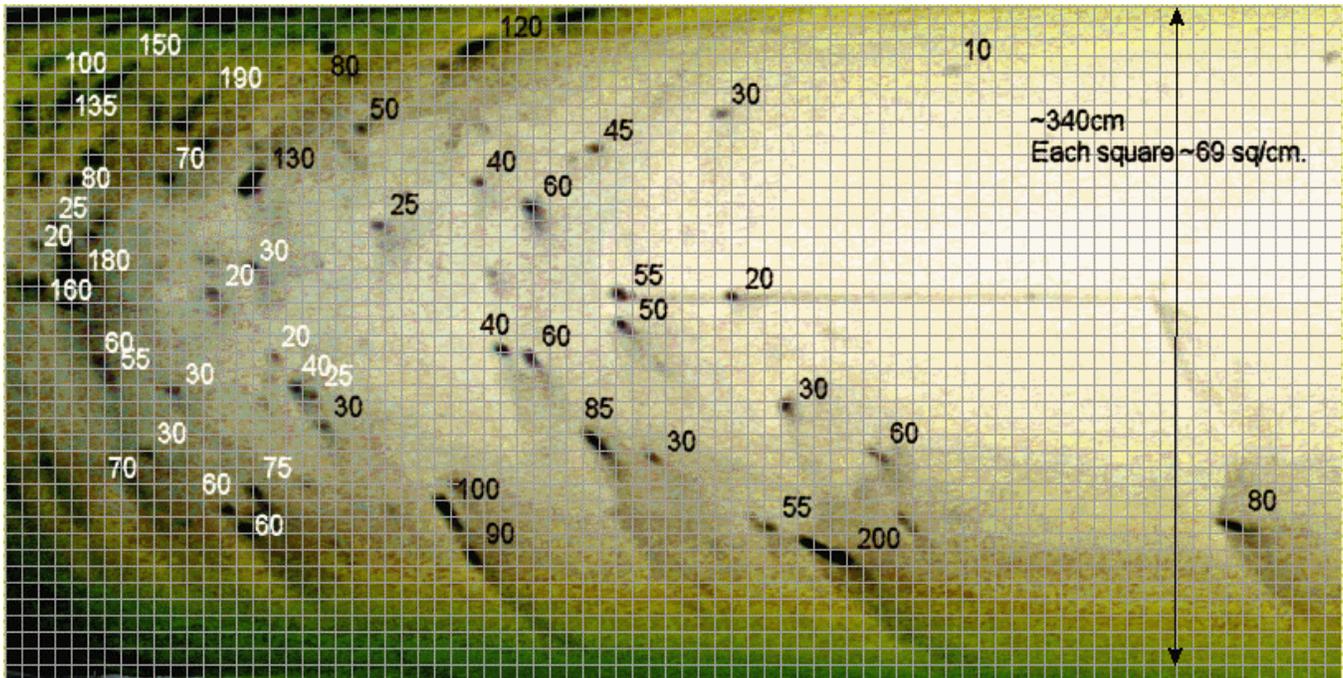
When spatter areas are averaged over the photograph the average **As** is **68 sq/cm**
