Richmond Road Turbine Spatters

Ken Bell
Rondeau Watershed, March 11th 2008

FINAL REPORT

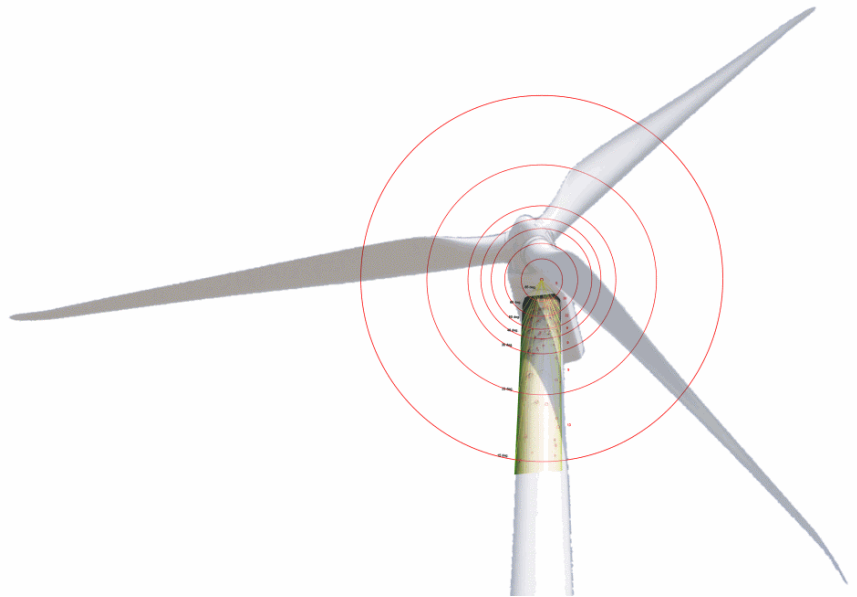
Within each transect individual spatters were circled and counted.

The degree width of each transect was measured with a protractor.

Two methods were used to count the 99 spatters circled. The high density of spatters at the top of the column made it virtually impossible to get an accurate count from Transect 1. I decided to circle only definable features and use a low, rather than a high estimate. In future counts, on other towers lighting and density may provide more clarity.

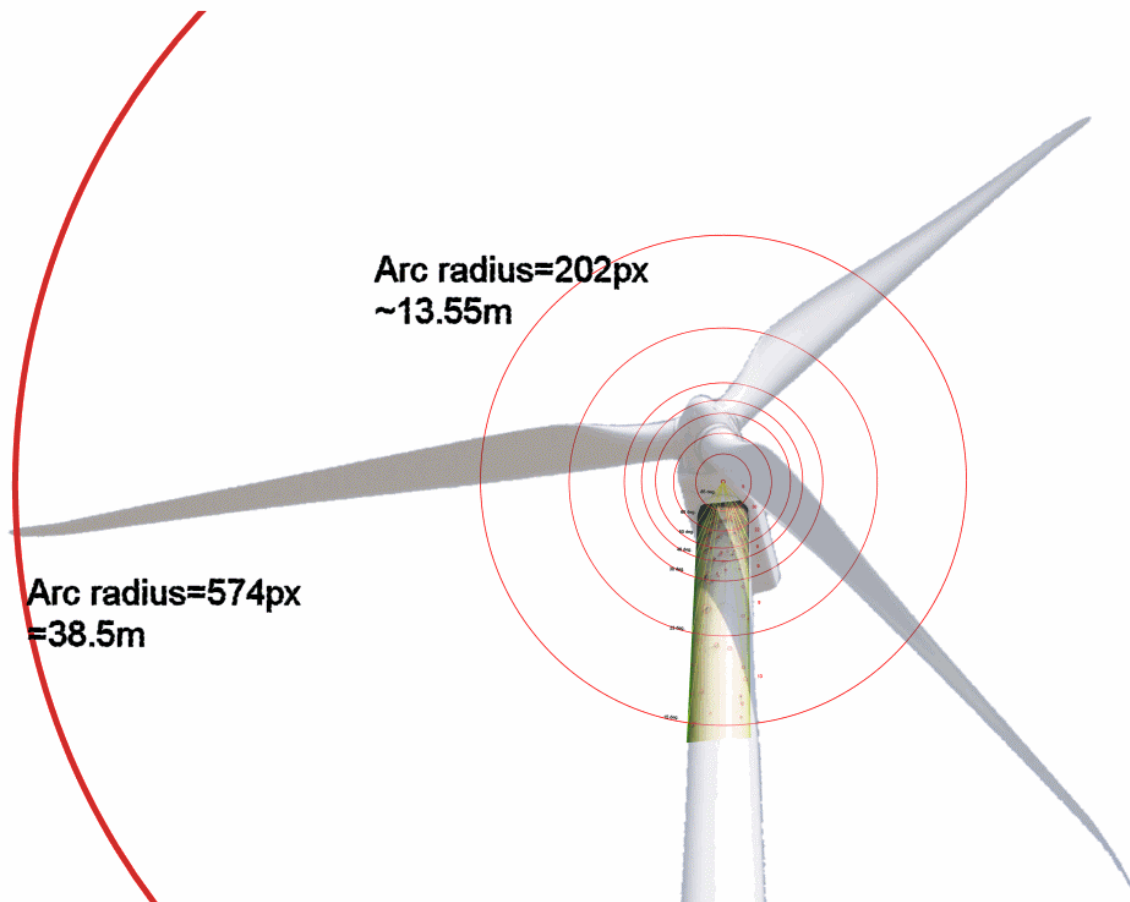
Using the 13.55m arc radius estimation, spatters were recounted at 1m intervals and plotted to derive a density function. This will be used to extrapolate a spatter count over the remaining 4080 sq. m ring (**A-A1**). A1 was estimated using the ratio of pixel radii of the Arcs. The left, (orthogonal) blade was referenced to minimize perspective distortion.

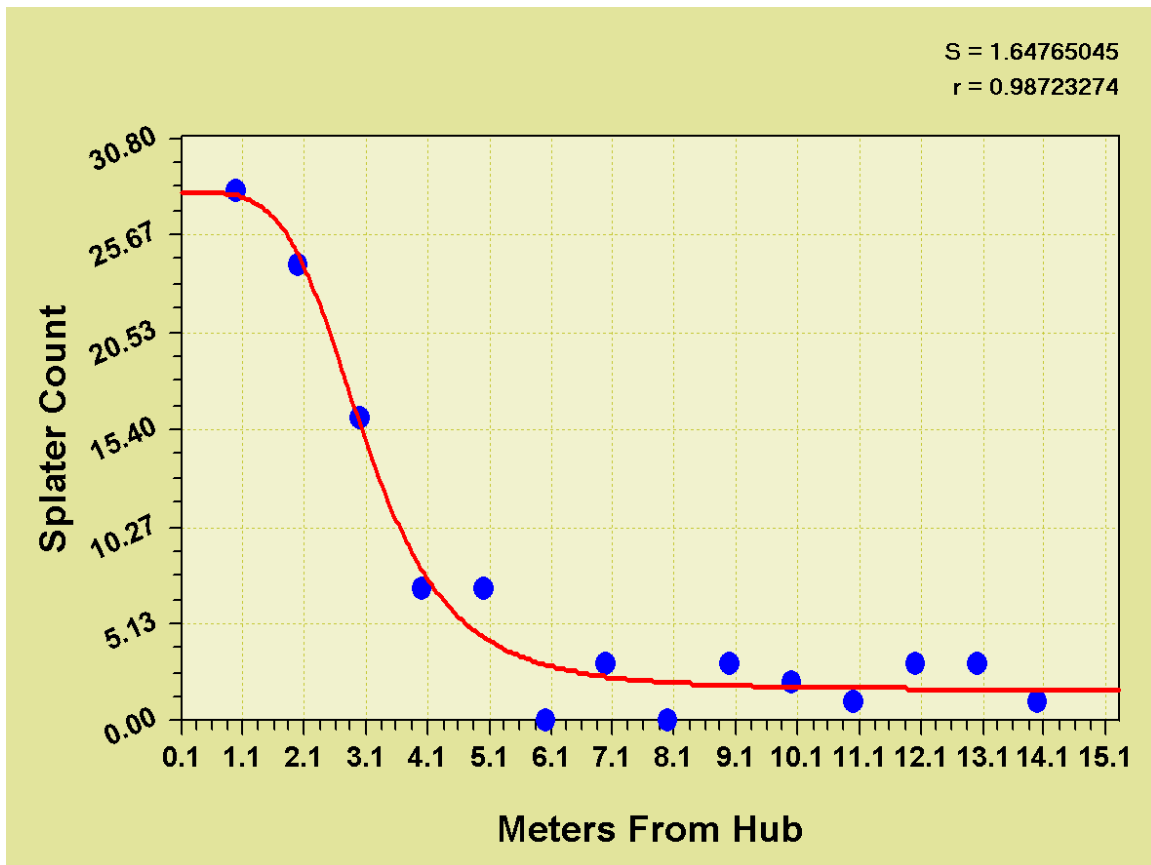
At 38.5m this model integrates to 149.06 splatters. Subtracting the initial 99 splatters, the model estimates 50 splatters over the remaining 24.95 meters.

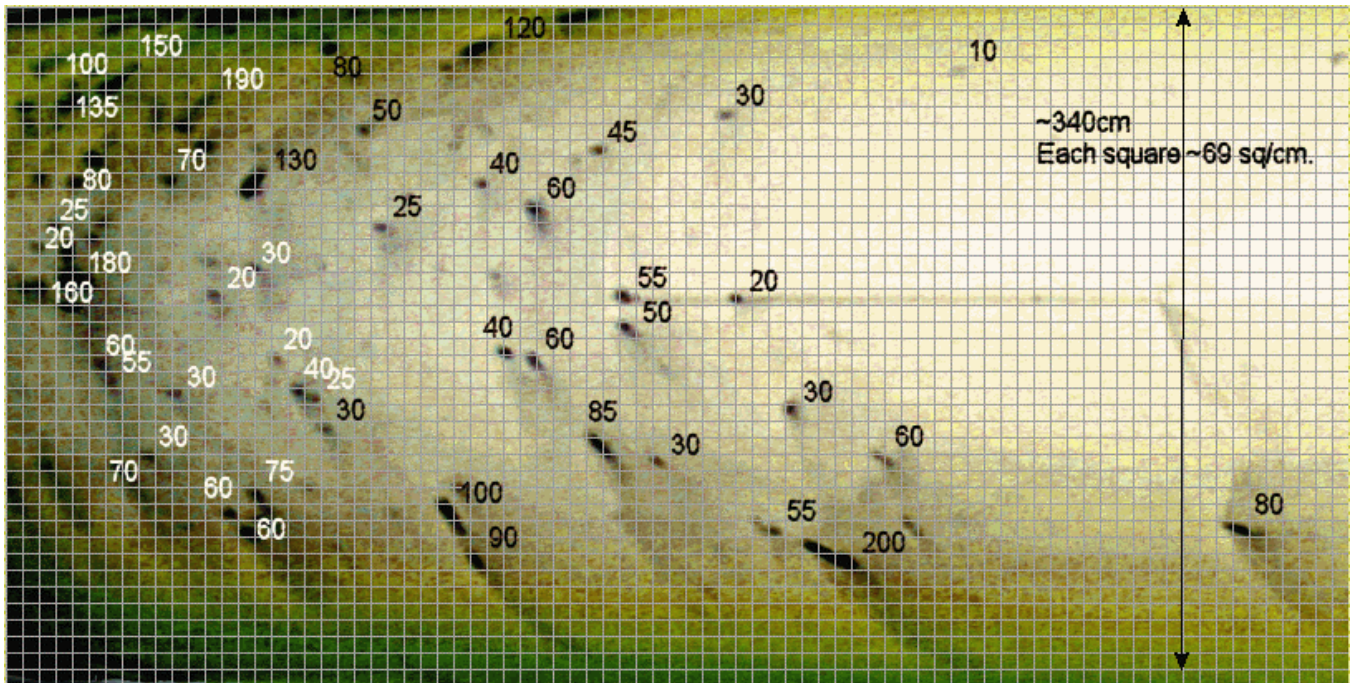
When spatter areas are averaged over the photograph the average **As** is **68 sq/cm**
