WINDFARM DEVELOPMENTS ON BLANKET BOG

***A cautionary tale from Derrybrien, Co Galway,
and
pointers for safeguards needed when similar developments
are proposed for the United Kingdom***

John Phillips, MA, CBiol, MIBiol

September 2005

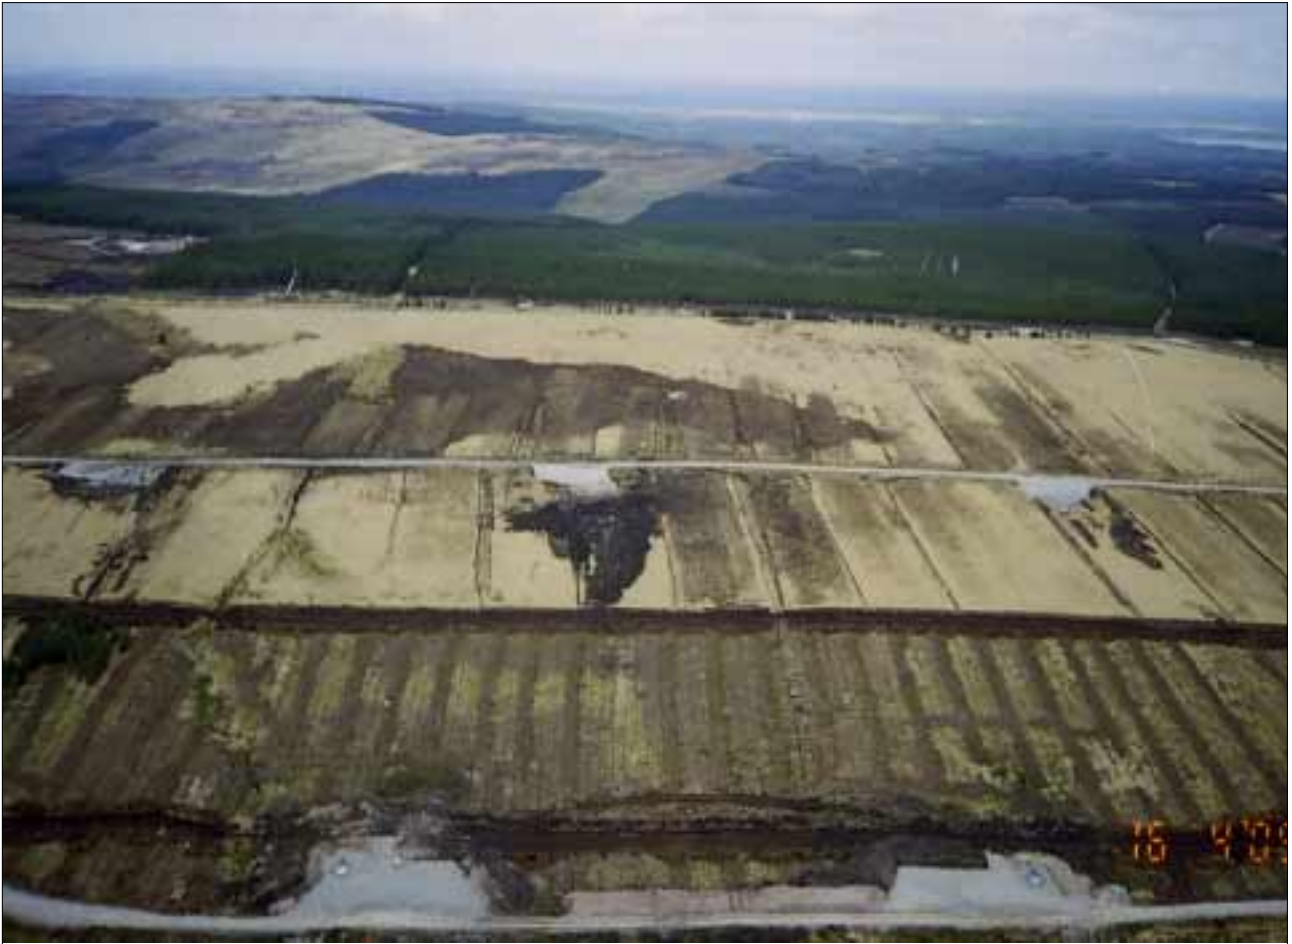
Plate 5: An aerial view of the site looking north towards Loughrea. A nine-turbine wind power site at Sonnagh Old is just visible on the skyline on the top left of the picture.

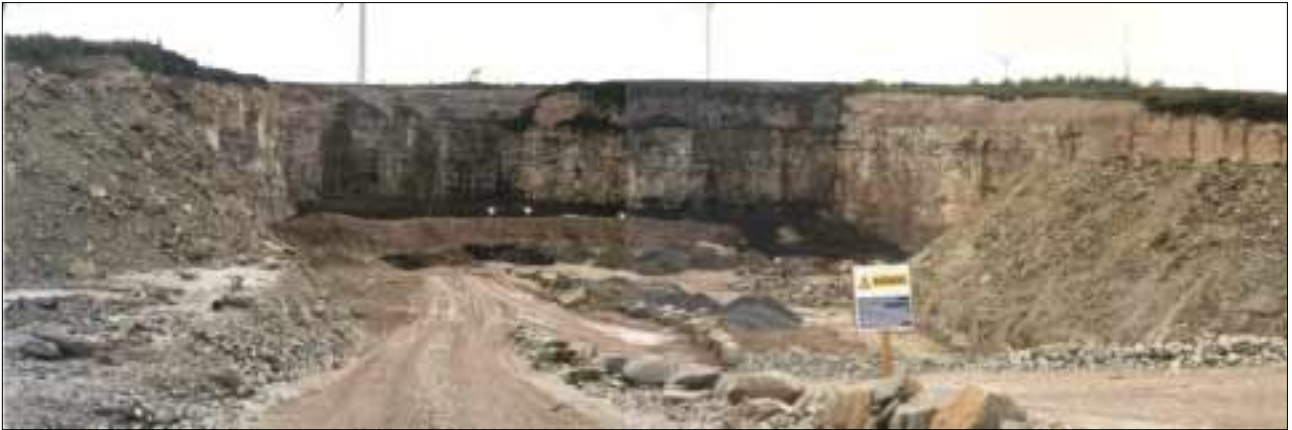
Plate 9: A panoramic view of the quarry taken August 2005.

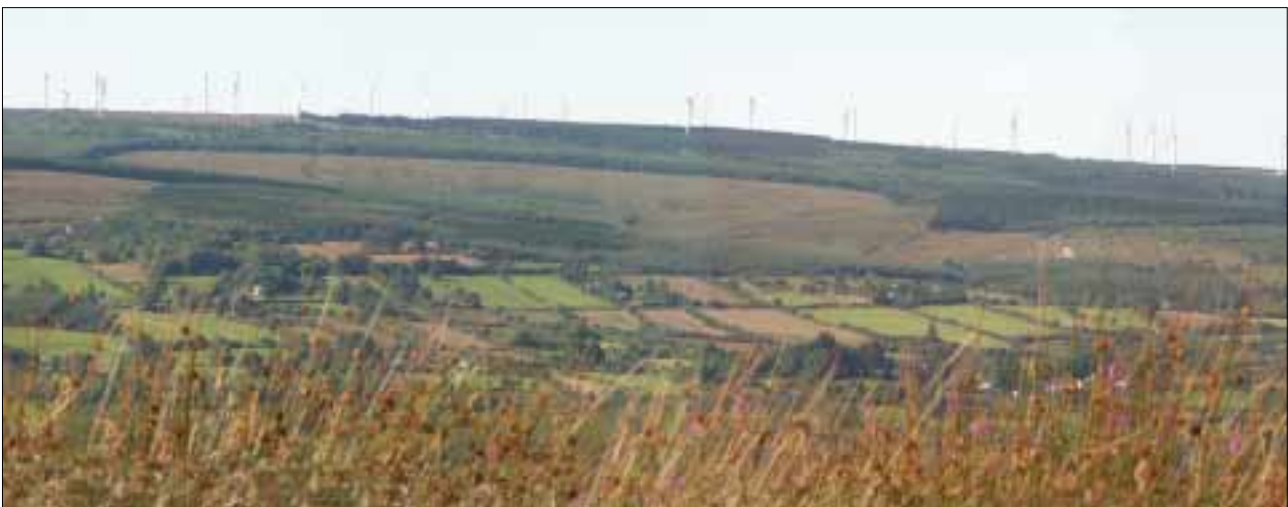
Plate 15: Cashlaundrumlahan, highest of the Slieve Aughty mountains, viewed here from the south. Derrybrien is a scattered community whose dwellings straddle the Gort-Potrumna road. This runs through the middle of the cultivation at the foot of the mountain (left to right in this picture). The slide occurred to the east of the village.
